**PrimeVue**  
**HOME INSPECTIONS**

**NEW BUILD SAMPLE REPORT**

*Inspected by Jude Hwang TREC #25266*

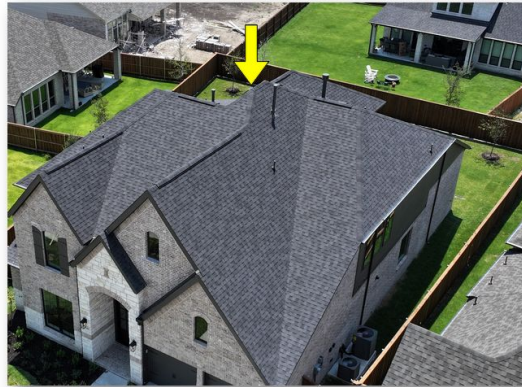
7.

Asphalt shingles covering of ridge on the roof were inadequately bonded.

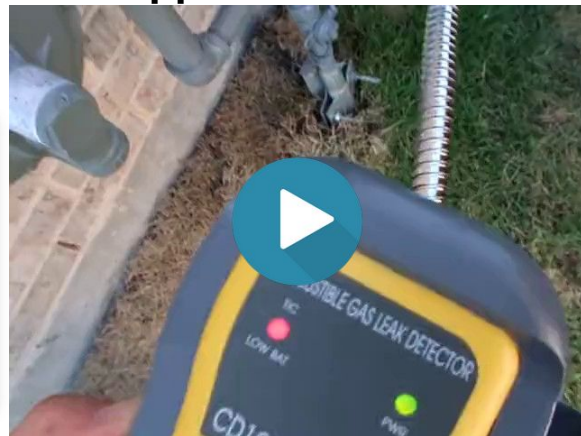
36. Gas is leaking significantly from the elbow of the main gas meter valve pipe coming into the house. An evaluation and repairs as necessary should be performed immediately by a qualified contractor.

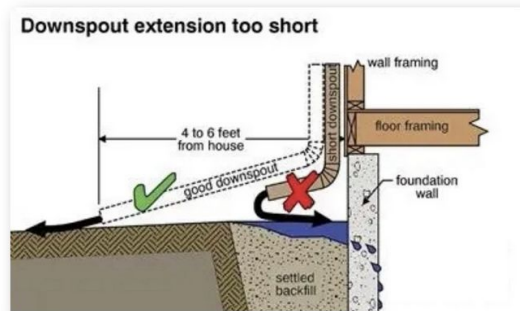
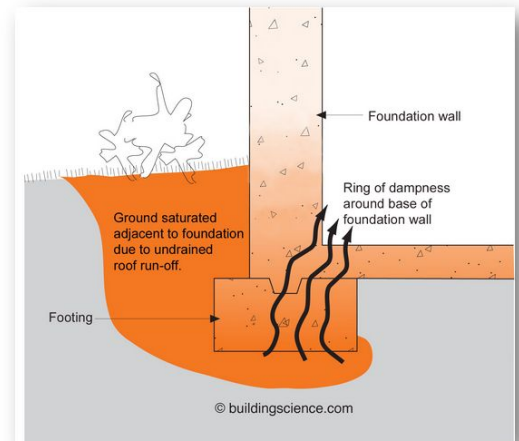
Downspouts designed to discharge roof drainage were damaged that may limit their ability to function as designed. Downspouts should be brought into good working order by a builder.

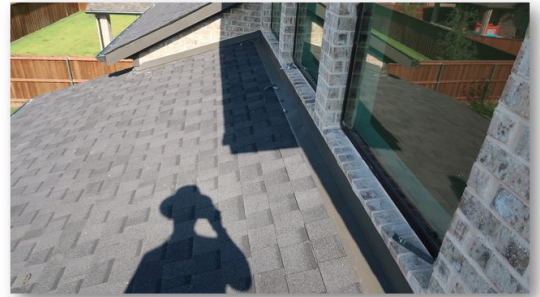
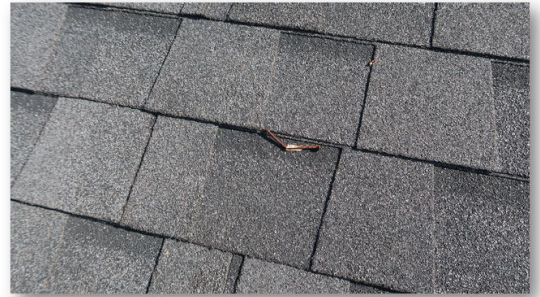
The roof surface of this house needs cleaning. Some materials, such as nails and hardware, were left behind by the roofers after completing the roofing work, and they are still on the roof.

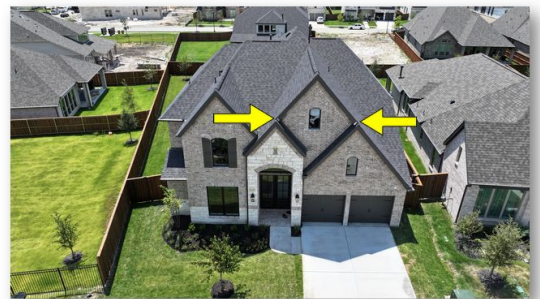
The front roofline flashing of this house lacks sufficient paint. It doesn't blend well with the surrounding trim color. Painting it to match the trim is needed.

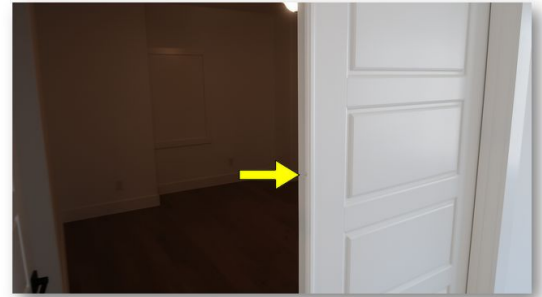
There is slight damage in the middle section of the molding on one side of the double doors in the second-floor media room. It should be repaired to ensure it looks presentable.

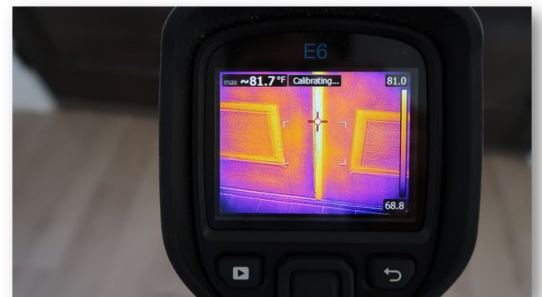
The main exterior double doors of this house are lacking weather seals, especially in the middle section.

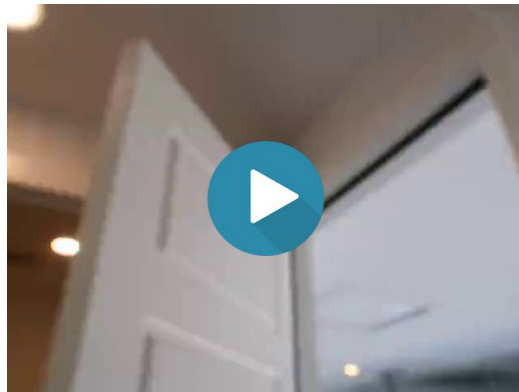
The door in the wall between the garage and the home living space have operable self-closing or automatic-closing device installed as is required by modern safety standards. Self- or automatic-closing doors are designed to slow the spread of fire starting in the garage and to prevent toxic exhaust fumes from entering indoor air. An operable self- or automatic-closing device should be installed by a qualified contractor.

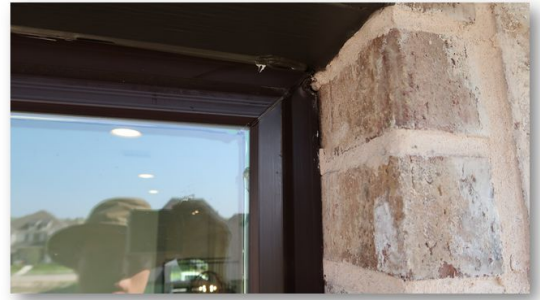
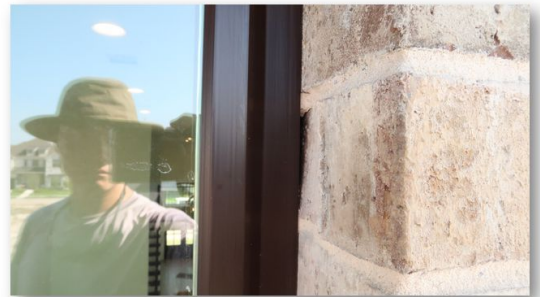
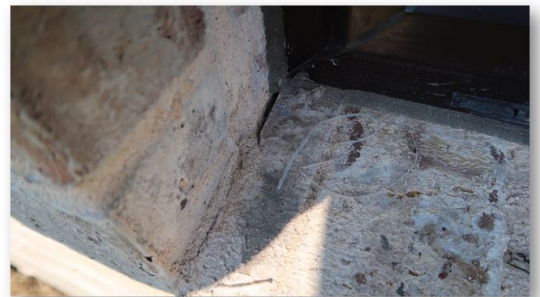
The dormer window on the south roof needs caulking and sealing overall. Numerous gaps were found between the window frame during the inspection.

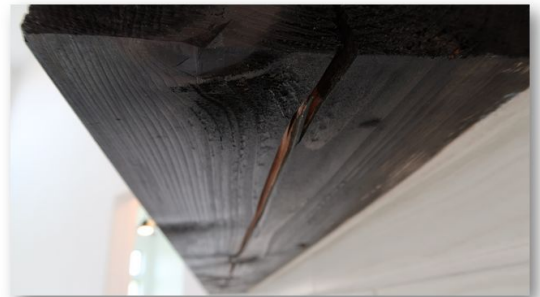
A crack was found under the fireplace decoration board. The builder plans to fill the gap with epoxy.

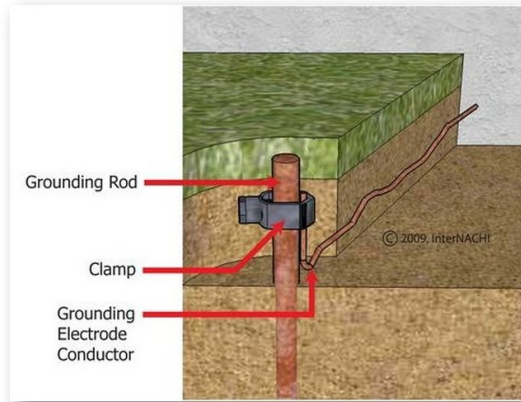
The ground electrode clamp is exposed above the ground. It is recommended to have it flush with the ground.

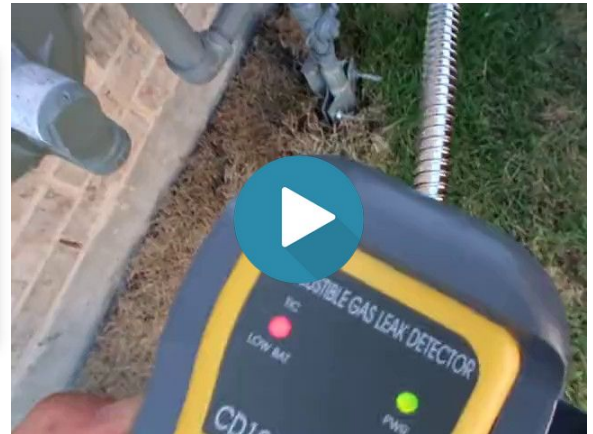
**Gas is leaking significantly from the elbow of the main gas meter valve pipe coming into the house. An evaluation and repairs as necessary should be performed immediately a by qualified contractor.**

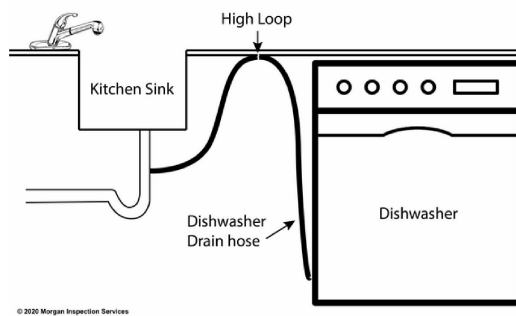
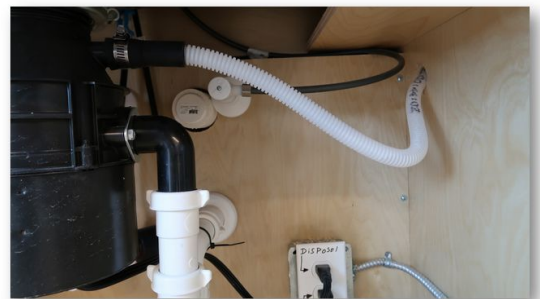
- No anti-siphon loop at the drain line

The dishwasher did not appear to have an anti-siphon device installed in the drain line. Anti-siphon devices are installed to prevent wastewater from the dishwasher from being siphoned back into the dishwasher and contaminating its contents. An anti-siphon device should be installed by a qualified technician.
