PrimeVue
HOME INSPECTIONS

HOME AND TERMITE INSPECTIONS
254-727-0900
TX

Inspected by Jude Hwang TREC #25266

DEFICIENCY SUMMARY

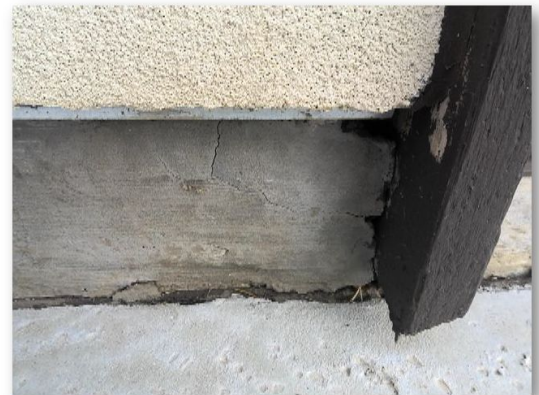
Unfinished foundation hardware, tie rods or snap ties observed at the time of inspection. The location is west side of front on the corner. Metal snap-ties protruding from the foundation were sharp and may cause injury. Snap-ties should be broken off at the foundation surface.

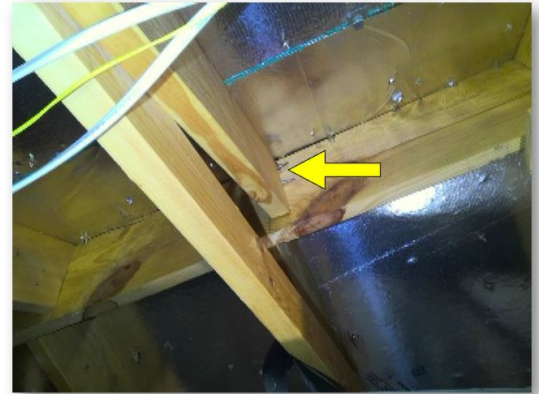
One or more rafters appeared to be separated from the ridge board. This could be correlated to evidence of structural movement. This can be repaired by nailing a supporting rafter to the existing rafter, forming a tight fit at the ridge. The supporting rafter should be the same width as the existing rafter and should be mitered at the end.

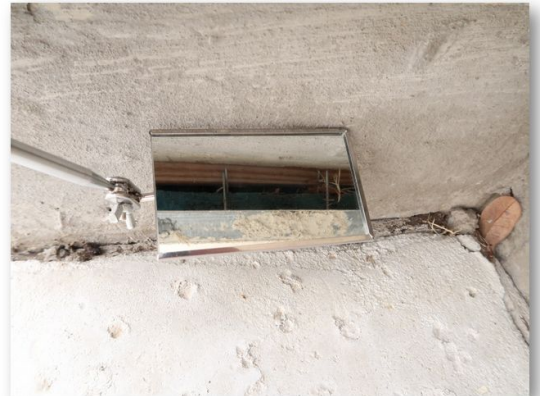
The weep screed on the house's exterior stucco requires evaluation by the builder. The area of concern is around the garage door, as shown in the photos.

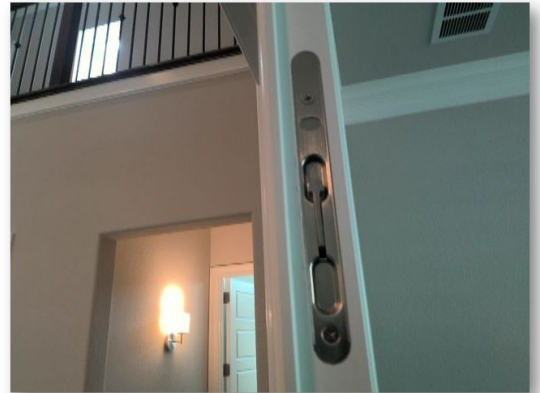
The lock hardware on the office door is not functioning. It needs to be repaired or replaced.

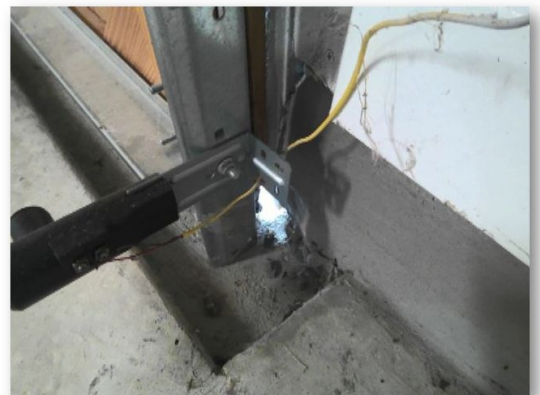
The garage door has a gap on the side where it leaves the interior exposed to allow animals or the elements to enter the garage, we recommend that this be sealed with a piece of trim or that the garage door be adjusted.

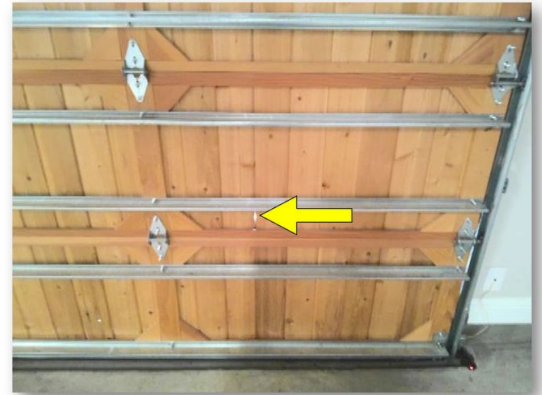
An air gap has been identified in the interior panel of the garage door. It is recommended to fill the gap with a wood filler.

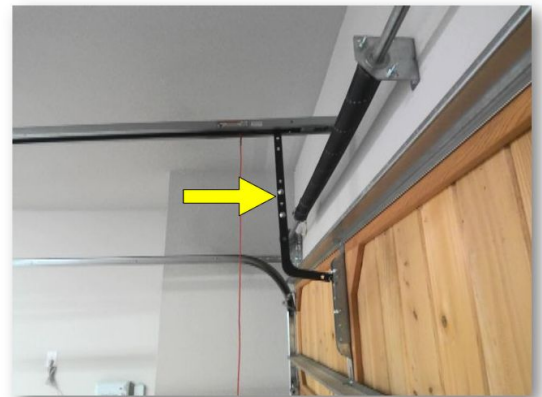
It was noted that the eastern garage door makes significantly more noise compared to the other doors. It is recommended to adjust the garage door's hockey stick to the 1 o'clock position.

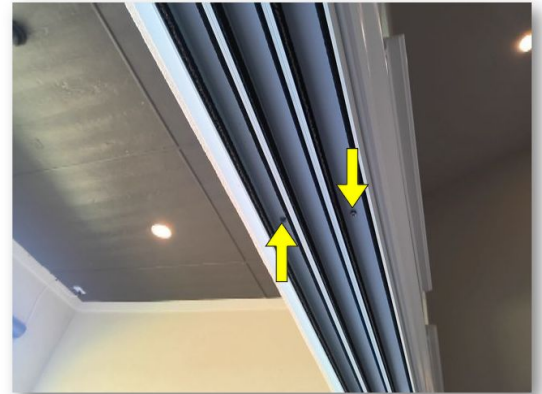
The rail mounting bolts for the main sliding door in the living room have loosened and are coming down. The bolts need to be tightened securely to prevent damage to the door during operation.

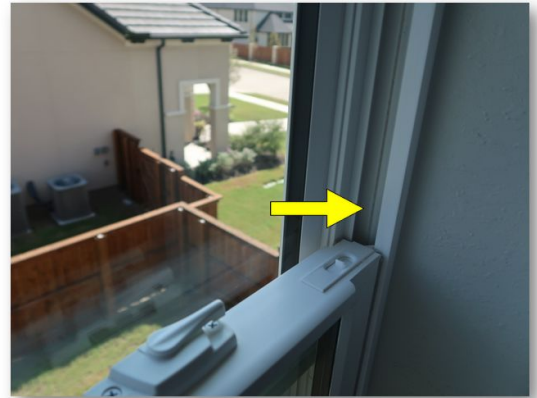
Absence fall protection at window

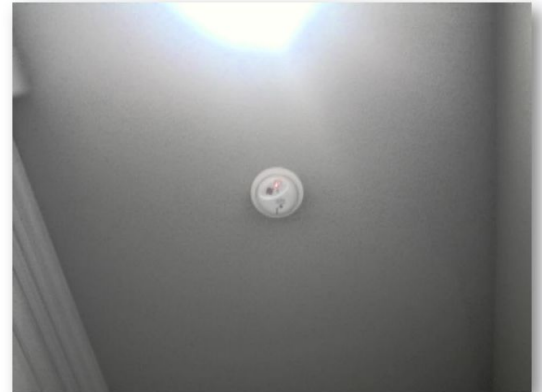
A red light is flashing abnormally on the smoke alarm device located in the ceiling between the indoor space and the garage. Evaluation and repair by the builder are needed.

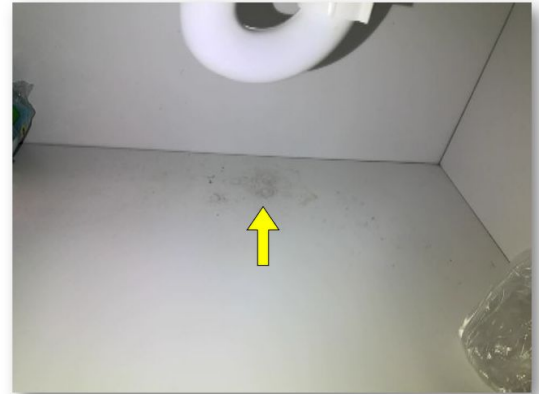
Mold has been observed on the floor of the sink cabinet in the bathroom with the upstairs drum. While there is no active leak at the moment, the underlying cause needs to be addressed. There is a possibility that water is dripping into the sink due to a lack of silicone sealant where the sink meets the wall.
