HOME AND TERMITE INSPECTIONS
254-727-0900
1234 DALLAS

Inspected by Jude Hwang TREC #25266

DEFICIENCY SUMMARY

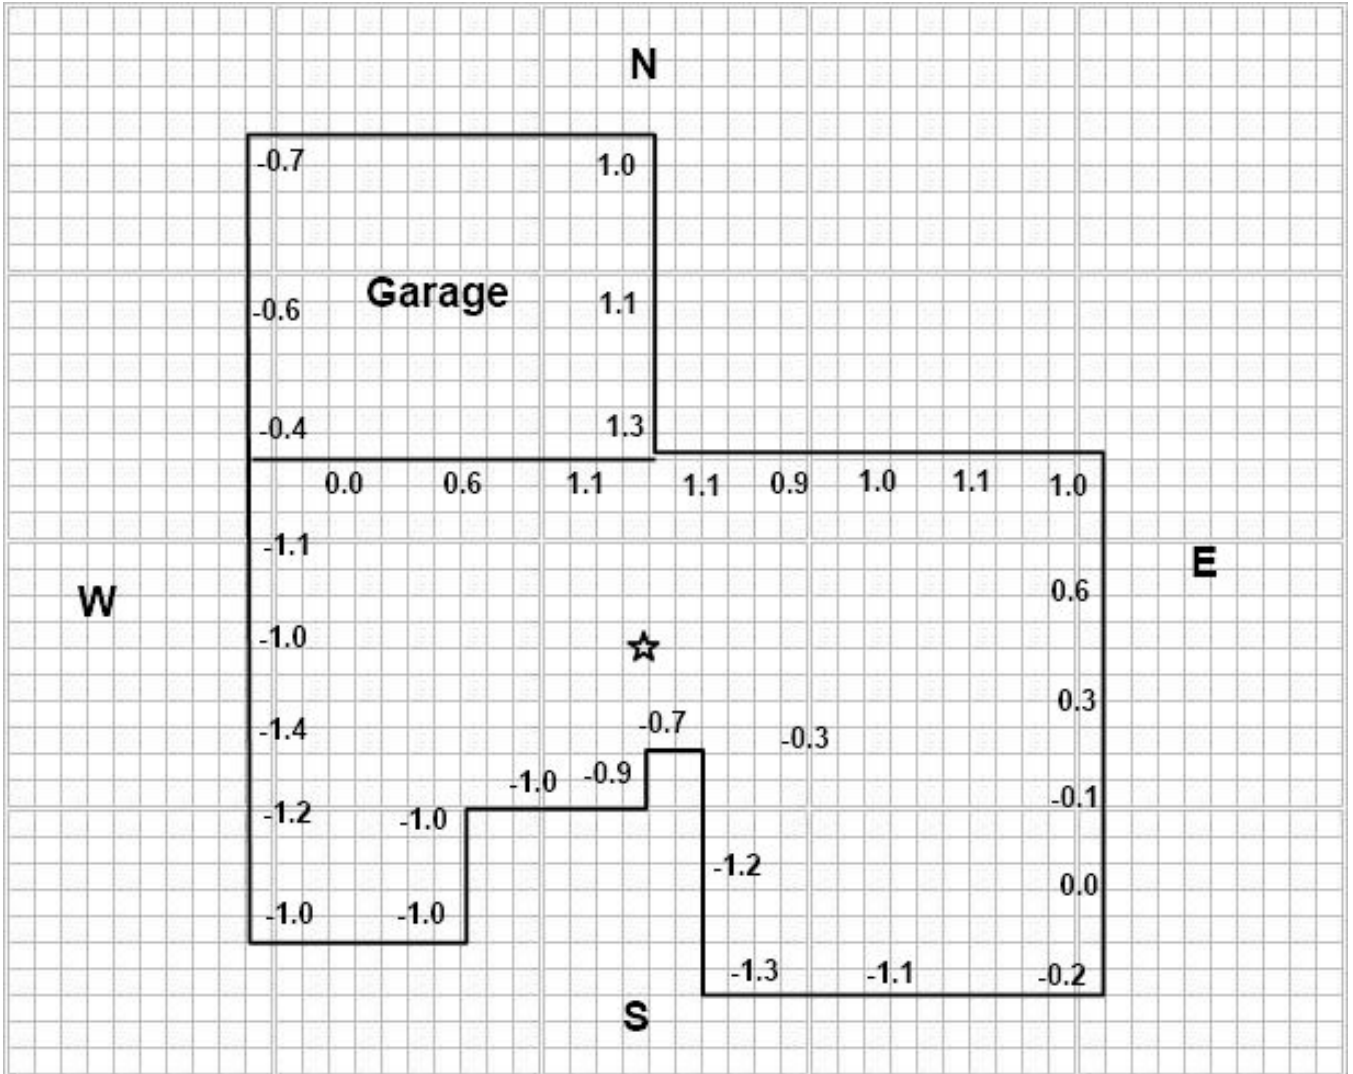
During the foundation elevation test, the area around the southwest corner showed a negative slope. The zero reference point is around the main entrance door. A certified foundation engineering precision evaluation is recommended.

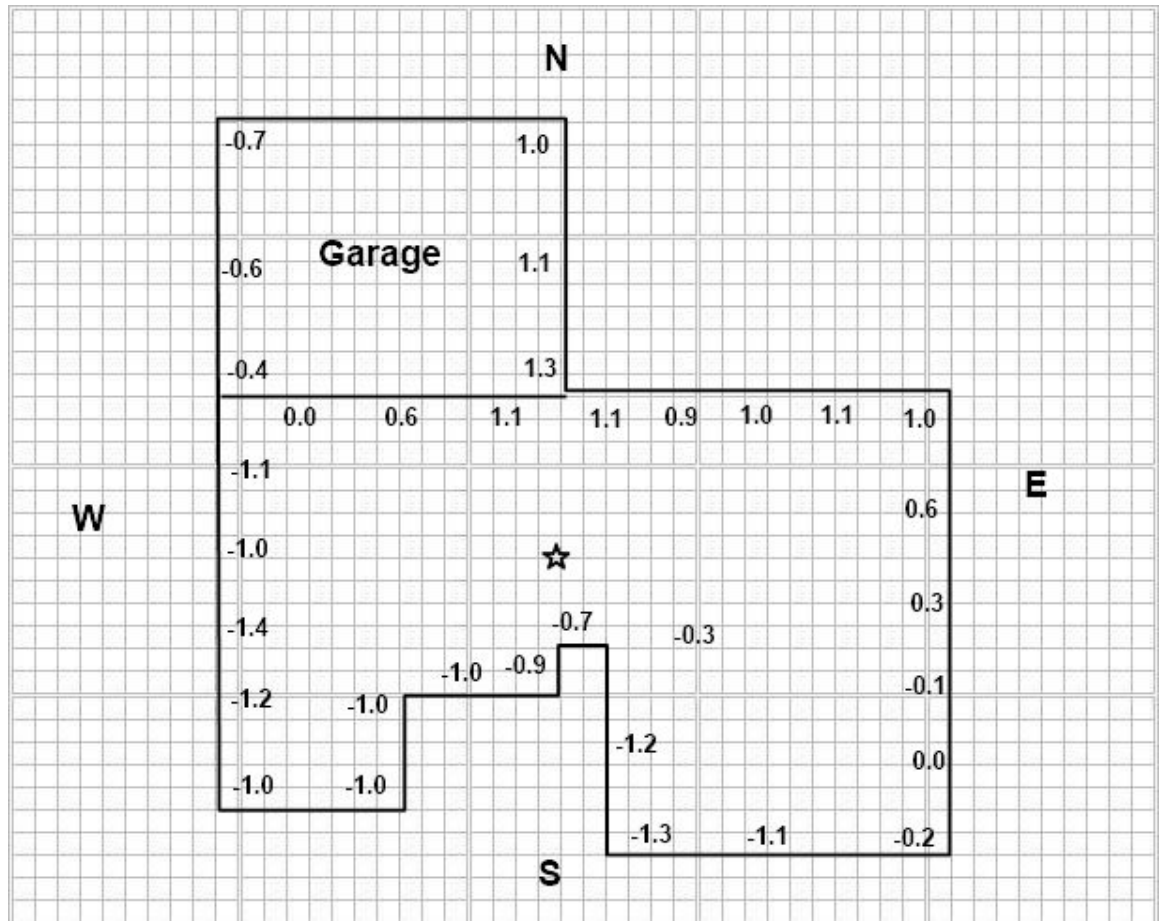
Foundation Elevation Test by ZipLevel

During the foundation elevation test, the area around the southwest corner showed a negative slope. The zero reference point is around the main entrance door. A certified foundation engineering precision evaluation is recommended.

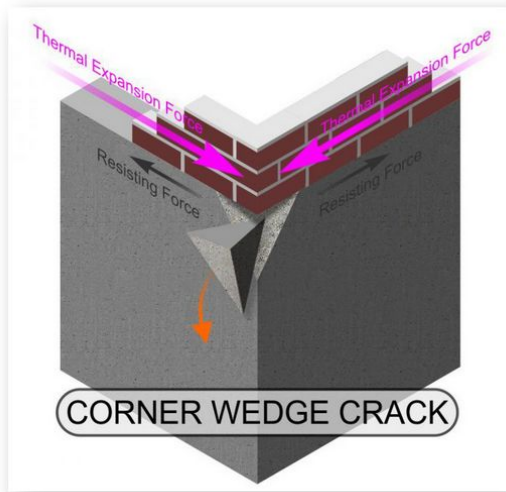
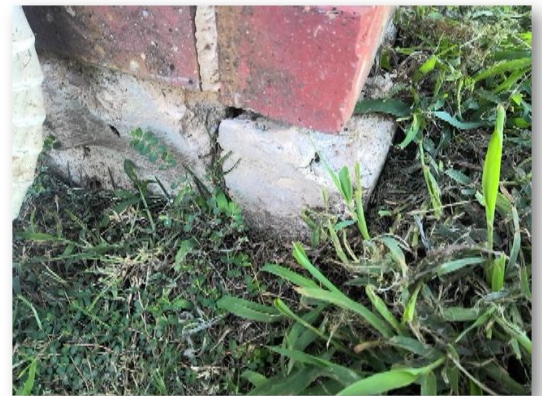
East Back

Tree(s) in close proximity of the foundation was observed. Client should consider the installation of a root barrier to reduce the possibility of damage to the foundation from tree roots

and moisture removal, or have the trees taken down so that they do not damage the property over time.

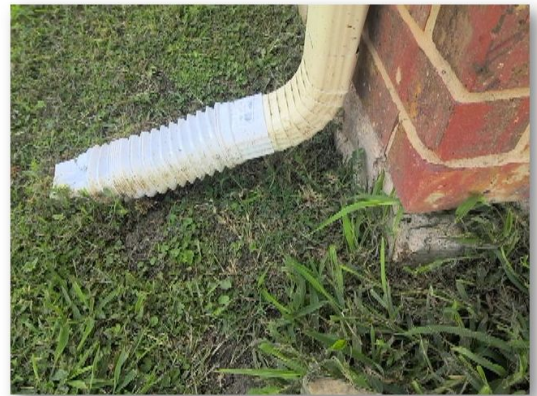
Missing Splash Gaurd

- Gutters draining too close to the structure
- Grade slopes toward the structure

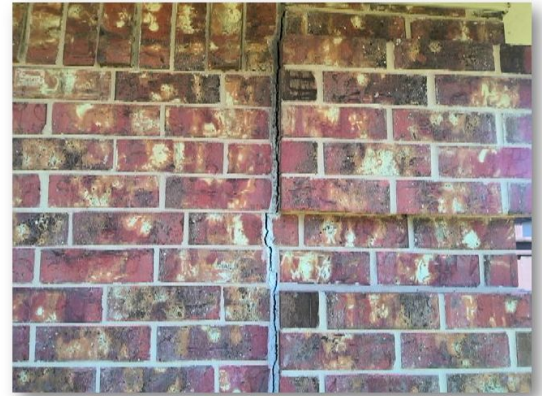
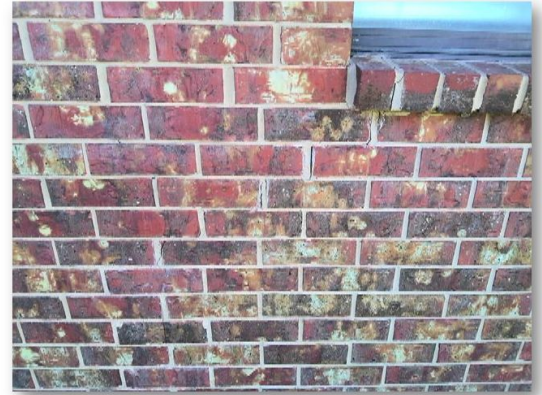
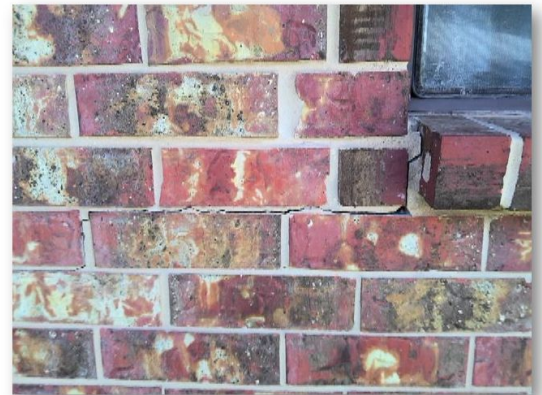
One or more common cracks were observed on the brick/stone veneer. This may be due to normal settling and/or thermal movement of the building materials. These areas should be sealed to prevent moisture penetration and monitored for further signs of movement.

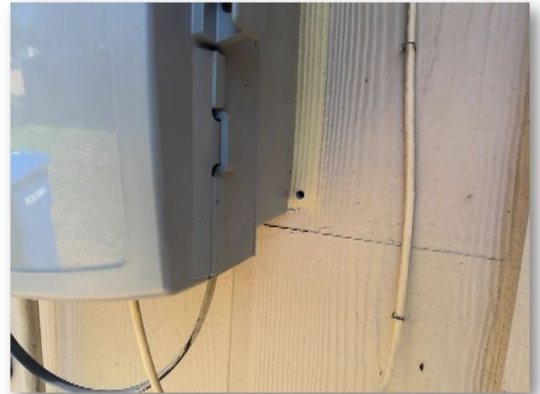
Pipes penetrating exterior walls left gaps that needed to be sealed by a qualified contractor with an appropriate sealant to prevent moisture and insect entry.

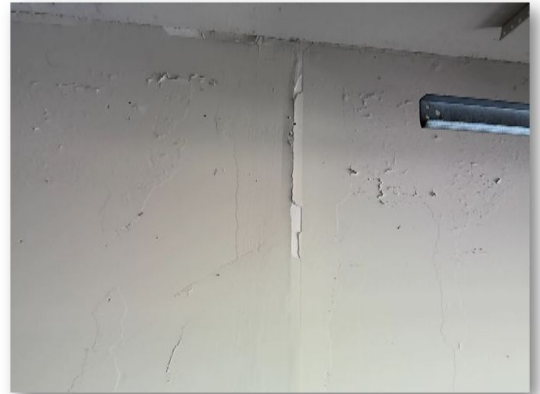
Drywall patches installed in the garage were poorly executed. Drywall seams visible in the walls of the garage were typical of poor installation.

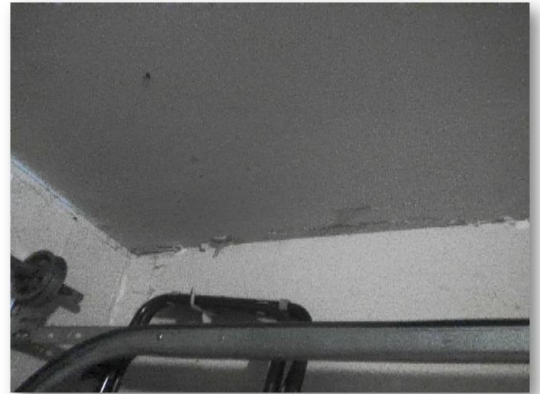
There are several areas where the ceiling and walls of the garage meet that show signs of chipping. Patching is needed, and since this could be due to structural movement, ongoing monitoring is recommended.

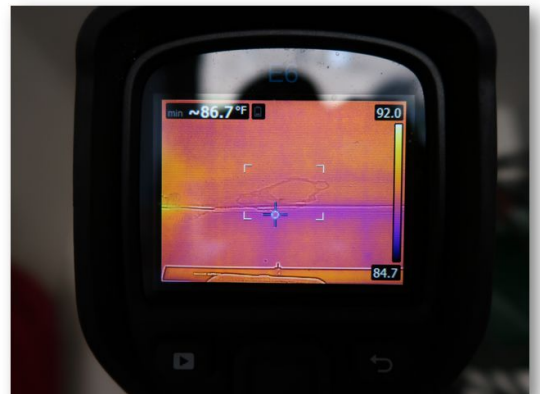
Water stains were discovered on the garage ceiling, but an infrared camera scan indicated no moisture retention.

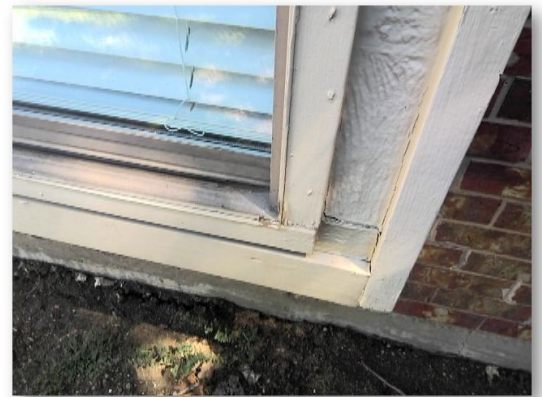
Windows and trim outside the house require caulking to prevent possible moisture damage

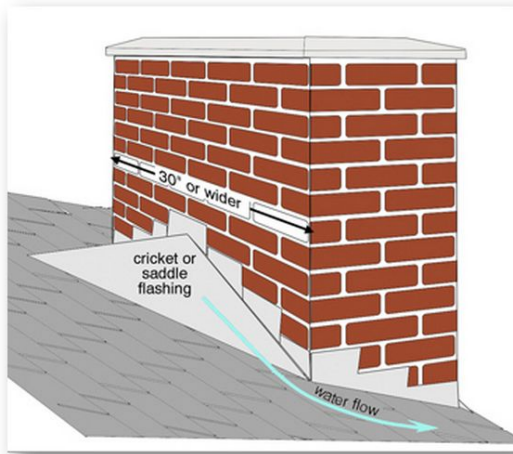
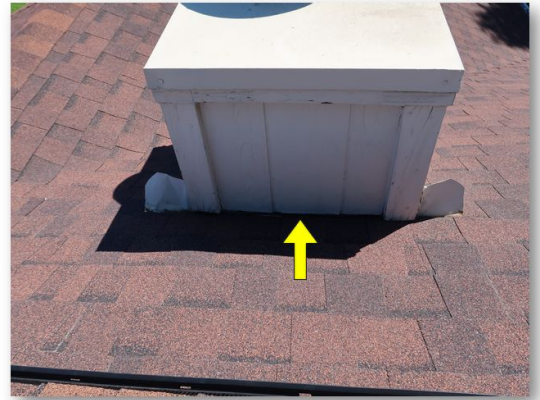
The chimney had no cricket. A cricket is a small roof built on the uphill side of the chimney to prevent roof drainage from pooling and causing damage from roof leakage.

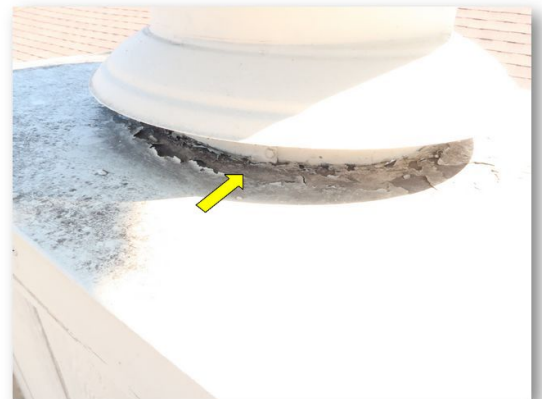
There is paint chipping on the chimney sidewall, and paint is peeling around the rain cover.

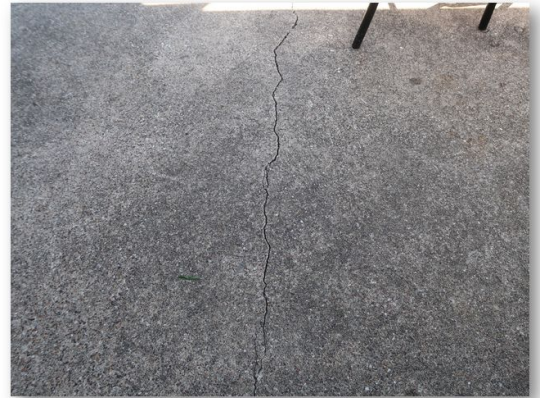
There are tile cracks and hairline cracks in the floors of the front porch and backyard patio.

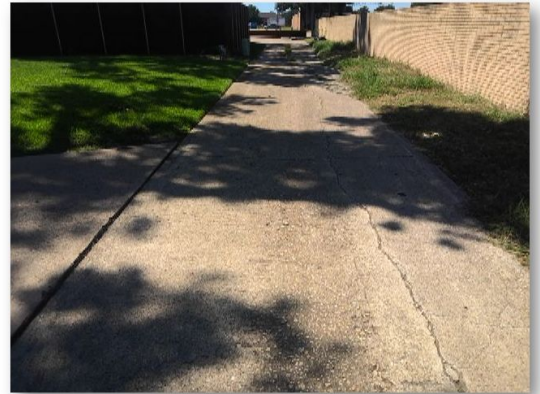
Notable cracks are evident in both the walkway floor and the curbing.

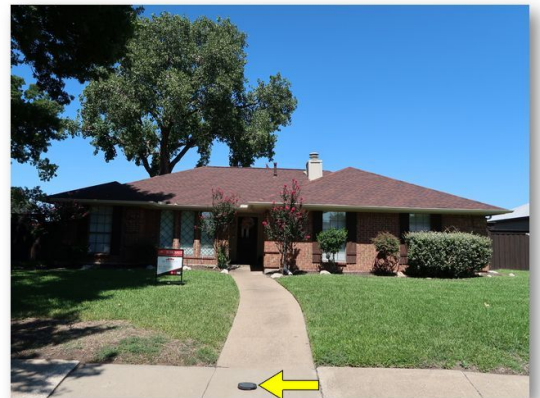
The city sewer line cover is protruding above the walkway floor. This poses a tripping hazard for children and pedestrians. The cover should be adjusted to be flush with the floor as soon as possible, as it is a safety hazard.

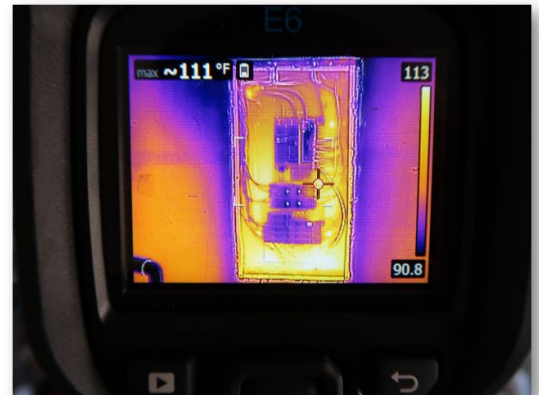
Various minor issues have been found in the electrical panel. An evaluation by a licensed electrician is needed.

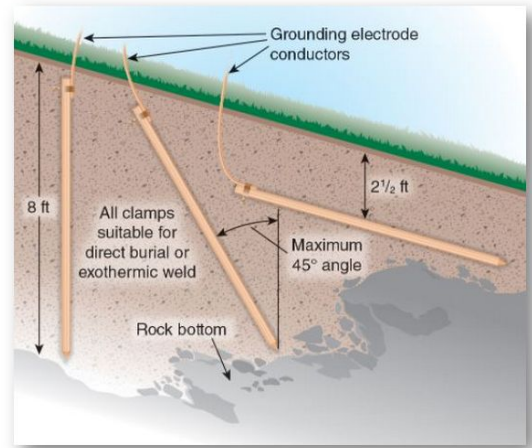
The electrical service was grounded to a driven rod. Driven rods have length requirements that cannot be confirmed once the rod has been installed. Confirming an effective service grounding would require the services of a qualified electrical contractor using special instruments.

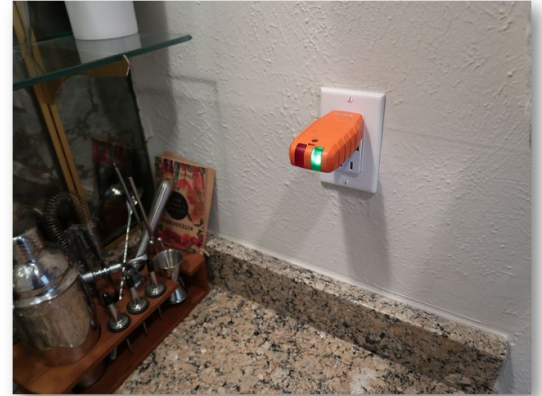
Electrical receptacles in the wet bar was installed upside down, with the ground holes above the neutral and hot slots. This condition sometimes indicates a switched receptacle.

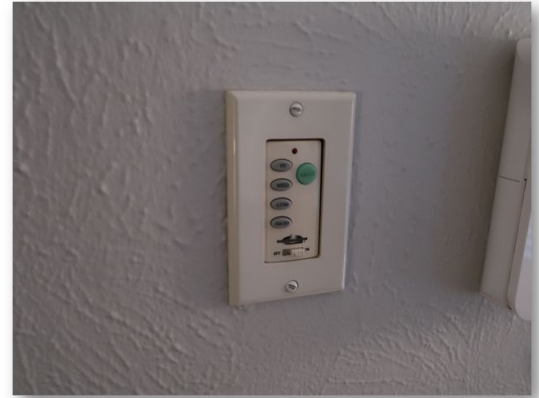
Ceiling fans inoperable or in need of repair

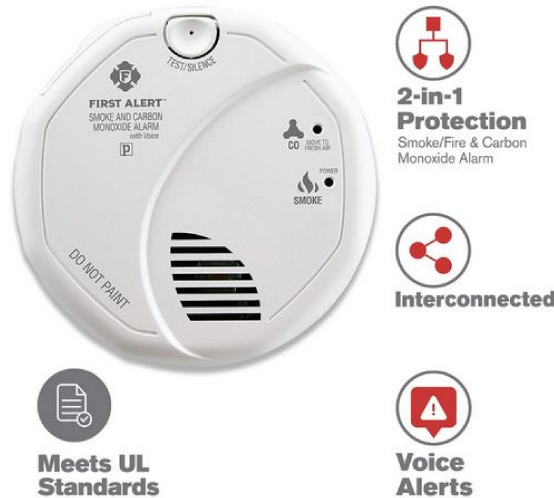
There are missing carbon monoxide alarms in the home. Carbon monoxide alarms should be installed in accordance with current standards, as follows: 2009 International Residential Code R315.2.1 New construction. Carbon monoxide alarms shall be provided in dwelling units when either or both of the following conditions exist. 1. The dwelling unit contains a fuel- fired appliance. 2. The dwelling unit has **an attached garage with an opening that communicates with the dwelling unit**. R315.3 Location. Carbon monoxide alarms in dwelling units shall **be installed outside of each separate sleeping area in the immediate vicinity of the bedrooms**. When a fuel-burning appliance is located within a bedroom or its attached bathroom, a carbon monoxide alarm shall be installed within the bedroom. Carbon monoxide is an odorless, colorless, and tasteless gas that is near impossible to identify without a proper detector. It is caused by fuels not burning completely, including wood, gasoline, coal, propane, natural gas, gasoline, and heating oil. This unburned fuel can come from anything from clothes dryers, water heaters, and ovens to ranges, a fire-burning fireplace, or a car left running in a closed garage.

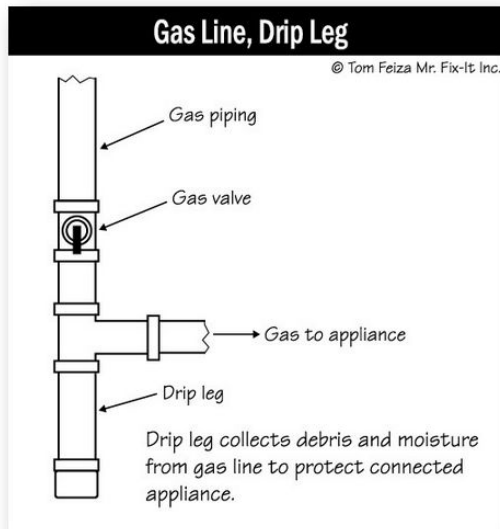
The direction of the gas line valve handle supplying the furnace is reversed, making it difficult to operate. It needs to be replaced. Additionally, the gas line sediment trap is missing.

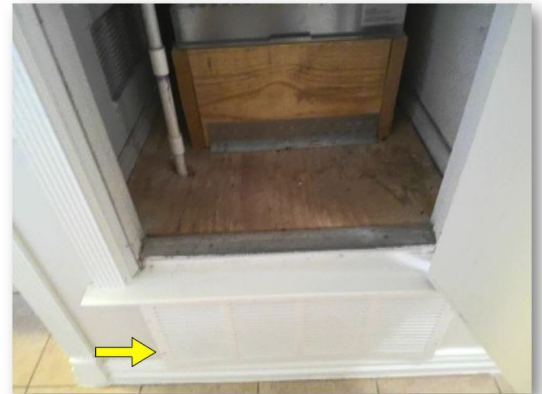
Moisture was detected by an infrared camera near the lower condensate drain line of the furnace return. A check by an HVAC professional is needed.

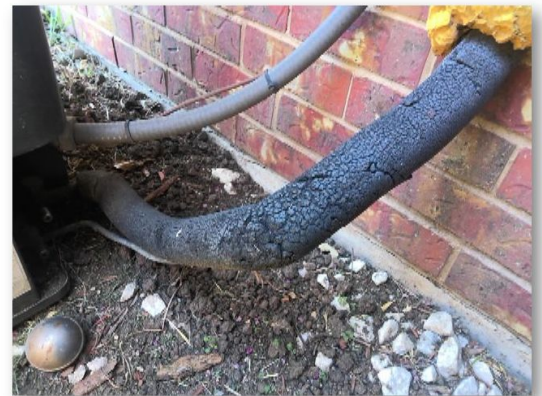
The insulation on the suction line of the outdoor AC unit is old and heavily worn. Replacement is recommended. Additionally, silicone sealing is needed around the area between the exterior wall and the fuse case.

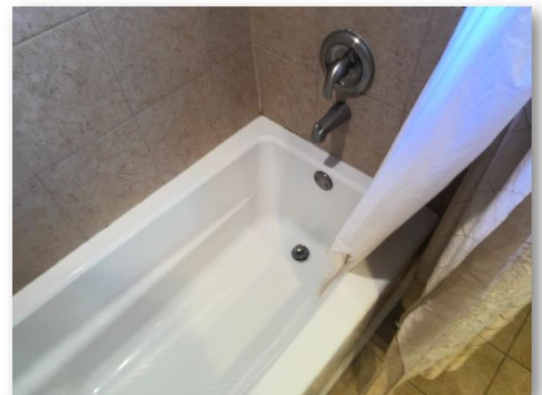
Several sinks and bathtubs have drain stoppers that are not functioning properly. Repairs are needed to ensure the drain stoppers work smoothly.

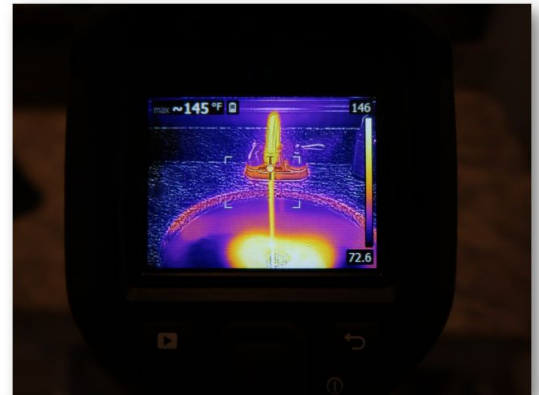
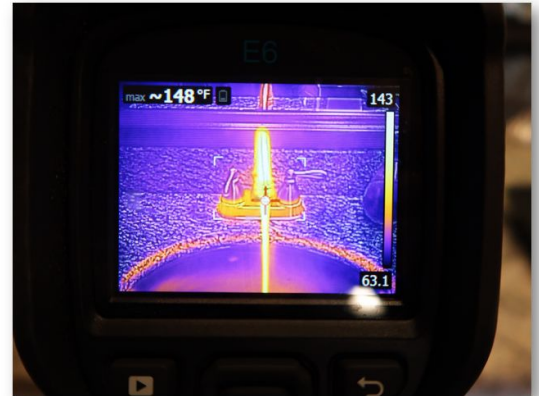
Water Temp: 145~148°F Recommended Hot Water setting should between 115°F – 120°F

The water temperature is generally set too high. The recommended maximum temperature is 120°F to prevent the risk of burns, especially to children's hands.
