**PrimeVue**  
HOME INSPECTIONS

**HOME AND TERMITE INSPECTIONS**  
**254-727-0900**

*Inspected by Jude Hwang TREC #25266*

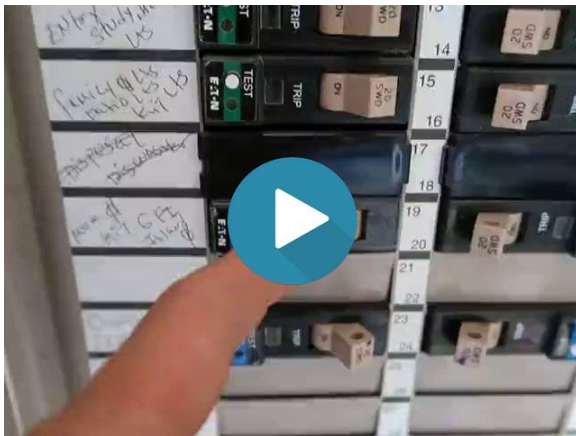
4.

D-The GFCI outlet associated with the kitchen island sink receptacle is frequently tripping, which could indicate an issue with the outlet itself or a potential underlying electrical problem; it is recommended to have this outlet evaluate and, if necessary, replaced by a certified electrician to ensure safety and consistent functionality.

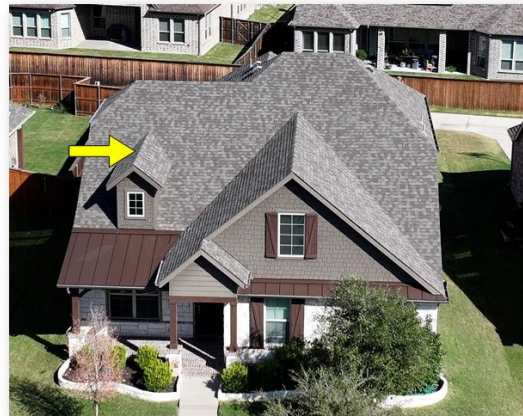
6.

**M-Mechanical damage** refers to any damage caused installing shingles or equipment, cleaning gutters, making repairs, or performing construction work of other types can put people on the roof with tools or equipment capable of damaging shingles.

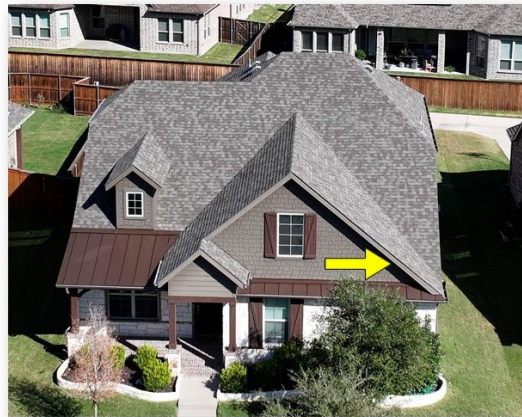
11. M-Chip damage was observed on the front eave of the house. Repair is recommended to prevent potential worsening of the damage and to maintain the integrity of the eave.

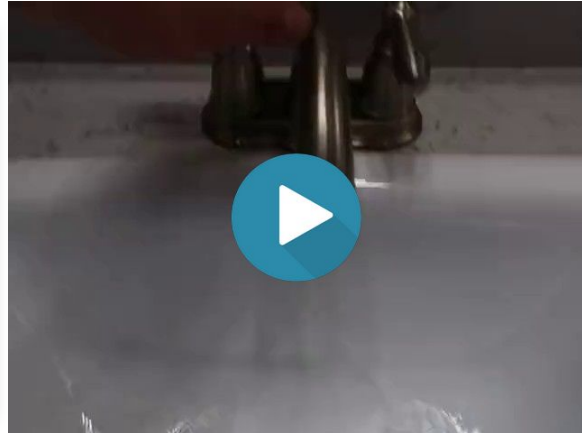
25.

M-One of the bathroom drain stoppers was not functioning properly, preventing effective operation; adjustment or replacement is recommended to restore full functionality.

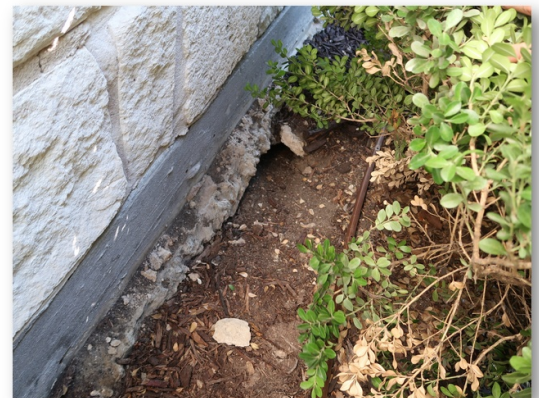
M-Sinkholes are observed around the front of the house. These depressions in the soil indicate poor drainage management, which can lead to water pooling near the foundation. Left

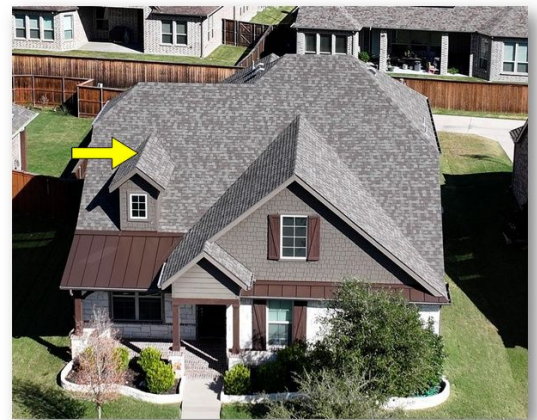
**M-Mechanical damage** refers to any damage caused Installing shingles or equipment, cleaning gutters, making repairs, or performing construction work of other types can put people on the roof with tools or equipment capable of damaging shingles.

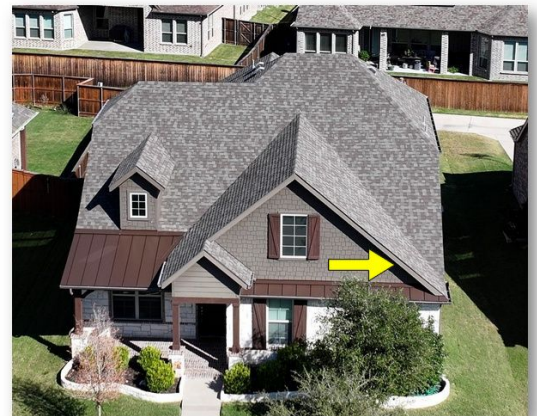
M-Chip damage was observed on the front eave of the house. Repair is recommended to prevent potential worsening of the damage and to maintain the integrity of the eave.

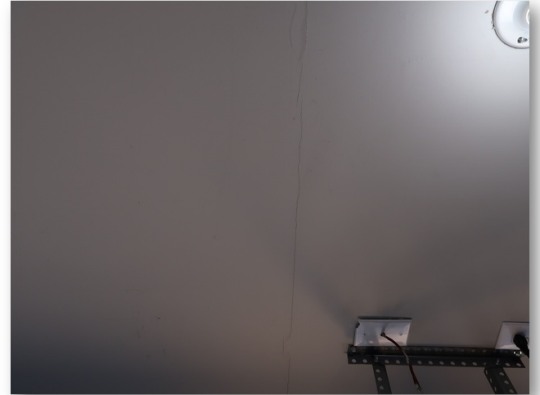
M- Minor cracking was visible in the garage ceiling.

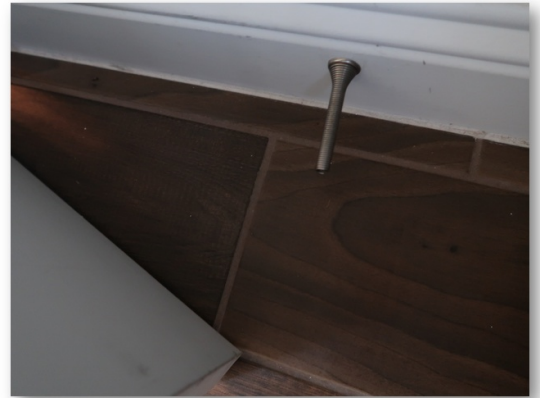
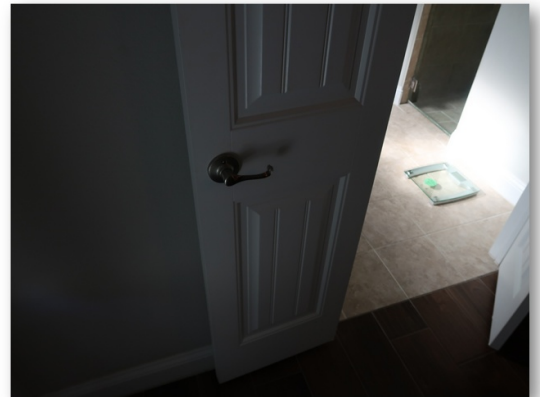
D-An interior doors were missing or pull off a stop. This condition is may result in wall and door damage. A stop be installed to protect the wall.

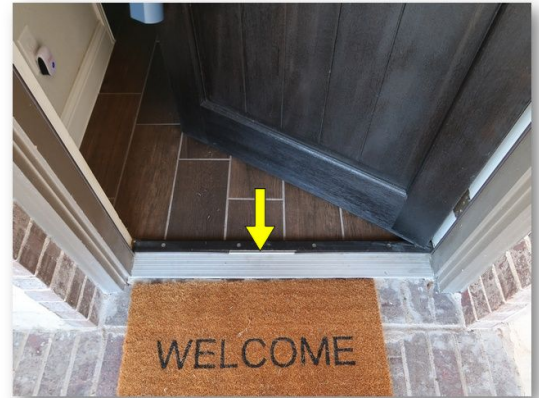
M-The weather seal at the bottom threshold of the exterior door at the house entrance is damaged, which may allow air and moisture intrusion; repairing or replacing the seal is recommended to ensure proper insulation and protection against weather elements.

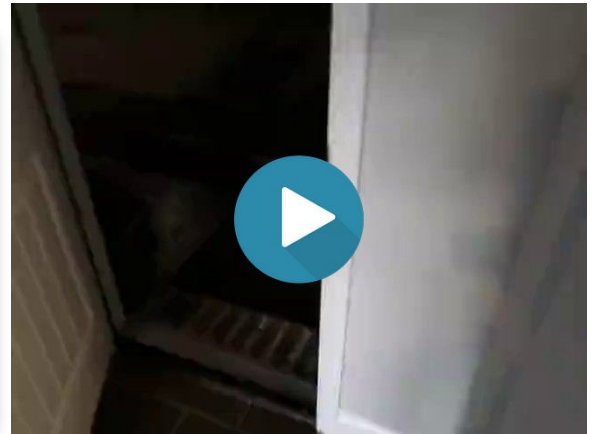
The door in the wall between the garage and the home living space operable self-closing or automatic-closing device installed as is required by modern safety standards. Self- or automatic-closing doors are designed to slow the spread of fire starting in the garage and to prevent toxic exhaust fumes from entering indoor air. An operable self- or automatic-closing device should be installed by a qualified contractor.

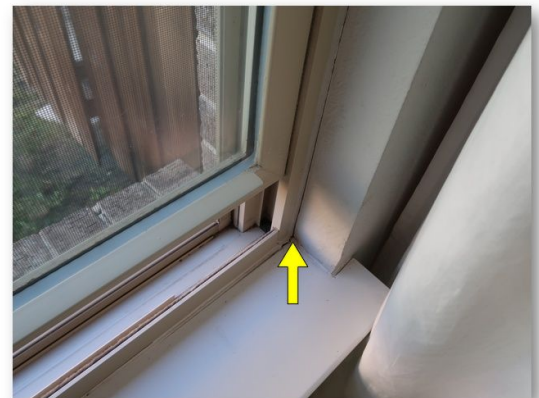
M-There is a gap in the silicone sealant at the corner of the exterior window frame on the front of the house, as well as at the bottom corner of one of the interior window frames. Sealing these gaps is recommended to prevent potential air and moisture intrusion.

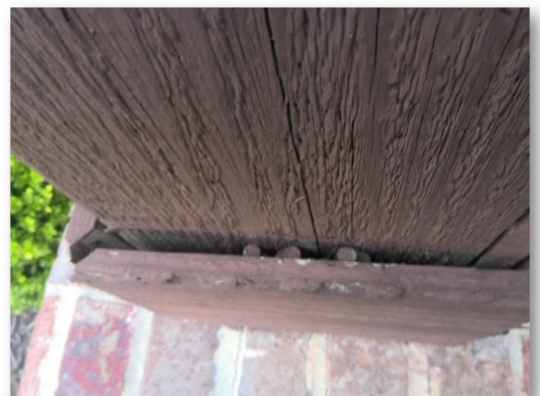
M-The connection at the bottom of the wooden porch column by the front door is separating, with nails visibly inserted. Repairing this area is recommended to ensure stability and prevent further separation.

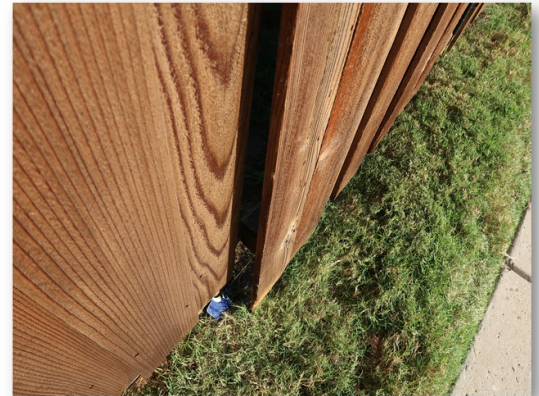
D-The gate on the fence by the garage does not close completely. Adjustment or repair is recommended to ensure proper functionality.

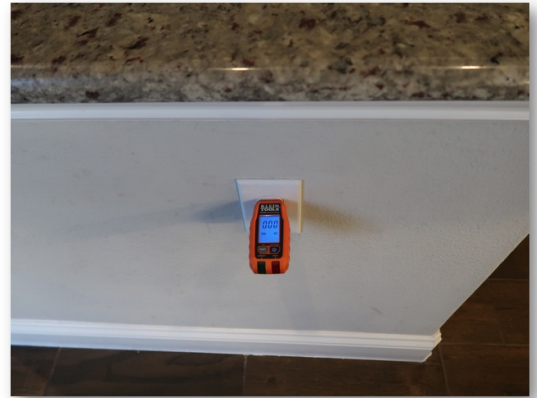
D-The GFCI outlet associated with the kitchen island sink receptacle is frequently tripping, which could indicate an issue with the outlet itself or a potential underlying electrical problem; it is recommended to have this outlet evaluate and, if necessary, replaced by a certified electrician to ensure safety and consistent functionality.

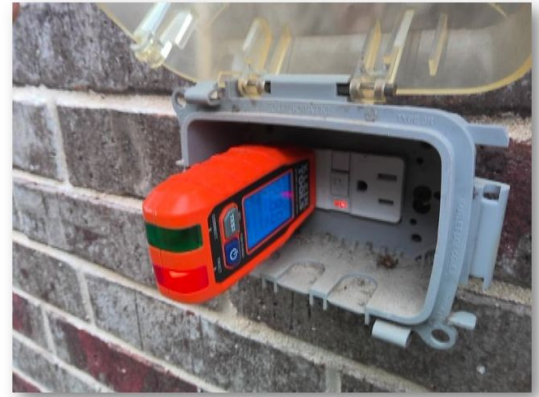
**S-**An open ground error was detected in the GFCI outlet near the electric meter, which can pose a safety risk. Evaluation and correction by a licensed electrician are recommended to ensure proper grounding and electrical safety.

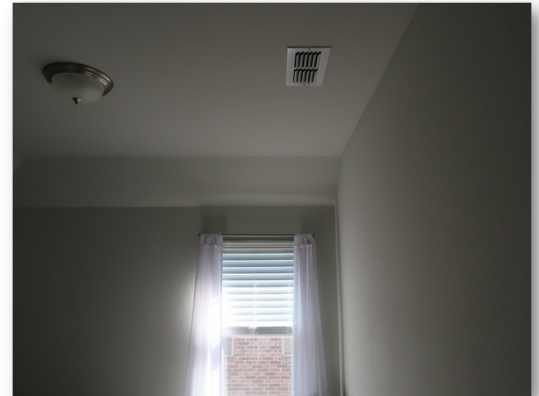
D-The HVAC supply in the second-floor guest room is not delivering air from the air handler, potentially due to a blockage or system malfunction; observation and evaluation by a certified HVAC technician are recommended to diagnose and restore proper airflow and functionality.

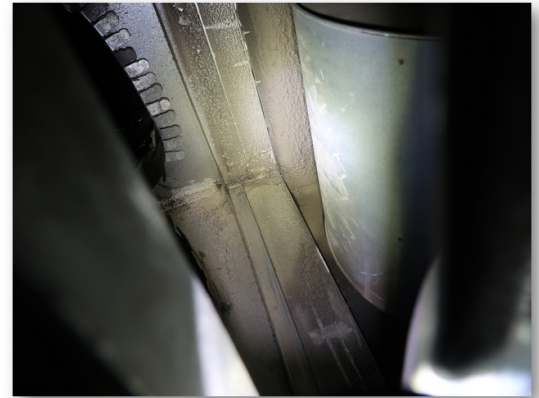
D-The furnace is currently missing an air filter, which can lead to decreased efficiency and potential buildup of dust and debris within the system; installing the appropriate filter is recommended to ensure optimal performance, protect internal components, and maintain air quality.

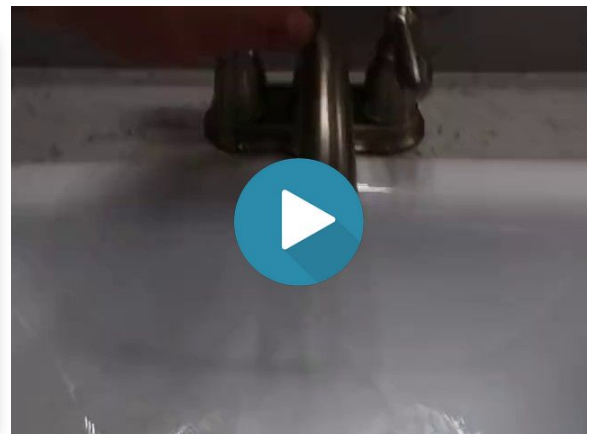
M-One of the bathroom drain stoppers was not functioning properly, preventing effective operation; adjustment or replacement is recommended to restore full functionality.

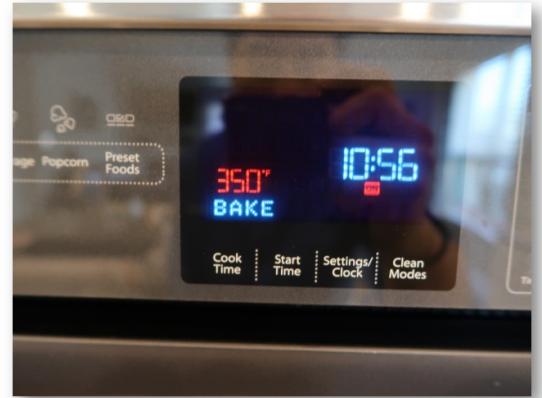
M-The interior of the oven is dirty, which may impact its performance and efficiency; a thorough cleaning is recommended to maintain functionality and hygiene.

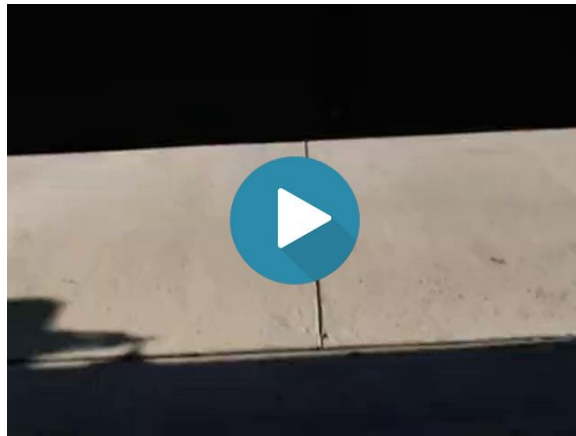
M-To ensure smooth operation of the garage door, it is recommended that the hockey stick part be adjusted to the 1 o'clock position.

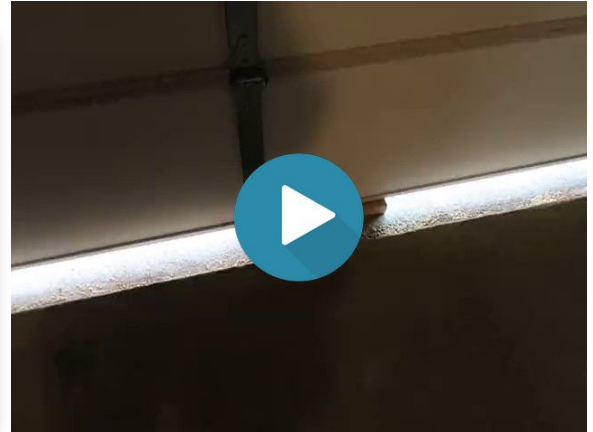
The pressure-activated automatic reverse feature was tested and appeared **not to be operating** in a satisfactory manner at the time of the inspection. Garage doors are not tested by the Inspector using specialized equipment and this inspection will not confirm adherence to manufacturer's specifications. This inspection is performed according to the Inspector's judgment from past experience.

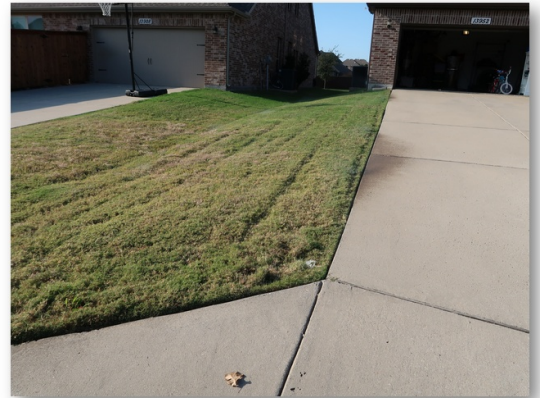
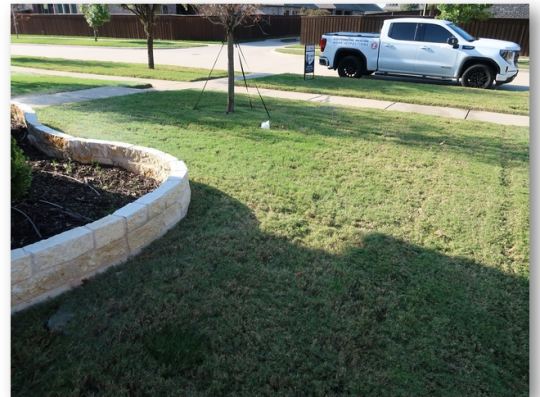
D-In sprinkler zones 2, 4, and 7, one of the heads is damaged, causing water to spray around the lawn area; repair or replacement of the affected sprinkler heads is recommended to ensure efficient water distribution.
