**PrimeVue**  
**HOME INSPECTIONS**

**NEW BUILD SAMPLE REPORT**

*Inspected by Jude Hwang TREC #25266*

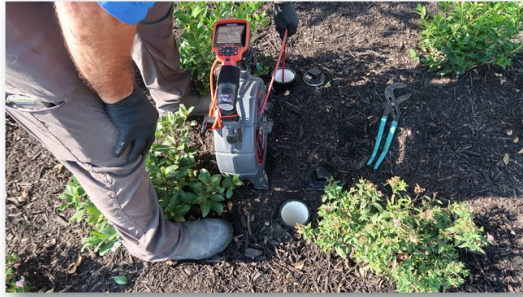
1.

During the inspection, the builder's representative was present, allowing me to communicate any issues with the house. At the beginning of the inspection, the plumber was checking the house clean-out with a sewer scope camera. The builder's representative mentioned that there were small plastic pieces inside the sewer line leading to the city. This is something that will need to be checked further in the future.

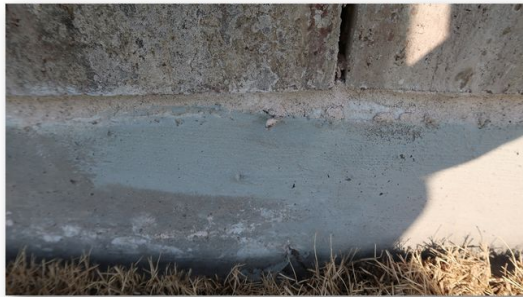
2.

Unfinished foundation hardware, including tie rods or snap ties, was observed on the east side during the inspection.

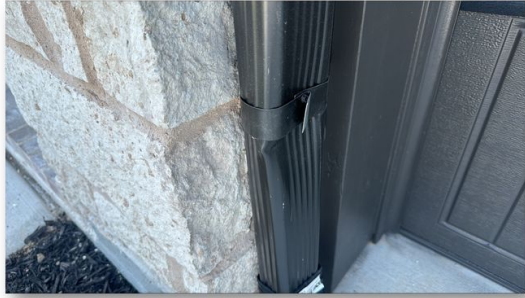
3. Downspouts designed to discharge roof drainage were damaged that may limit their ability to function as designed.

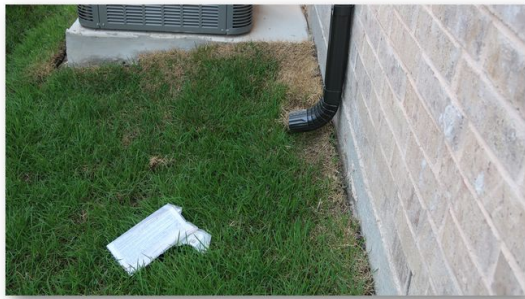
4. **A complete gutter system with extensions is recommended on this structure.**

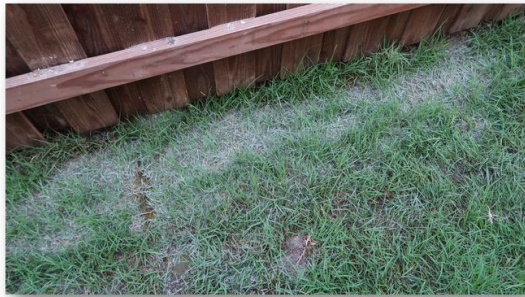
5. There is evidence of standing water observed on the west side around A/C unit, which could indicate poor drainage and/or grading. Recommend monitor and/or have landscaper correct.

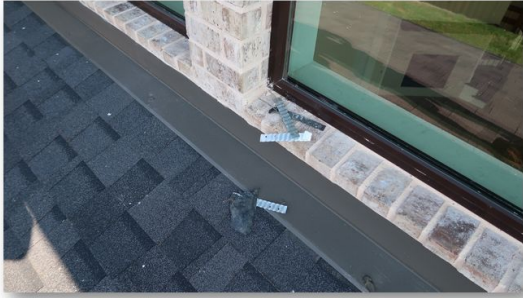
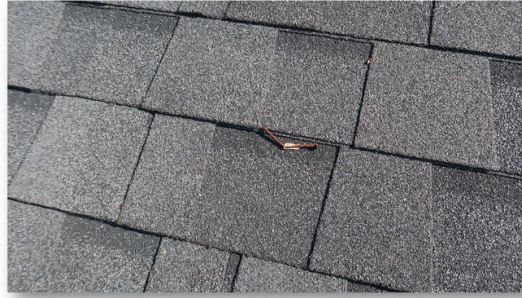
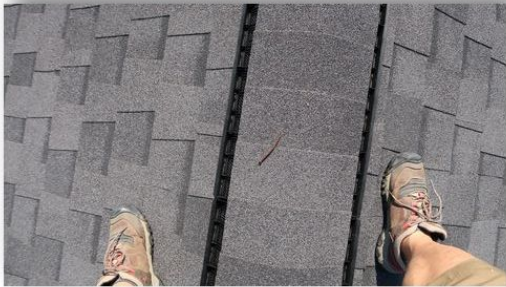
6.

The roof surface of this house needs cleaning. Some materials, such as nails and hardware, were left behind by the roofers after completing the roofing work, and they are still on the roof.

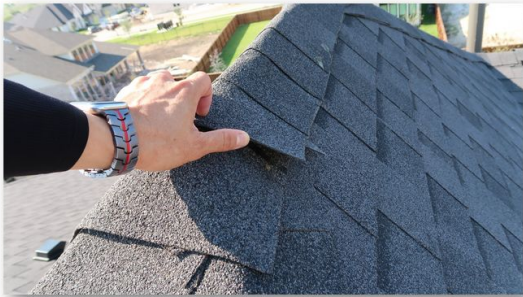
7.

Asphalt shingles covering of ridge on the roof were inadequately bonded.

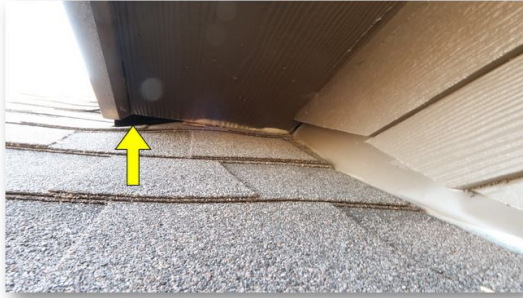
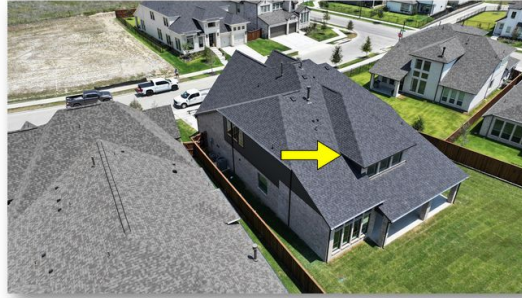
8. Roof, next to the sidewall flashing **had gaps that should be filled** with an appropriate sealant by a qualified contractor to help prevent moisture and insect entry.

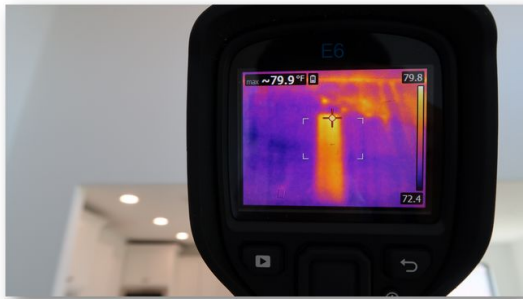
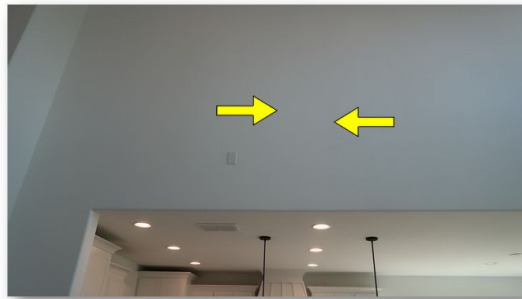
9. The infrared camera scan revealed a missing insulation issue in the structural stud inside the upper wall between the kitchen and living room. To improve energy efficiency and savings, it is recommended to request that the builder reinforce the insulation in that area.

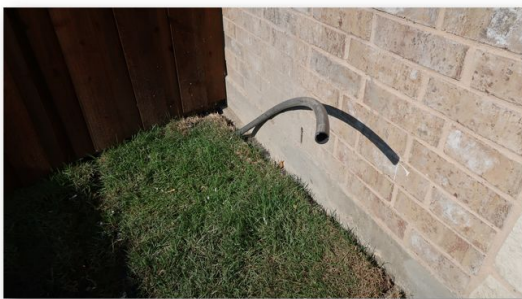
10. A pipe for internet cable installation is protruding on the east side of the house.

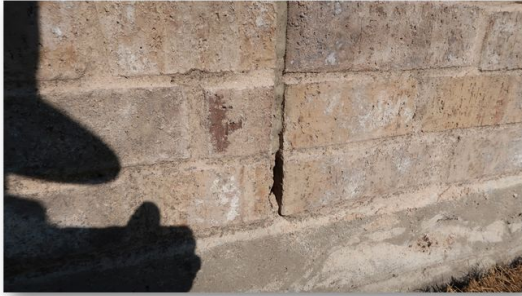
11. The caulking at the bottom of the expansion joint on the east side of the house is insufficient. It needs to be filled.

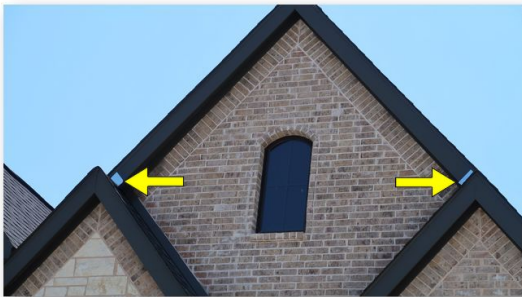
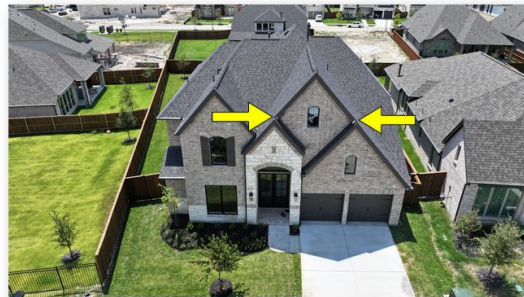
12. The front roofline flashing of this house lacks sufficient paint. It doesn't blend well with the surrounding trim color. Painting it to match the trim is needed.

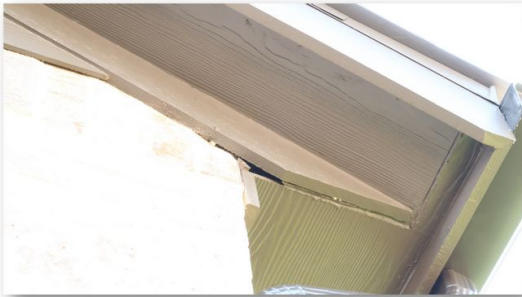
13. West side backyard corner, The exterior wall trim had gaps that should be filled

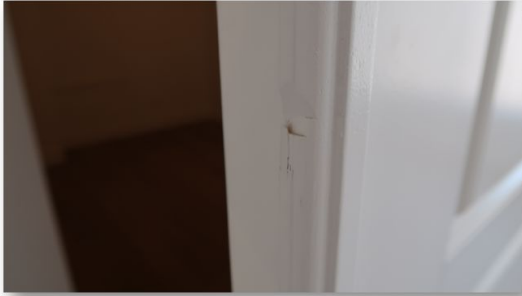
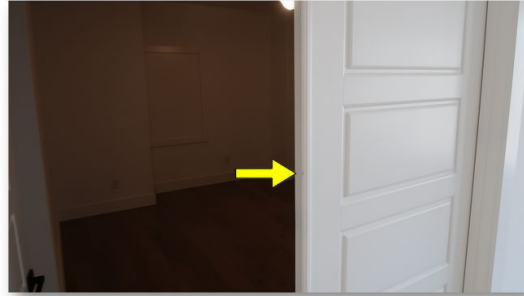
14. There is slight damage in the middle section of the molding on one side of the double doors in the second-floor media room. It should be repaired to ensure it looks presentable.

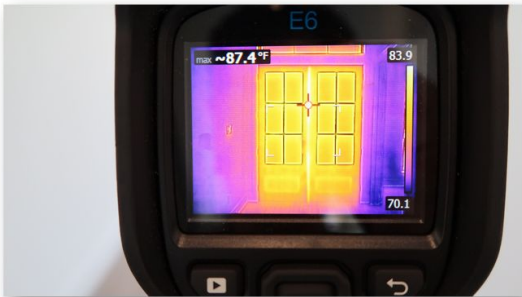
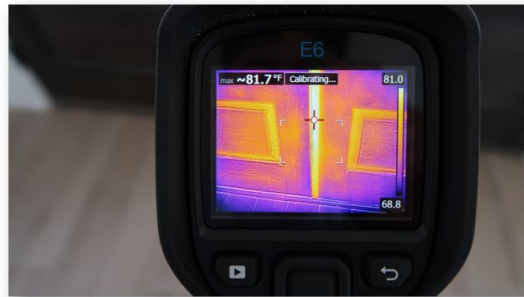
15. The main exterior double doors of this house are lacking weather seals, especially in the middle section.

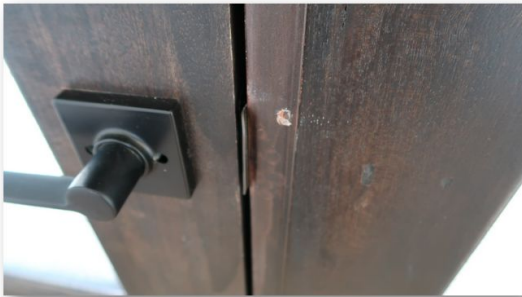
16. There is damage to the weather seal in the middle section of the main exterior double doors of this house, which requires repair by the builder.

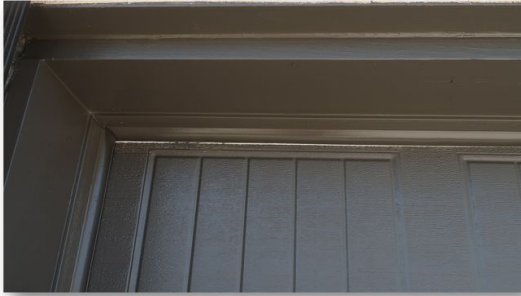
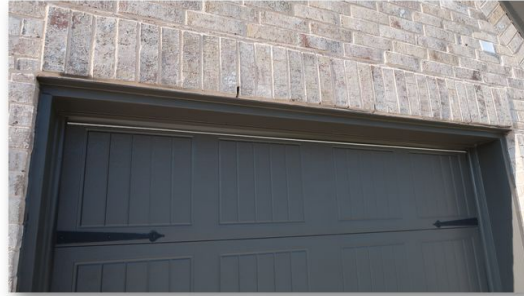
17. Additional paint in the same color is needed at the top exterior part of the garage door.

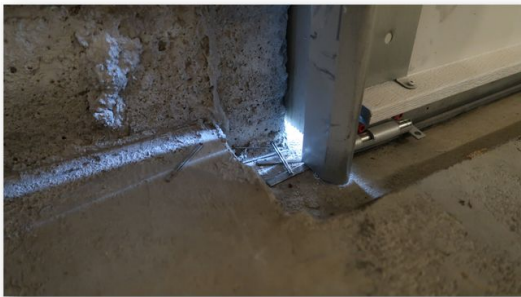
18. The garage door has a gap on the side where it leaves the interior exposed to allow animals or the elements to enter the garage, we recommend that this be sealed with a piece of trim or that the garage door be adjusted.

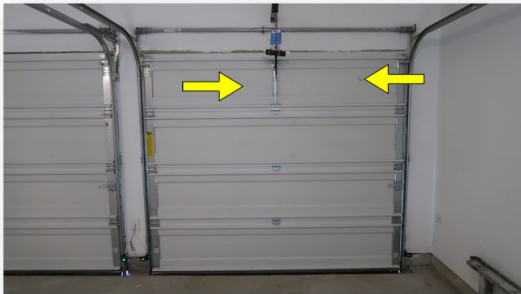
19. There are two areas of damage on the upper surface of the right garage interior door. These should be repaired by the builder before the final walkthrough.

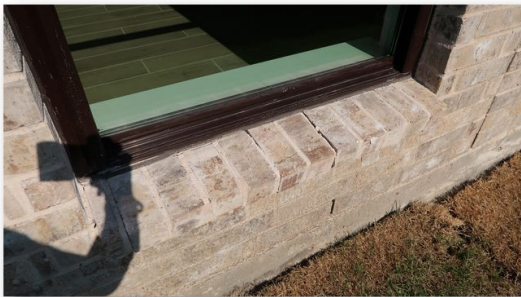
22. There is significant mortar separation in the outdoor window frame on the south side of the living room, and proper construction is needed.

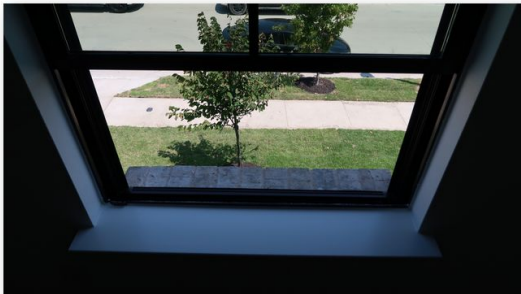
23. Although some windows in the home had no fall prevention installed. Windows located less than 24 inches above the floor and greater than 72 inches above finish grade, such windows had no fall protection installed as is required by modern safety standards.

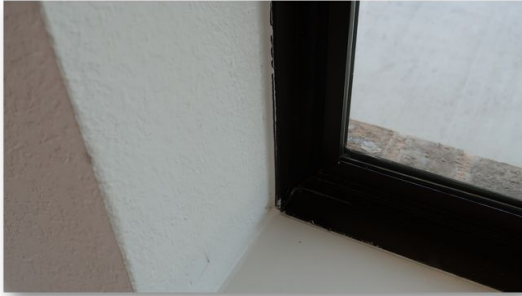
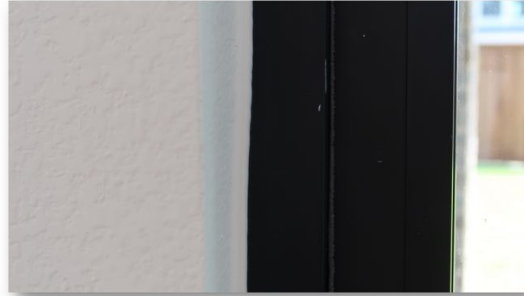
24. There are many sealant marks left on the interior living room window frame.

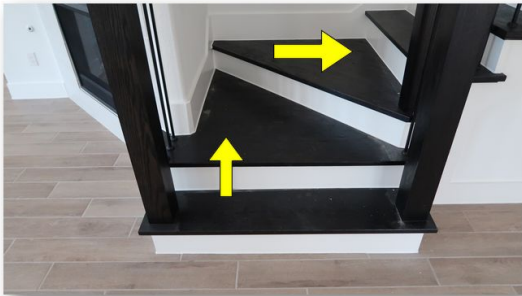
25. The surface of the corner section of the interior stairs is uneven, and some damage has been observed

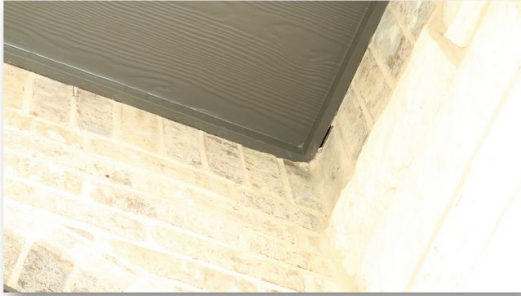
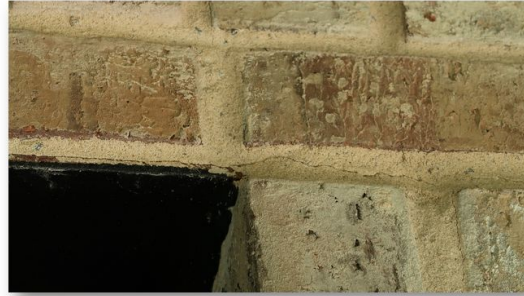
28.

There is a visible gap in the trim of the backyard patio ceiling, and hairline cracks in the mortar were also found. Caulking and patching are needed.

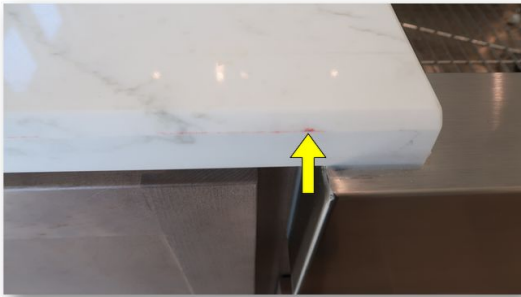
29.

A red stain was found on the edge of the main kitchen marble countertop. It needs to be removed as it is not aesthetically pleasing.

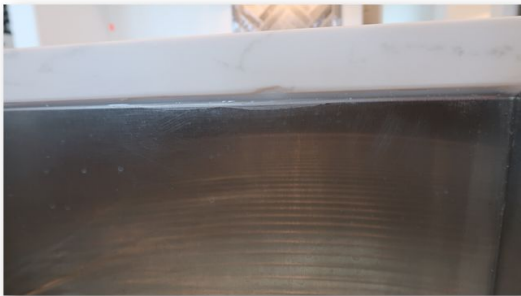
30.

Damage was found between the edge of the main kitchen marble countertop and the sink. It should be repaired so that the damage is not visible.

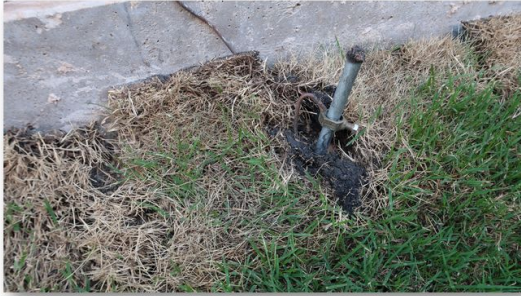
31.

The ground electrode clamp is exposed above the ground. It is recommended to have it flush with the ground.

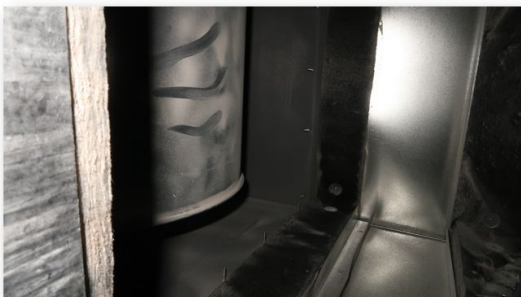
34.

The plenum on the blower side of the furnace return needs cleaning, as a significant amount of dust has accumulated. The builder is responsible for this cleaning.

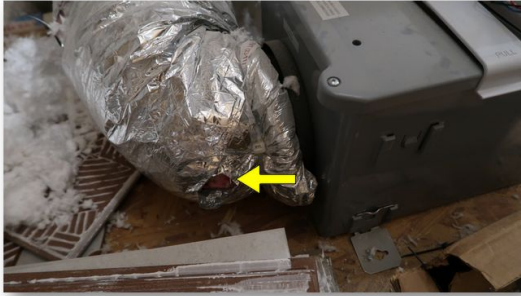
35. Damage was found on the superficial surface of several ducts near the attic entrance during the inspection. The damage needs to be repaired.

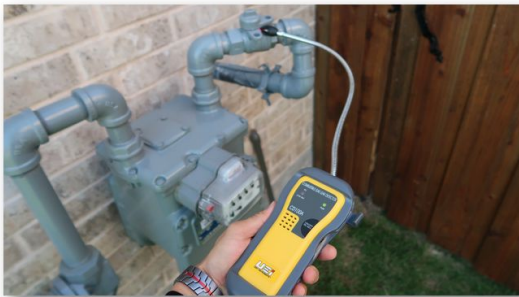
36. Gas is leaking significantly from the elbow of the main gas meter valve pipe coming into the house. An evaluation and repairs as necessary should be performed immediately by a qualified contractor.

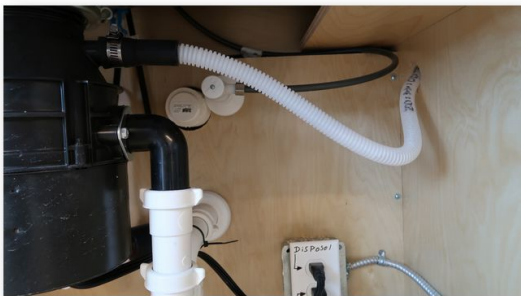
37. The dishwasher did not appear to have an anti-siphon device installed in the drain line.

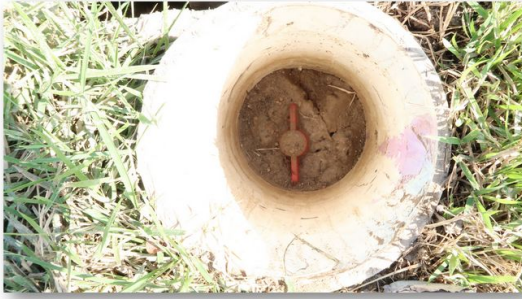
38.

The main valve of the irrigation sprinkler is covered in mud, making it difficult to control the valve. The mud needs to be removed.

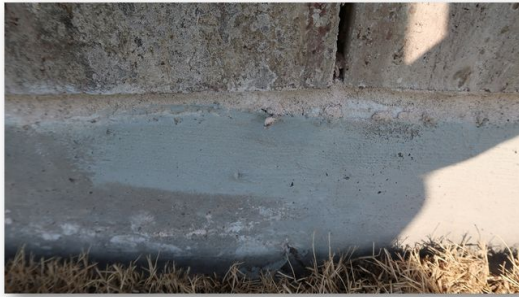
Unfinished foundation hardware, including tie rods or snap ties, was observed on the east side during the inspection. Metal snap-ties protruding from the foundation were sharp and may cause injury. Snap-ties should be broken off at the foundation surface.

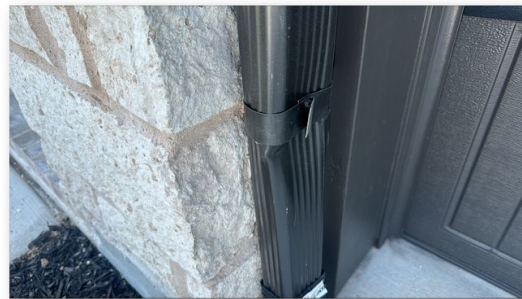
Downspouts designed to discharge roof drainage were damaged that may limit their ability to function as designed. Downspouts should be brought into good working order by a builder.

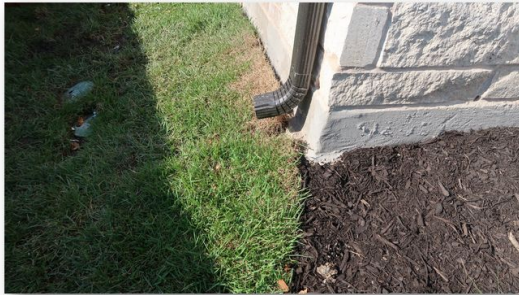
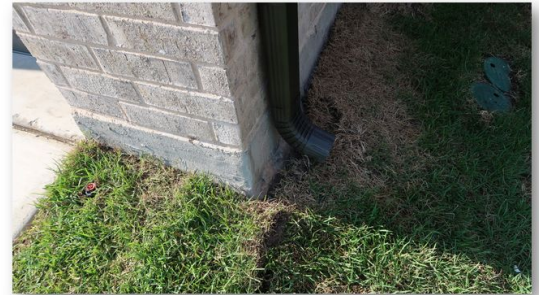
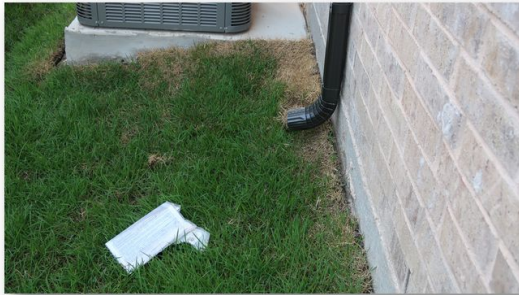
**A complete gutter system with extensions is recommended on this structure.** The gutter system is designed to expedite the drainage of water away from the property. Splash plates located under the down spouts can help direct water away from the foundation and reduce soil erosion, which can reduce the effectiveness of the termite chemicals placed in the soil.

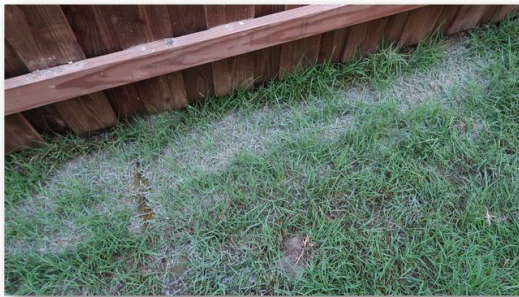
There is evidence of standing water observed on the west side around A/C unit, which could indicate poor drainage and/or grading. Recommend monitor and/or have landscaper correct.

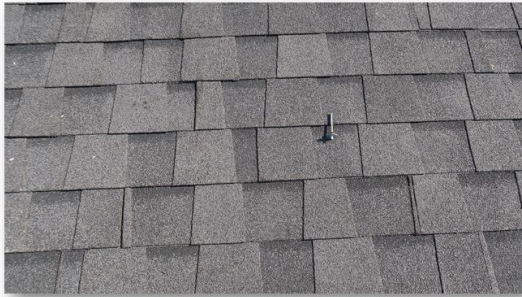
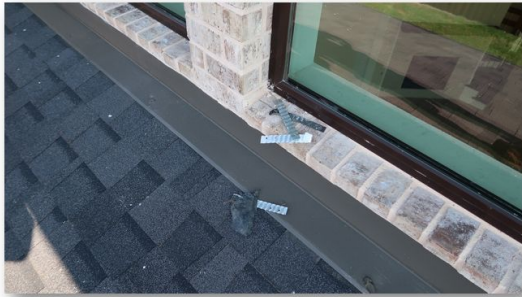
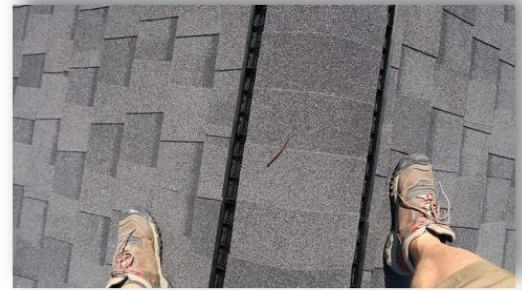
The roof surface of this house needs cleaning. Some materials, such as nails and hardware, were left behind by the roofers after completing the roofing work, and they are still on the roof.

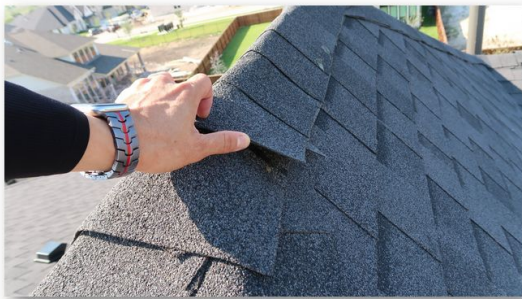
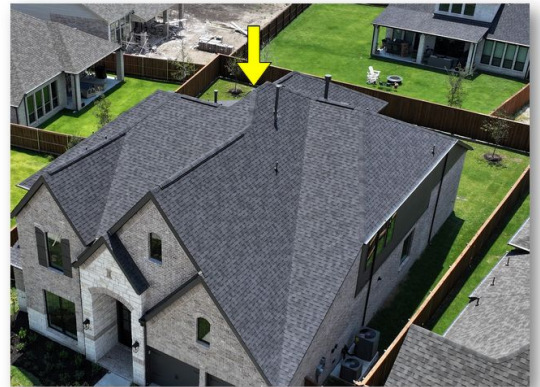
Asphalt shingles covering of ridge on the roof were inadequately bonded. Shingles should be replaced once the weather has warmed to ensure that full bonding has developed. Bonding is the most important factor in shingle resistance to wind damage.

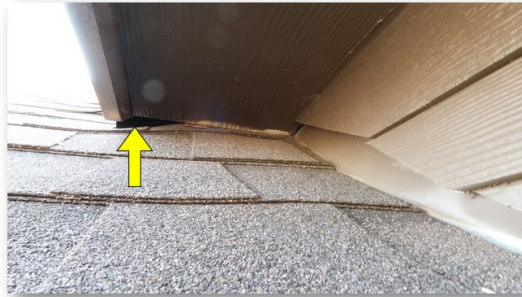
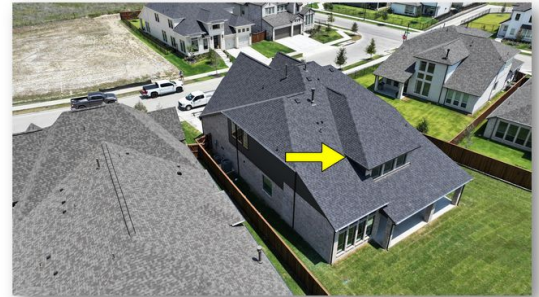
Roof, next to the sidewall flashing **had gaps that should be filled** with an appropriate sealant by a qualified contractor to help prevent moisture and insect entry.

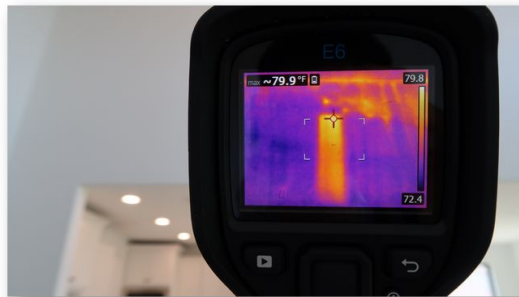
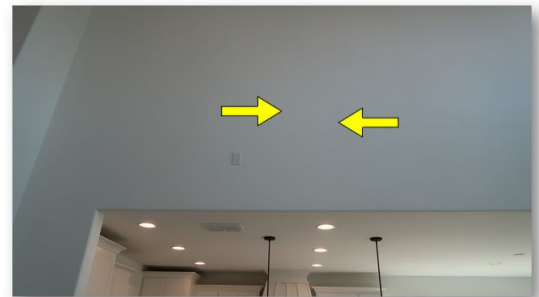
The infrared camera scan revealed a missing insulation issue in the structural stud inside the upper wall between the kitchen and living room. To improve energy efficiency and savings, it is recommended to request that the builder reinforce the insulation in that area.

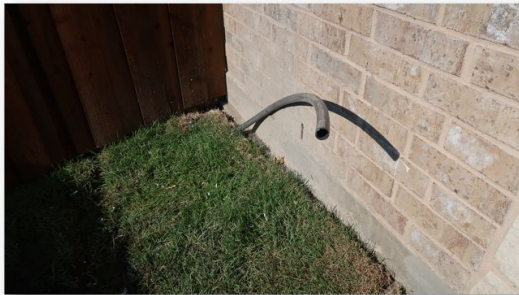
A pipe for internet cable installation is protruding on the east side of the house.

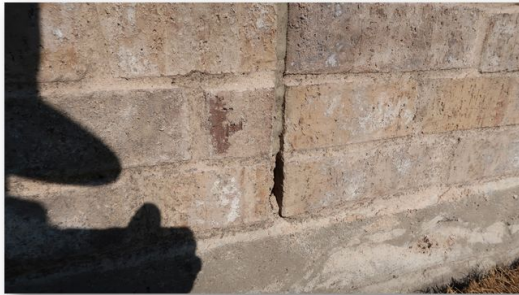
The caulking at the bottom of the expansion joint on the east side of the house is insufficient. It needs to be filled.

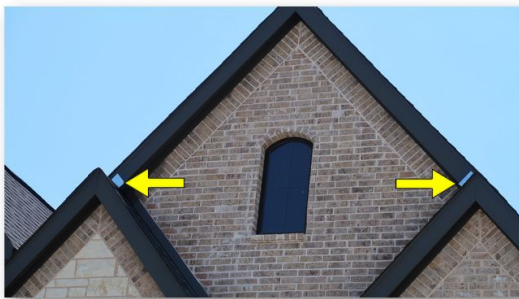
The front roofline flashing of this house lacks sufficient paint. It doesn't blend well with the surrounding trim color. Painting it to match the trim is needed.

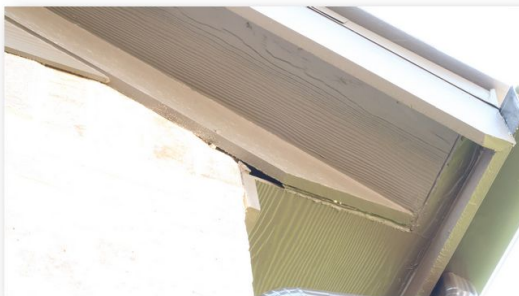
**West side backyard corner, The exterior wall trim had gaps that should be filled** with an appropriate sealant by an qualified contractor to help prevent moisture and insect entry.

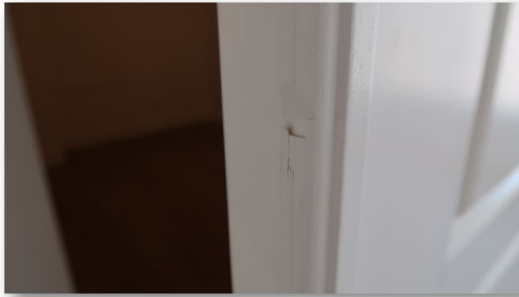
There is slight damage in the middle section of the molding on one side of the double doors in the second-floor media room. It should be repaired to ensure it looks presentable.

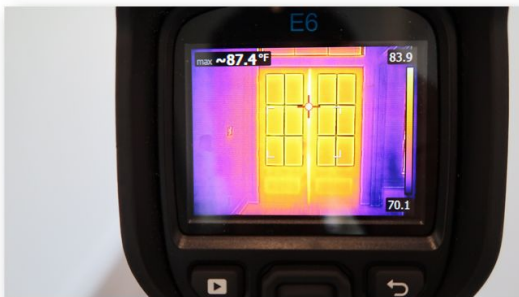
The main exterior double doors of this house are lacking weather seals, especially in the middle section.

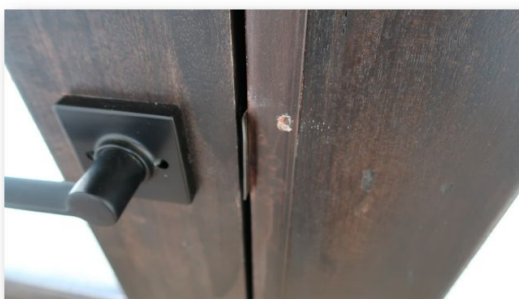
There is damage to the weather seal in the middle section of the main exterior double doors of this house, which requires repair by the builder.

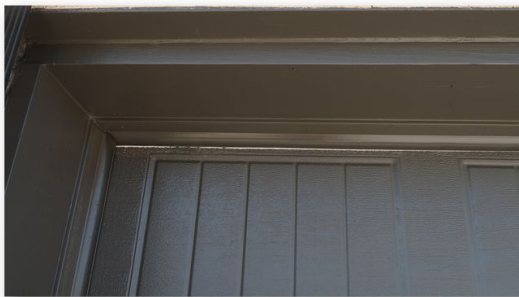
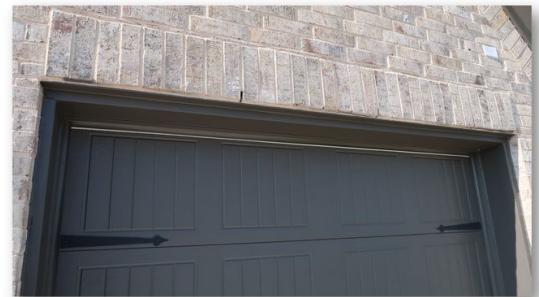
Additional paint in the same color is needed at the top exterior part of the garage door.

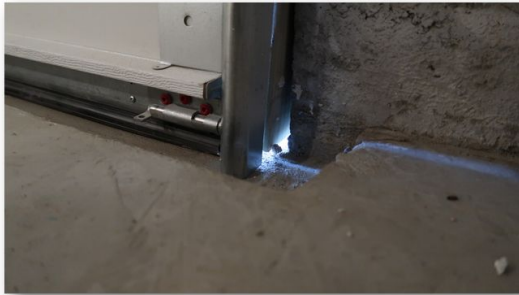
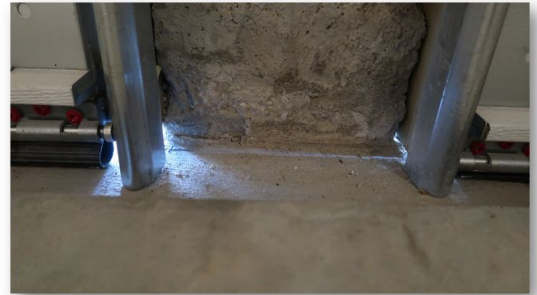
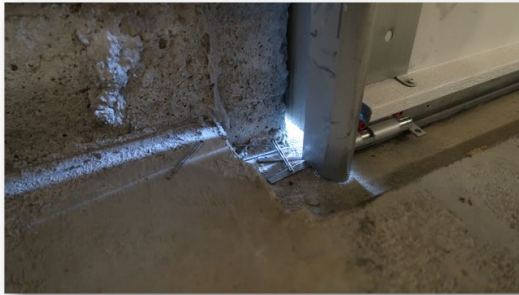
The garage door has a gap on the side where it leaves the interior exposed to allow animals or the elements to enter the garage, we recommend that this be sealed with a piece of trim or that the garage door be adjusted.

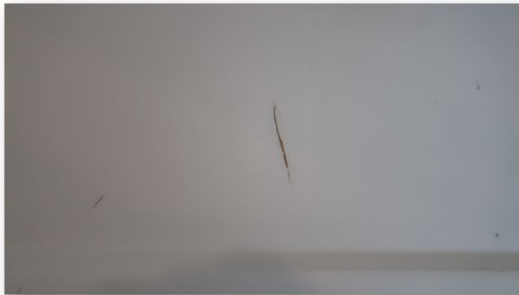
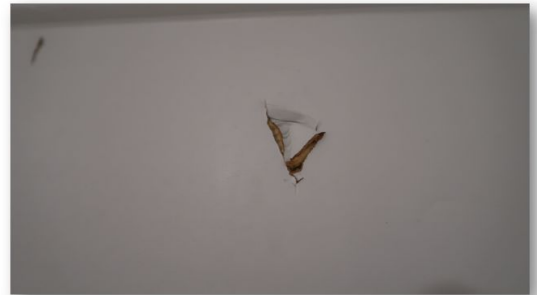
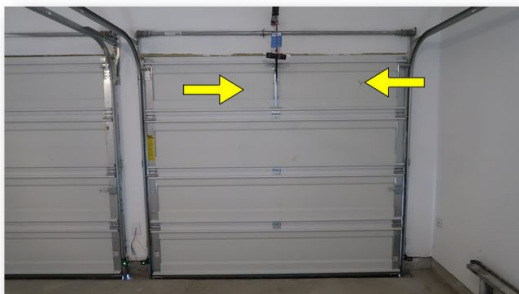
There are two areas of damage on the upper surface of the right garage interior door. These should be repaired by the builder before the final walkthrough.

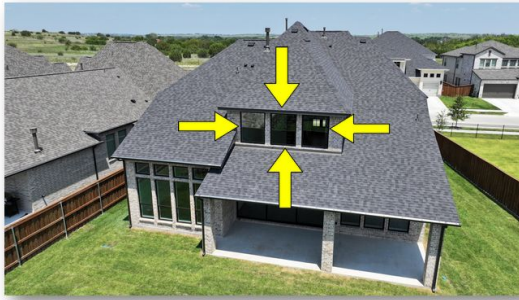
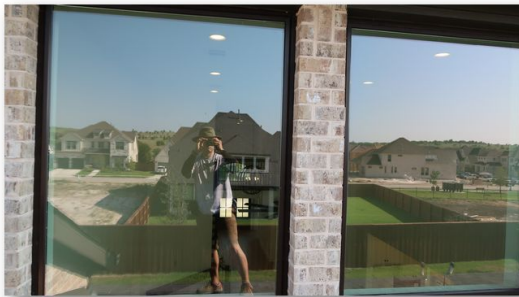
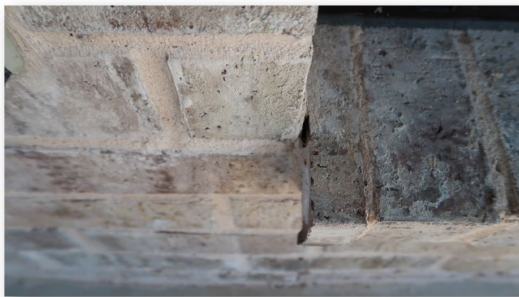
The dormer window on the south roof needs caulking and sealing overall. Numerous gaps were found between the window frame during the inspection.

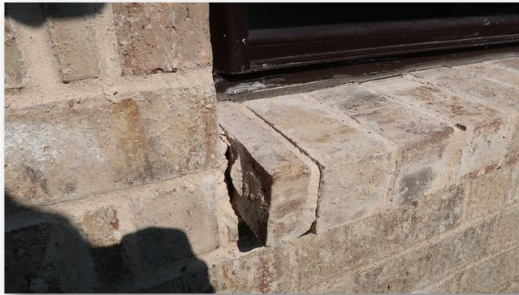
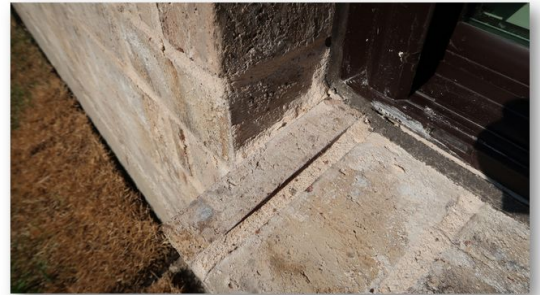
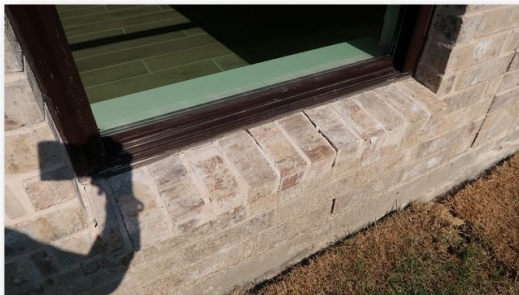
There is significant mortar separation in the outdoor window frame on the south side of the living room, and proper construction is needed.

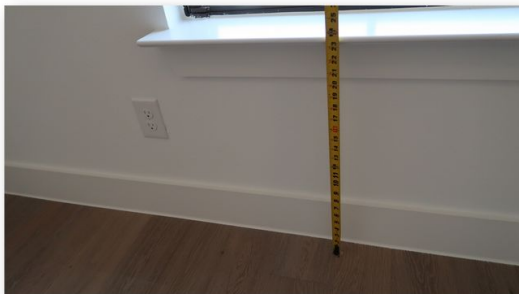
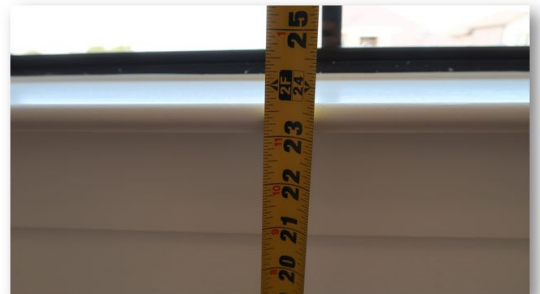
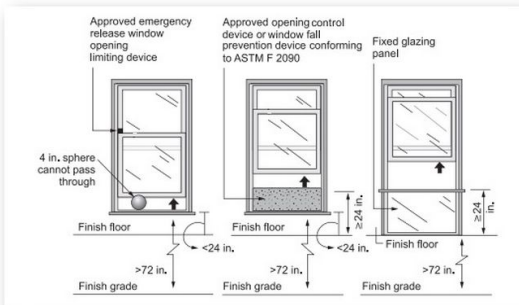
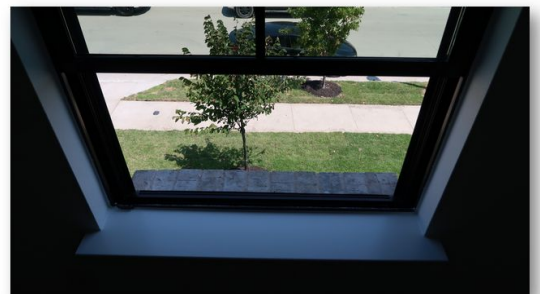
Although some windows in the home had no fall prevention installed. Windows located less than 24 inches above the floor and greater than 72 inches above finish grade, such windows had no fall protection installed as is required by modern safety standards.

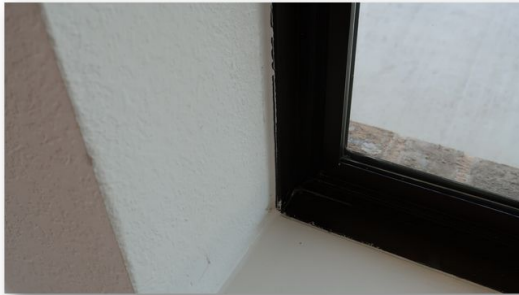
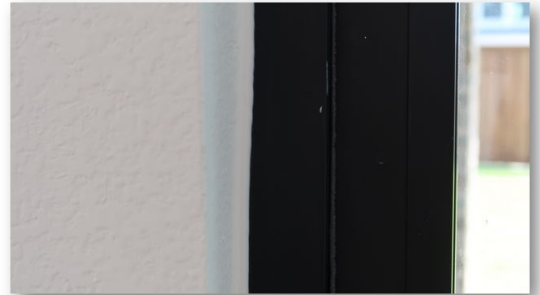
There are many sealant marks left on the interior living room window frame. The buyer wants the builder to remove these marks due to their complaint.

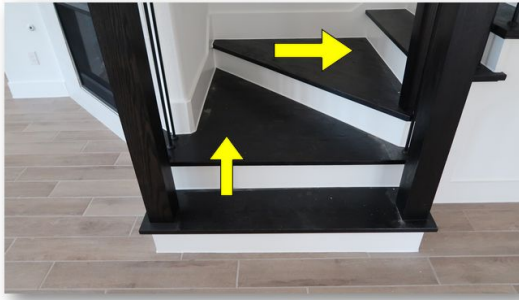
The surface of the corner section of the interior stairs is uneven, and some damage has been observed

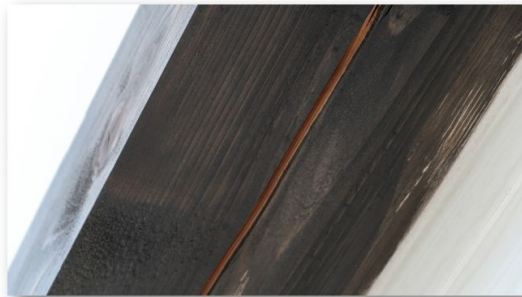
A crack was found under the fireplace decoration board. The builder plans to fill the gap with epoxy.

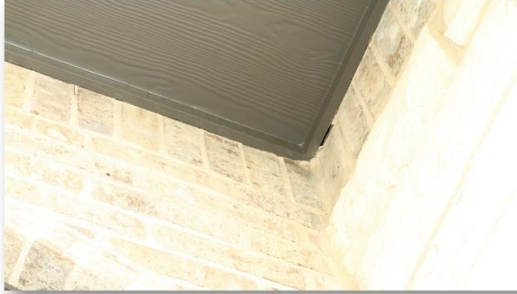
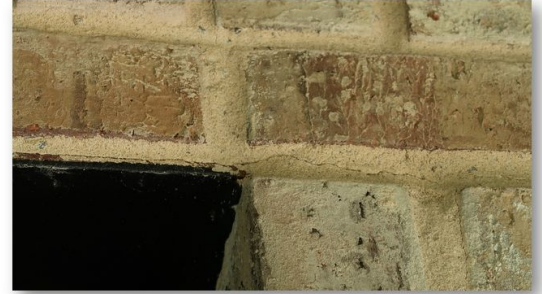
There is a visible gap in the trim of the backyard patio ceiling, and hairline cracks in the mortar were also found. Caulking and patching are needed.

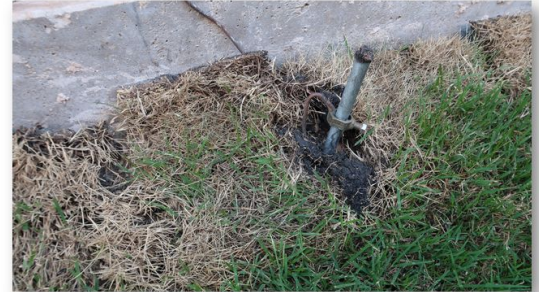
The ground electrode clamp is exposed above the ground. It is recommended to have it flush with the ground.

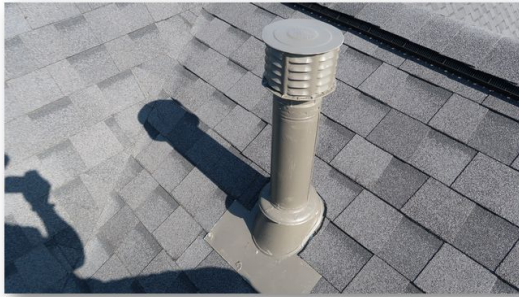
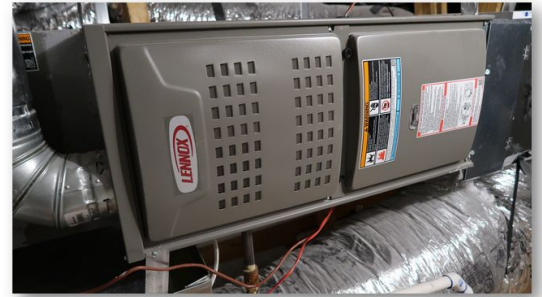
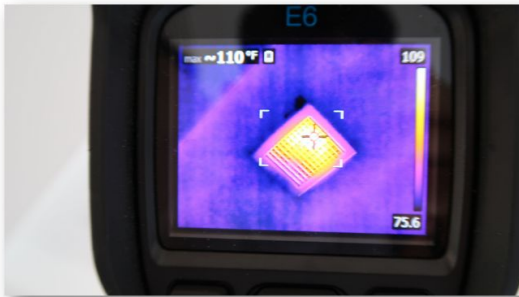
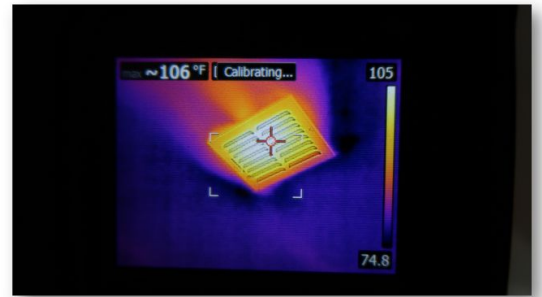
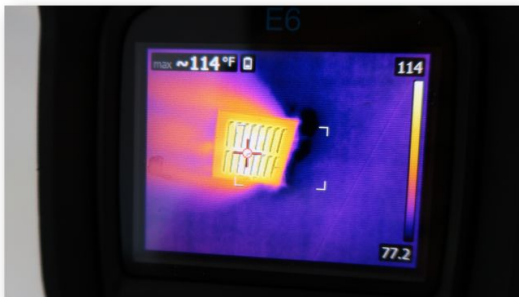
**NI - A full evaluation of the integrity of a heat exchanger requires dismantling of the furnace and is beyond the scope of this visual inspection. (This is a specific T.R.E.C. guideline limitation).**

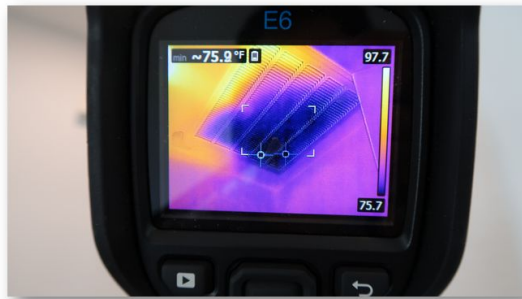
***Normal A range 15°F - 22°F***

These temperatures are within the recommended tolerances.

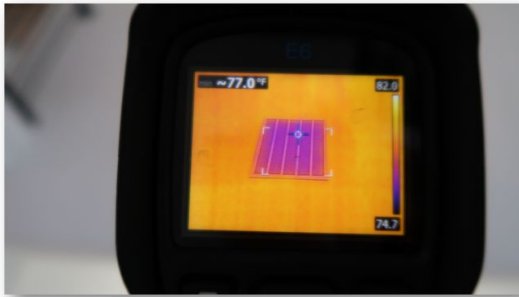
**Normal A range 15°F - 22°F**

These temperatures are within the recommended tolerances.

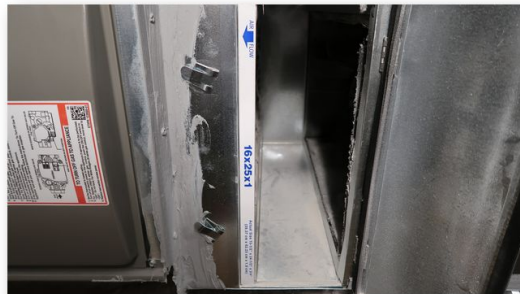
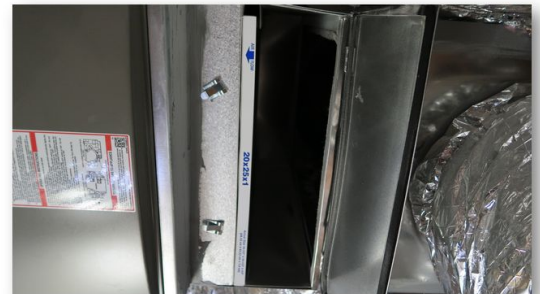
*Type of Ducting:* Flex Ducting  
*Heating-A/C filter:* Disposable 4"  
*Filter Type:* Disposable  
*Filter Size:* 16"x25x1"  
*Filter Condition :* **Very Dirty**

The **Supply & Return & Duct system** appeared to be in **Fair Condition** and appears to have equal distribution.

It is recommended to replace the filter with a 4-inch thick one.

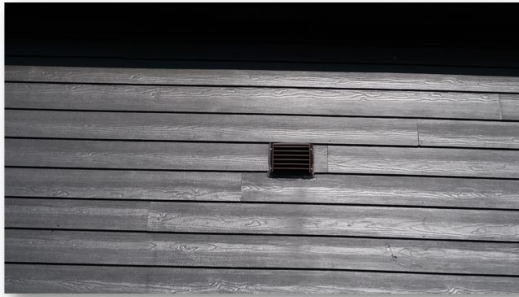
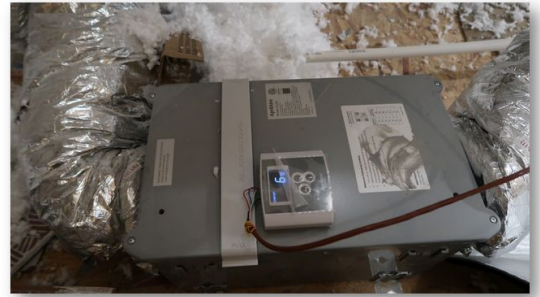
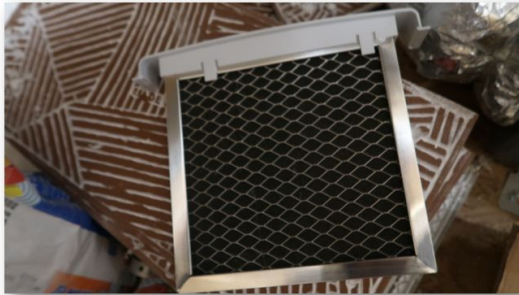
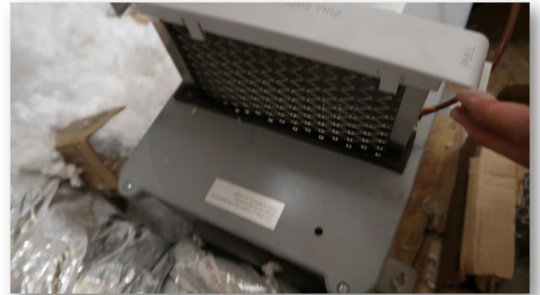
The outside fresh air return component is connected to the furnace return. Regular filter cleaning is recommended.

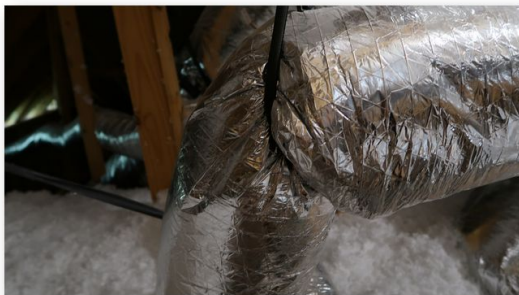
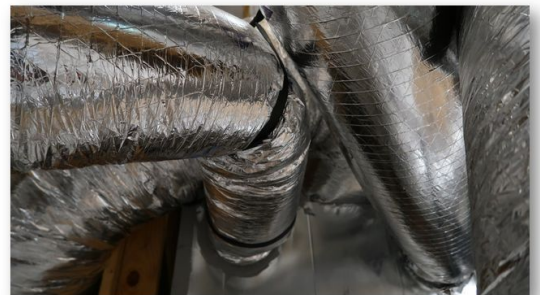
The items listed below are the Inspectors observations of deficiencies and/or exceptions if any associated with the **Supply & Return & Duct System** that were noted on this structure at the Time of the Inspection:

- Ducting is kinked

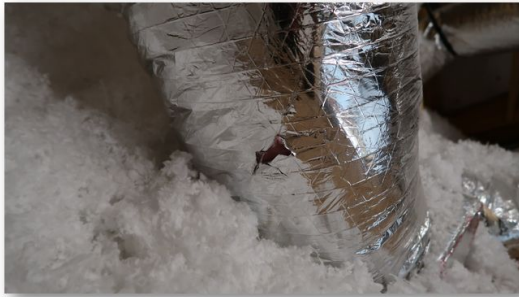
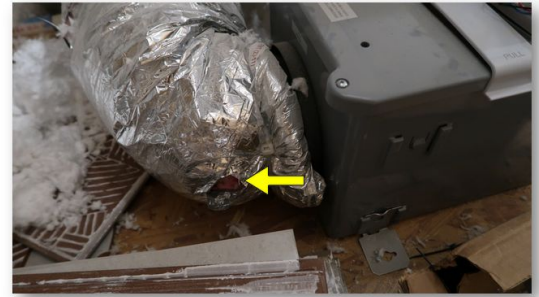
Damage was found on the superficial surface of several ducts near the attic entrance during the inspection. The damage needs to be repaired.

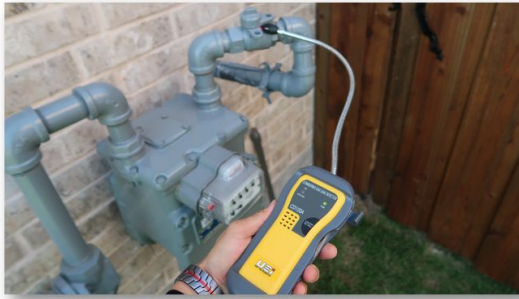
**Gas is leaking significantly from the elbow of the main gas meter valve pipe coming into the house. An evaluation and repairs as necessary should be performed immediately a by qualified contractor.**

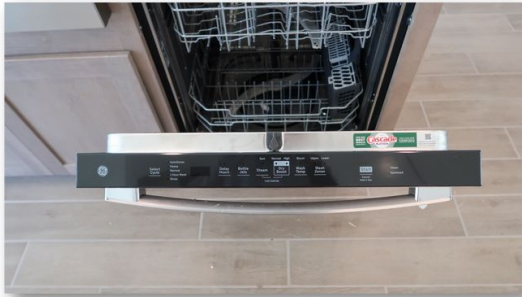
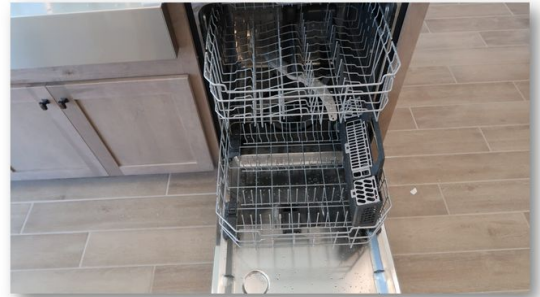
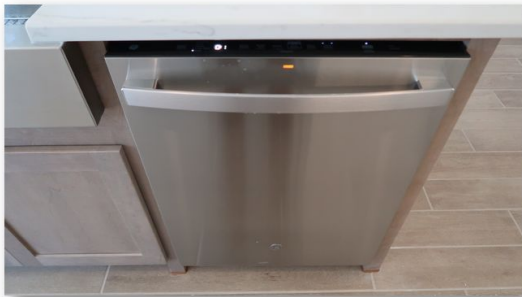
- No anti-siphon loop at the drain line

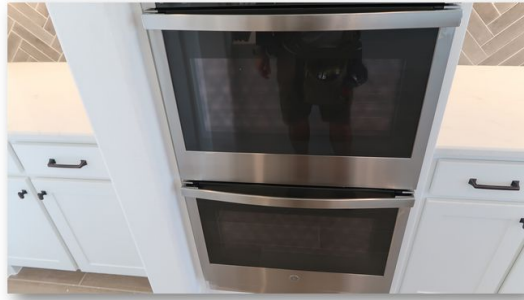
Unit #1:  Electric  Gas  
Tested at 350°F, Variance noted: 350°F (max 25°F)

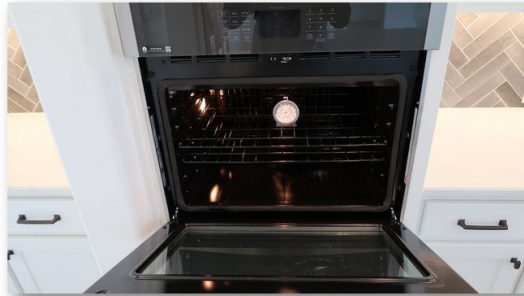
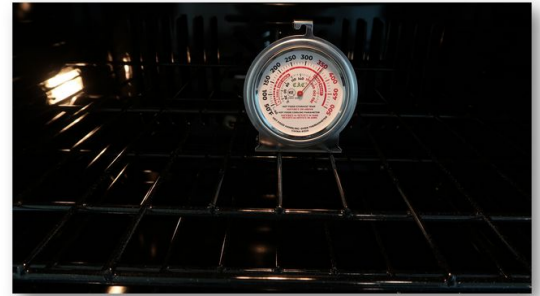
Unit #2:  Electric  Gas  
Tested at 350°F, Variance noted: 350°F (max 25°F)

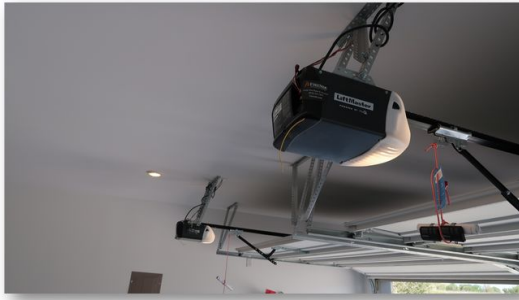
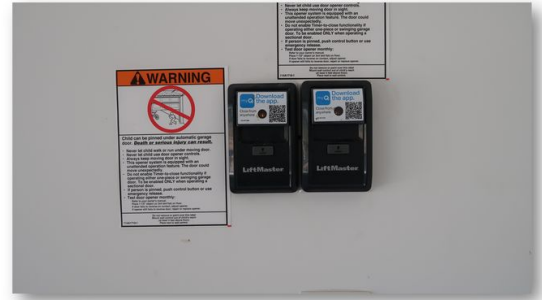
At the time of the inspection it is the Inspectors opinion that the **Garage Door Operator** appeared to be in **Operable Condition**.

The garage door operator(s) were tested by operating the wall-mounted transmitter and checking for proper operation. The door(s) were examined for significant damage or installation-related deficiencies. No reportable conditions were present at the time of inspection unless otherwise noted in this report.

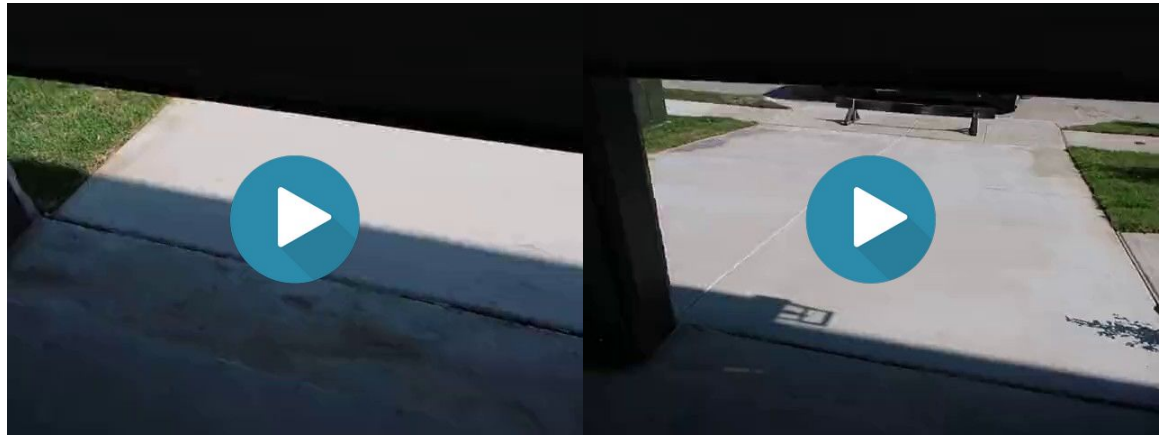
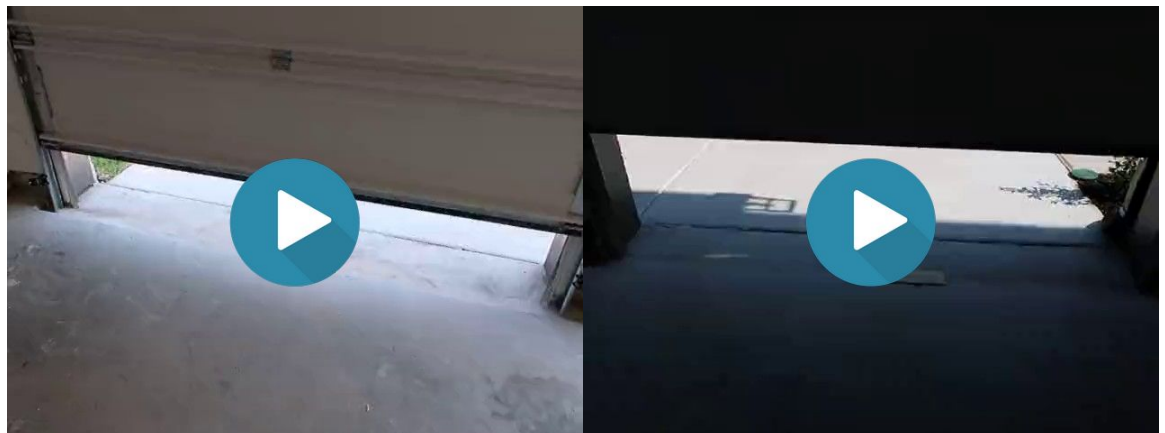
The overhead garage door was equipped with a photoelectric sensor. Photoelectric sensors are devices installed to prevent injury by raising the vehicle door if the sensor detects a person on a position in which they may be injured by the descending door. Installation of photo sensors in new homes has been required by generally-accepted safety standards since 1993.

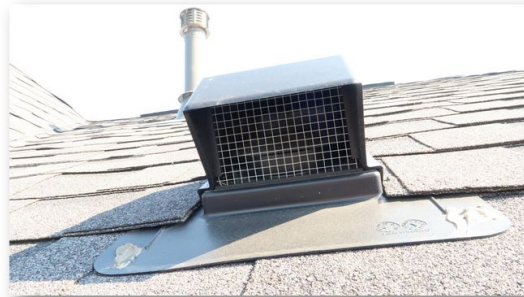
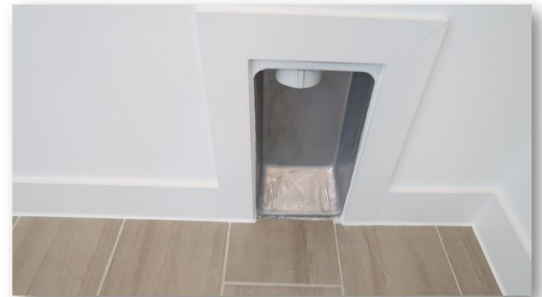
At the time of the inspection it is the Inspectors opinion the **Dryer Vent component** appeared to be in **Operable Condition**.

The dryer vent should be cleaned at least annually if not more frequently. Cleaning your dryer vent piping will allow the dryer to vent properly and work more efficiently. Dryer vents that are not cleaned regularly can be a fire hazard.

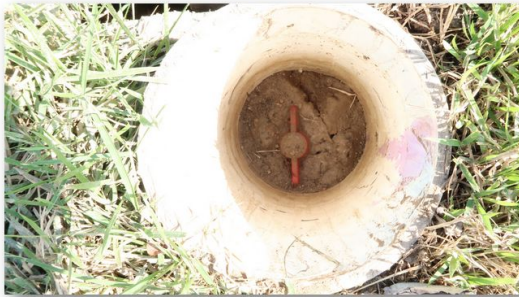
The main valve of the irrigation sprinkler is covered in mud, making it difficult to control the valve. The mud needs to be removed.
