PrimeVue
HOME INSPECTIONS

HOME AND TERMITE INSPECTIONS
254-727-0900
TX

Inspected by Jude Hwang TREC #25266

DEFICIENCY SUMMARY

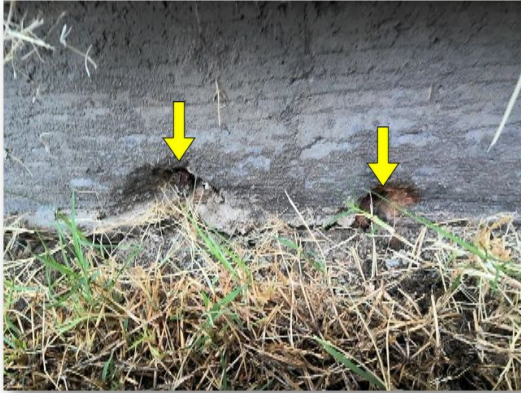
1. Unfinished foundation hardware, tie rods or snap ties observed at the time of inspection.

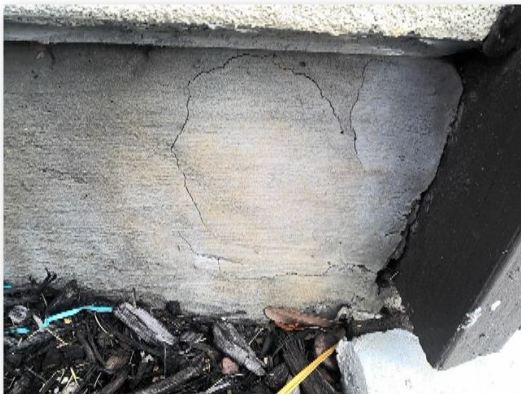
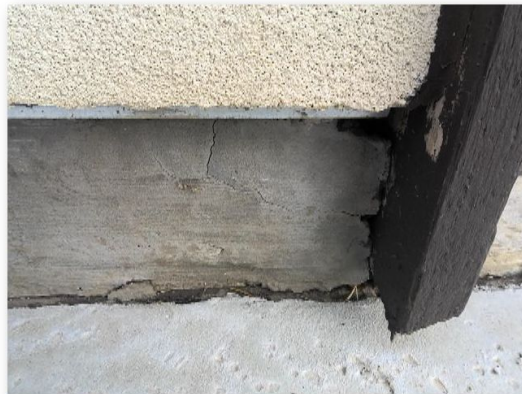
2. The portions of the concrete foundation wall surfaces minor crack in parge coat around bottom of garage door.

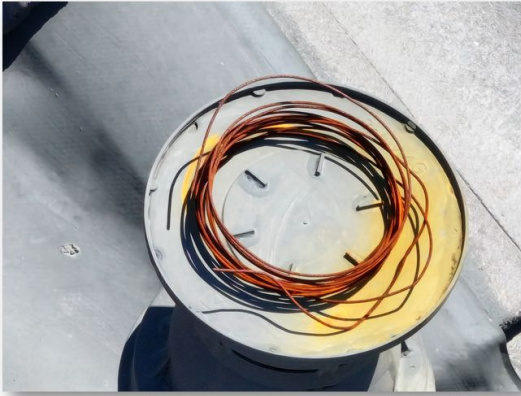
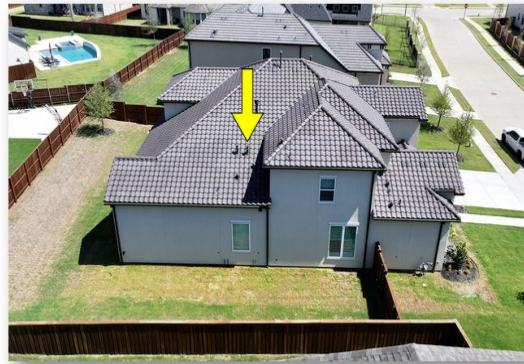
3. When the house was being built, for some unknown reason, the roofer placed a piece of wire from the roofing materials on top of the water heater duct cover.

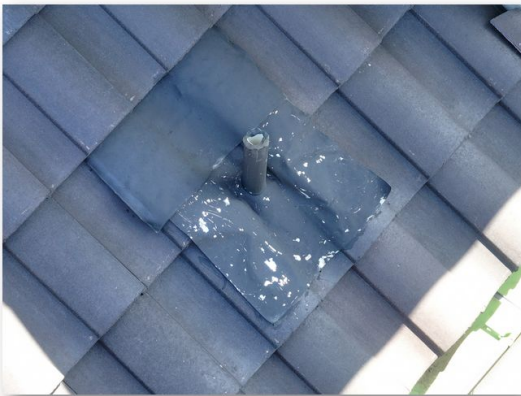
4. The flashing for the stack vents needs to be reinstalled.

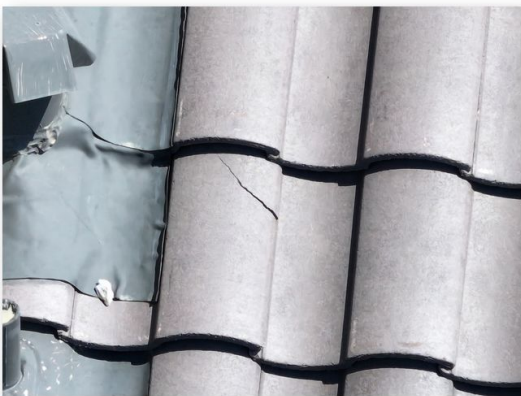
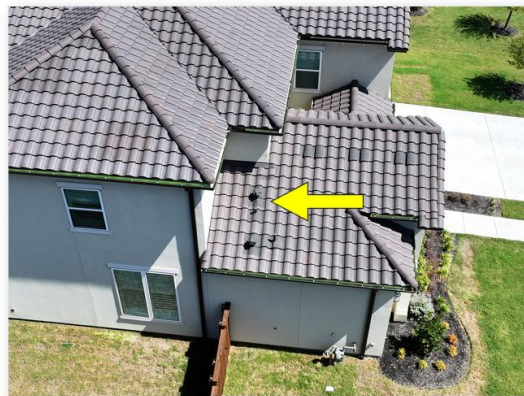
5. The roof had cracked and/or broken clay roof tiles that should be replaced to help prevent damage from roof leakage.

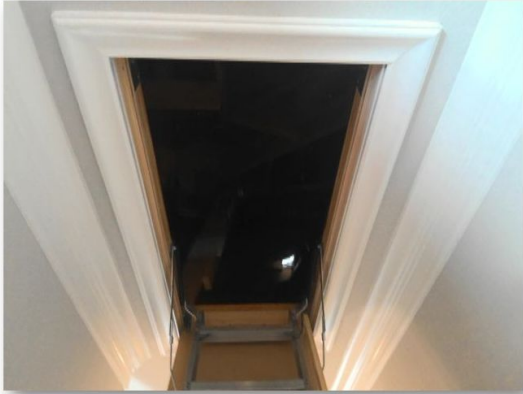
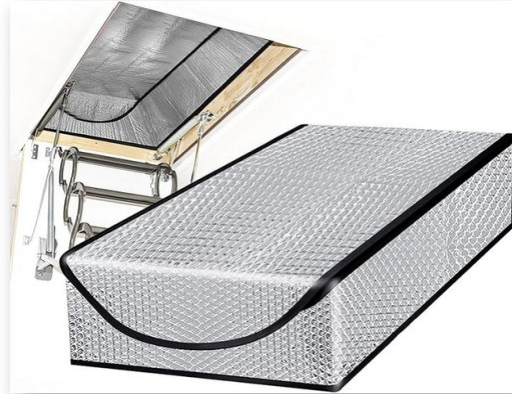
6.

To improve insulation and energy savings between the attic space and living space, it is recommended to install an attic cover.

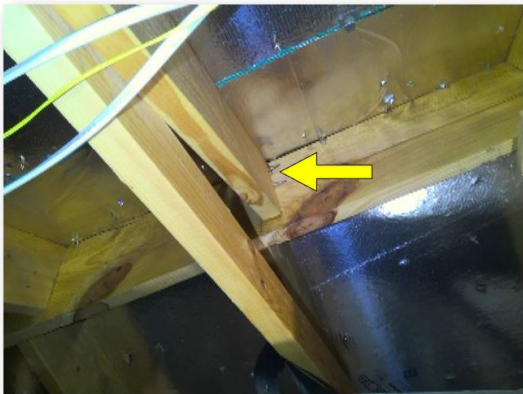
7.

One or more rafters appeared to be separated from the ridge board.

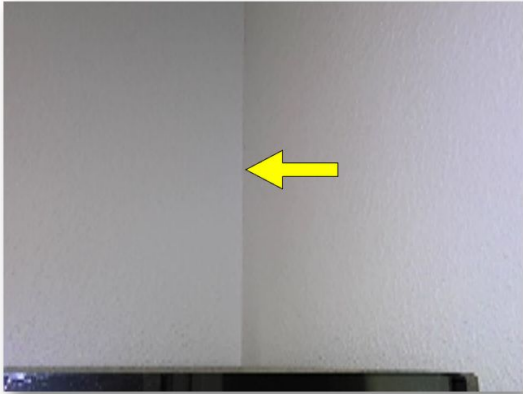
8. A hairline crack was found at the corner of the master bedroom closet entrance.

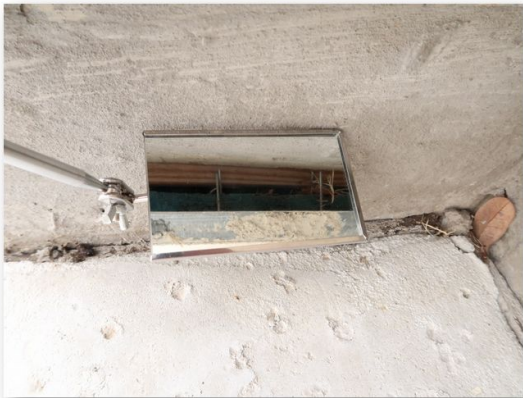
9. The weep screed on the house's exterior stucco requires evaluation by the builder. The area of concern is around the garage door, as shown in the photos.

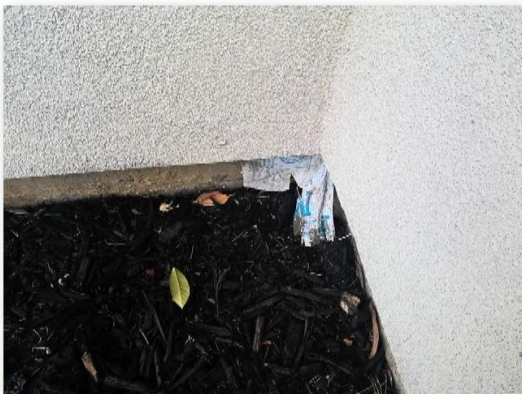
10. A piece of the vapor barrier house wrap has shifted out at the lower corner of the front of the house, creating an unsightly appearance.

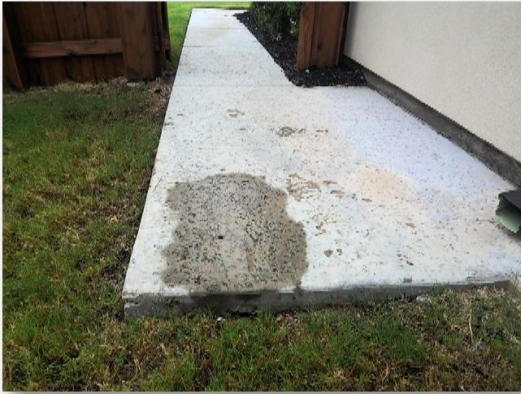
11.

At the northeast corner of the house, there is a visible gap at the edge of the concrete pad due to insufficient concrete pouring.

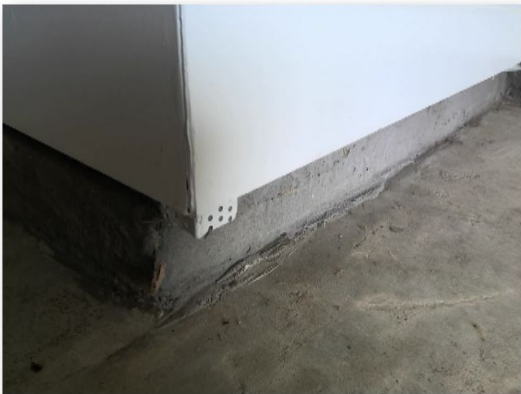
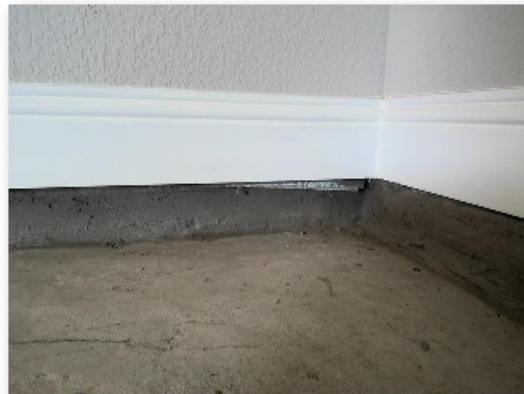
12.

The lower trim materials in the corner of the garage are exposed, making it appear as though the installation is incomplete.

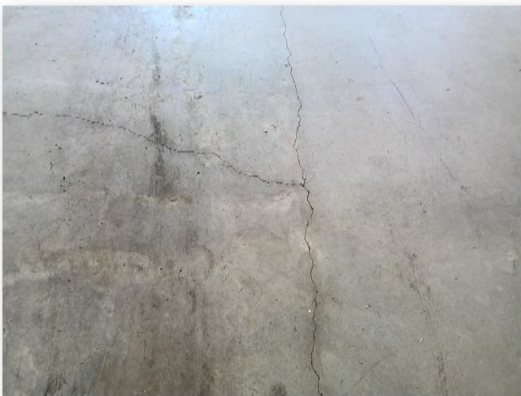
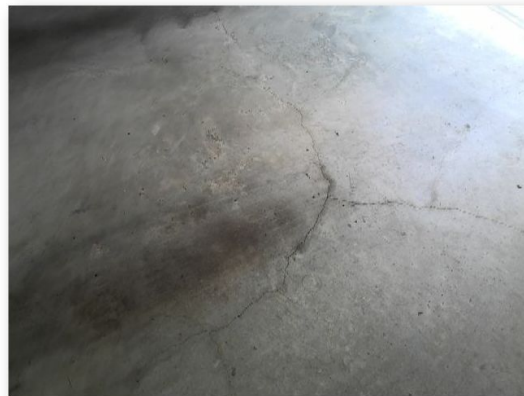
13.

The garage floor had common shrinkage hairline cracks. These cracks are not a structural concern.

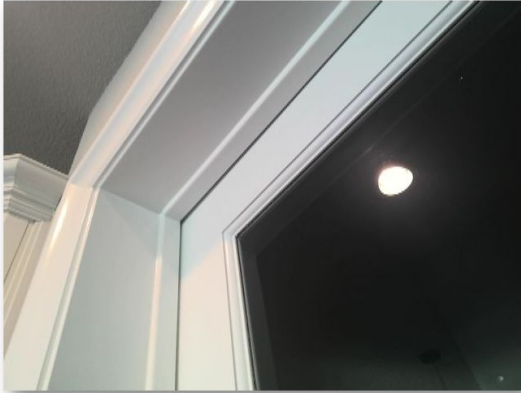
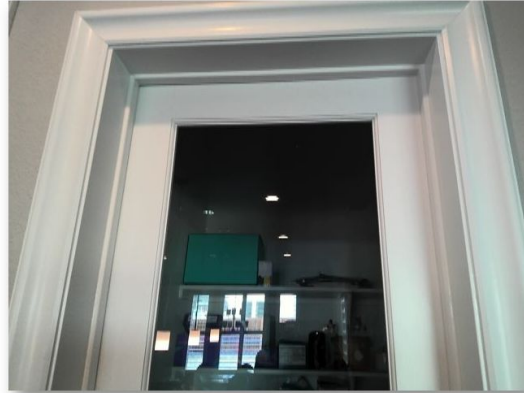
14. The hardware hinges on the kitchen pantry door need adjustment. There is a gap at the top.

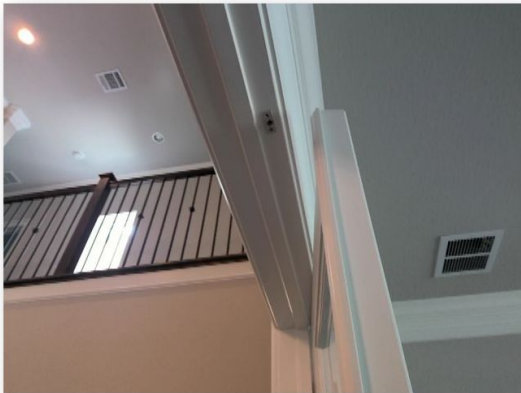
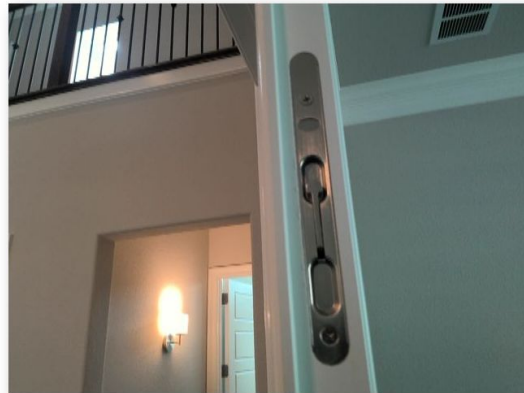
15. The lock hardware on the office door is not functioning. It needs to be repaired or replaced.

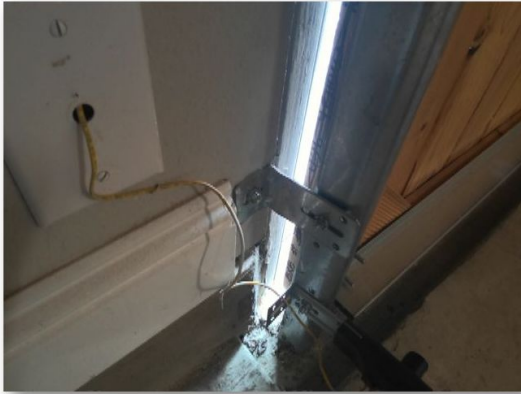
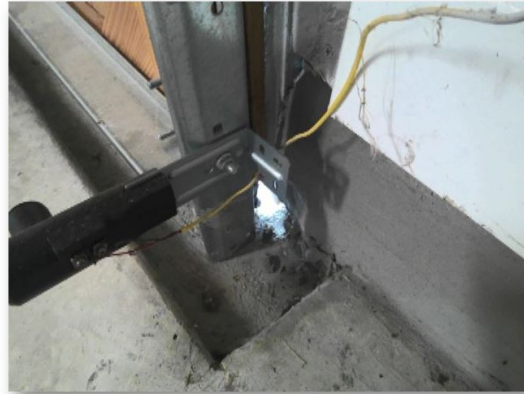
16. The garage door has a gap on the side where it leaves the interior exposed to allow animals or the elements to enter the garage

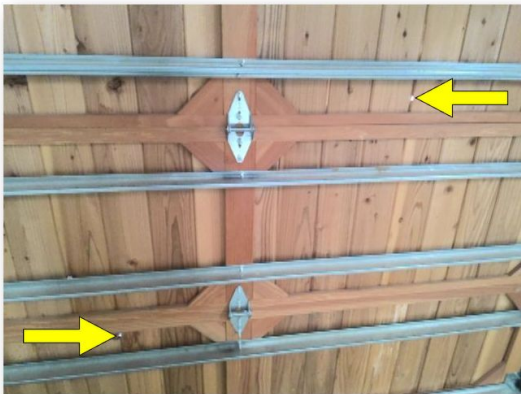
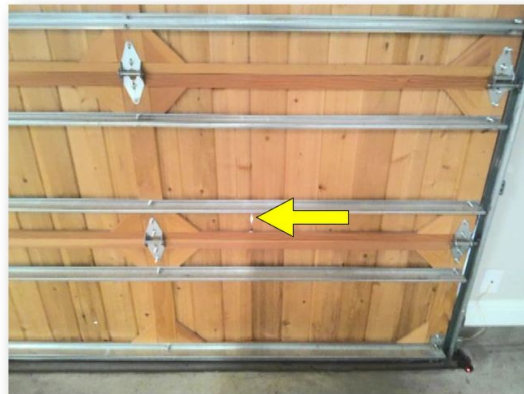
17. An air gap has been identified in the interior panel of the garage door. It is recommended to fill the gap with a wood filler.

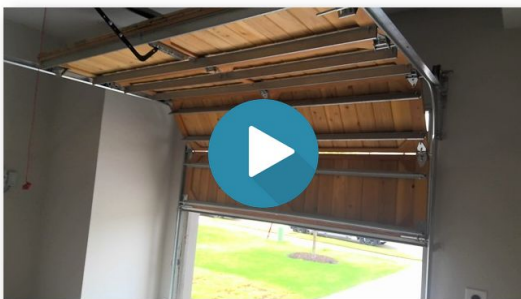
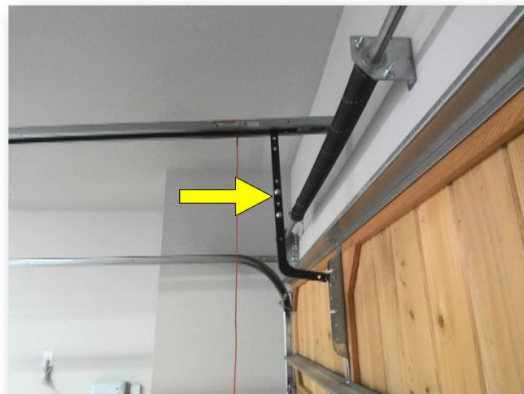
18. It was noted that the eastern garage door makes significantly more noise compared to the other doors. It is recommended to adjust the garage door's hockey stick to the 1 o'clock position.

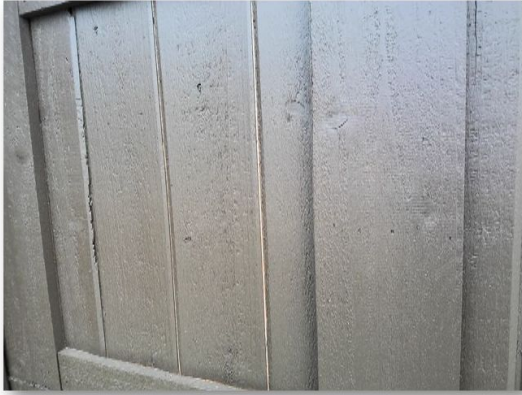
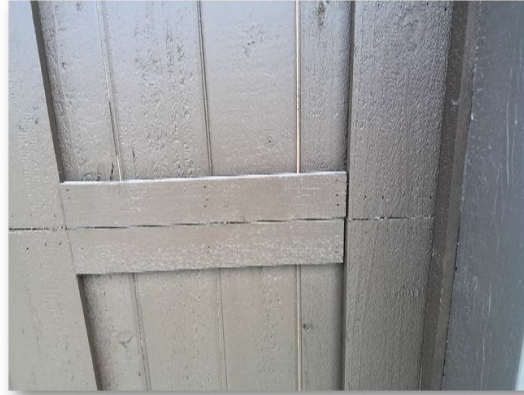
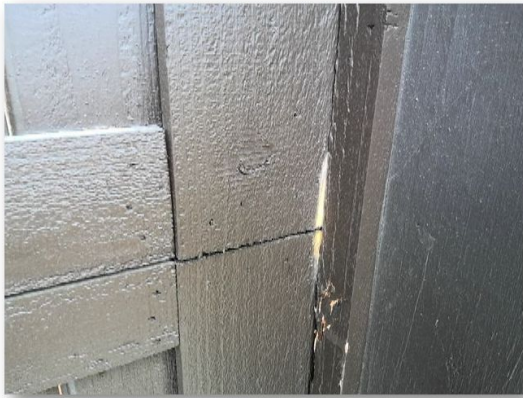
19.

A garage vehicle door had peeling paint. Timely maintenance will help extend its lifespan.

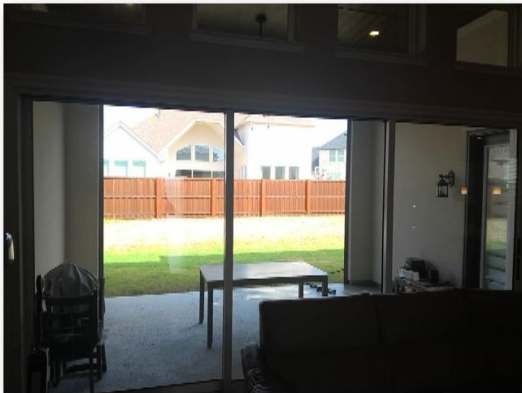
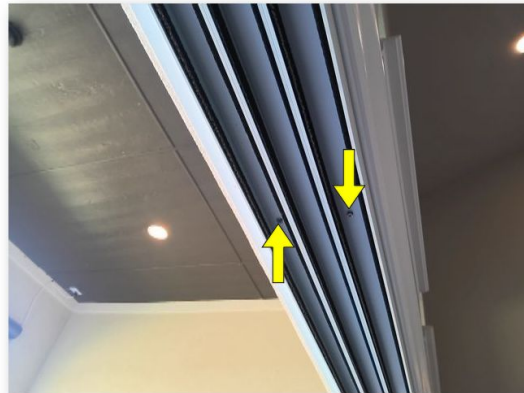
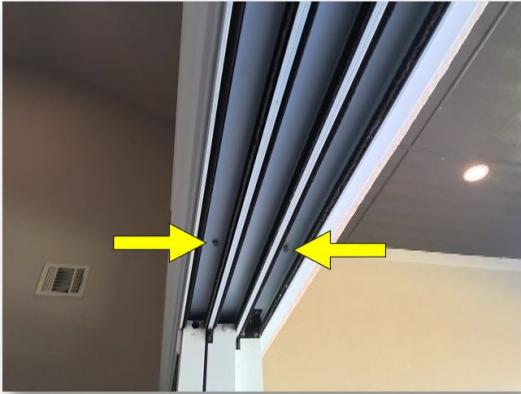
20.

The rail mounting bolts for the main sliding door in the living room have loosened and are coming down. The bolts need to be tightened securely to prevent damage to the door during operation.

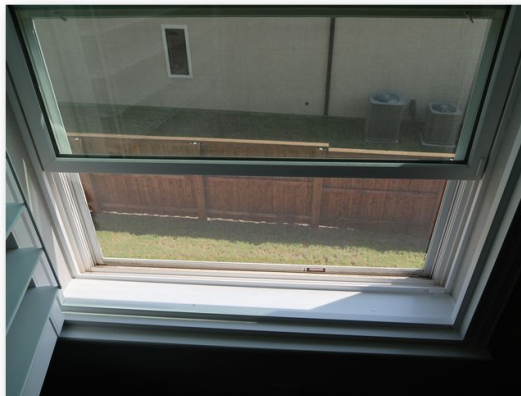
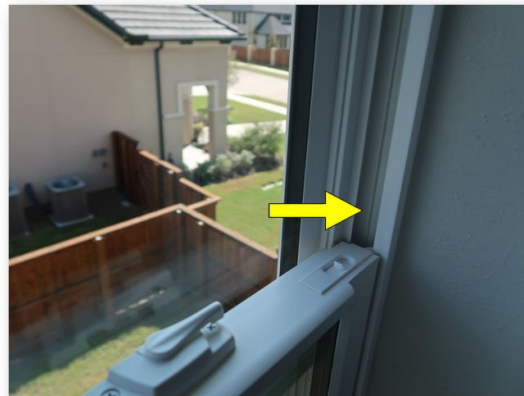
21. Absence fall protection at window

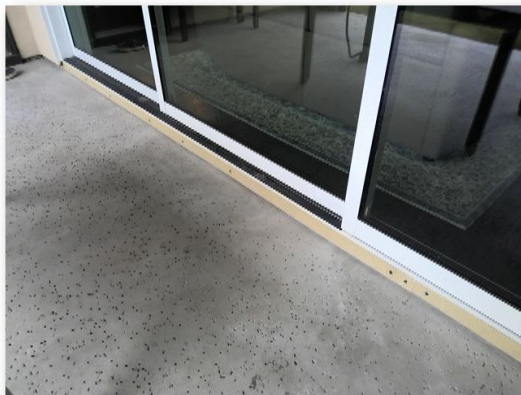
22. The trim work under the backyard patio is incomplete. Prompt action is needed to finish it.

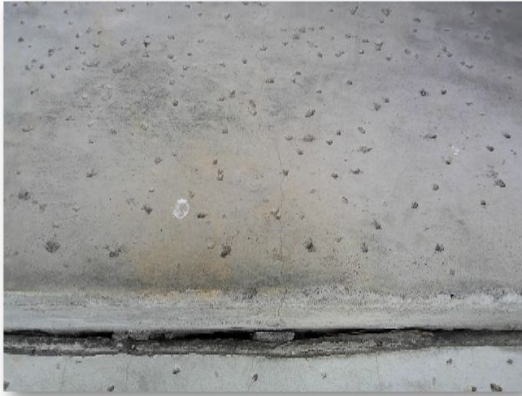
23.

A hairline crack has been found on the floor of the front porch.

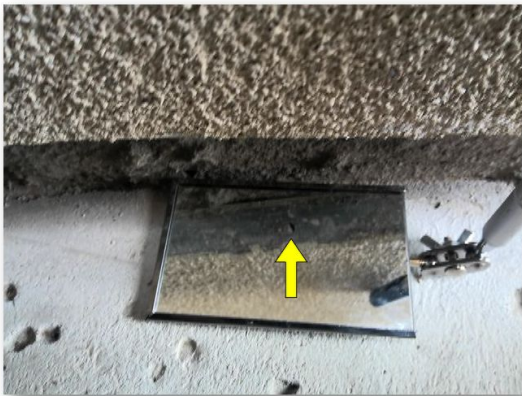
24.

The drain hole in the lower weep screed of the front porch stucco is clogged. A thorough evaluation of the lower weep screed is needed.

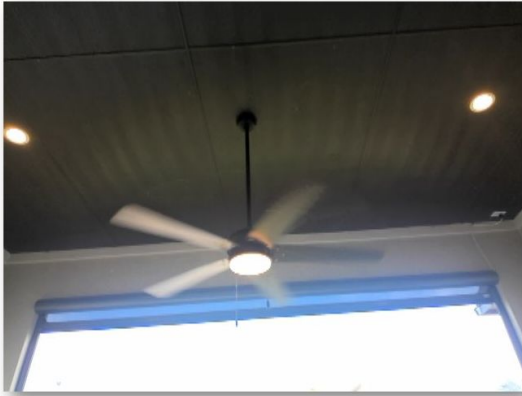
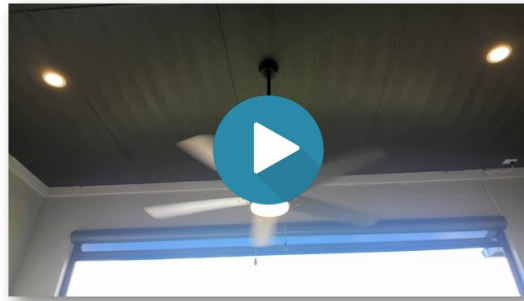
25. A ceiling fan in the Backyard Patio was noisy during operation. This condition is typical of deteriorated fan components.

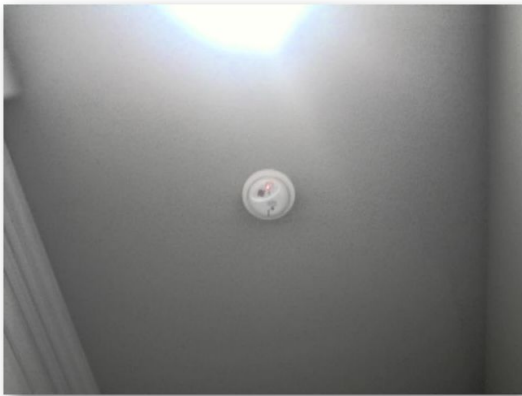
26. A red light is flashing abnormally on the smoke alarm device located in the ceiling between the indoor space and the garage. Evaluation and repair by the builder are needed.

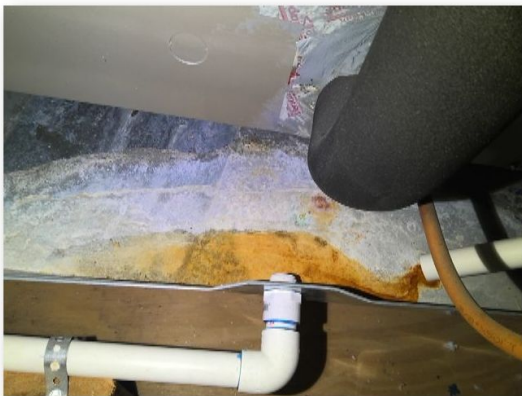
- 27.

Rust-colored water is visibly present on the drain pan of Furnace #2 in Cooling Unit #2. It appears to be leaking from the secondary drain pipe. Evaluation by an HVAC professional is needed.

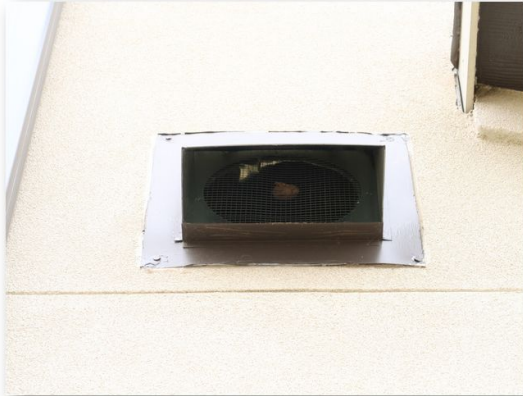
28.

A beehive is forming inside the mesh grill vent on the exterior Northside wall. It needs to be removed.

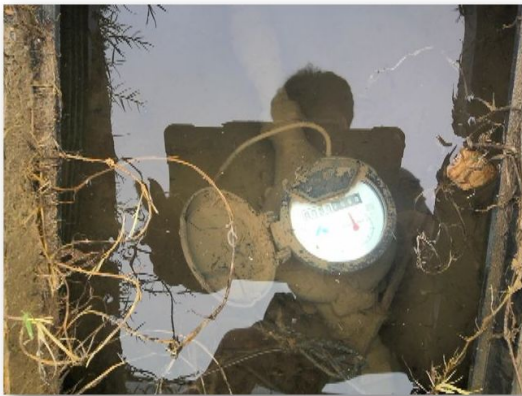
29.

The water meter box is continuously submerged in water. Over time, this could lead to issues such as corrosion of electronic components or metal valves. Measures should be taken to address drainage and prevent such problems.

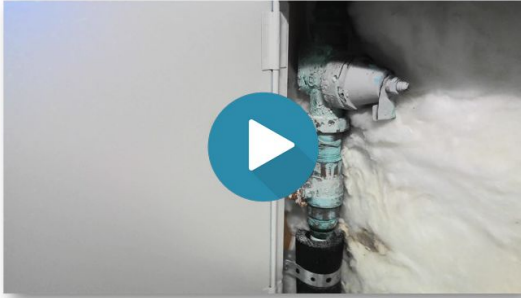
30. The main water valve on the garage wall interferes with the access door, causing inconvenience. The location of the door needs adjustment.

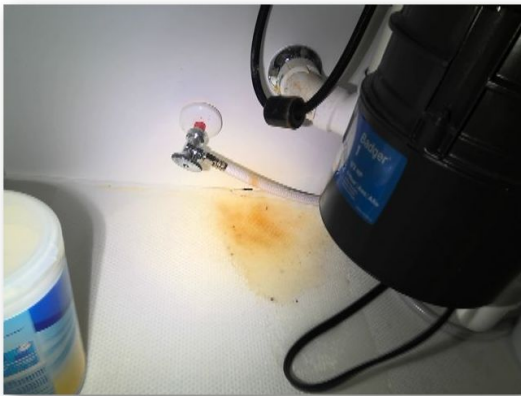
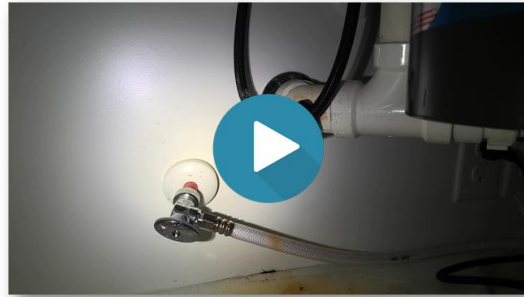
31. Sink leaks into cabinet below

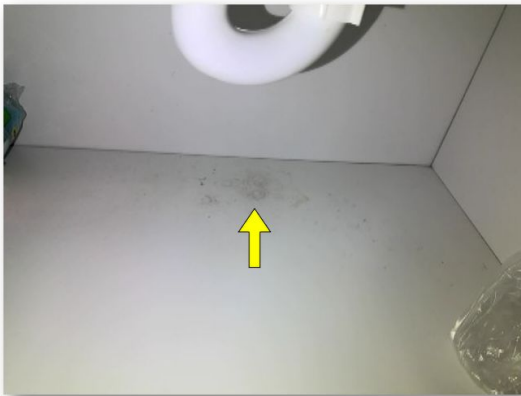
32. Mold has been observed on the floor of the sink cabinet in the bathroom with the upstairs drum. While there is no active leak at the moment, the underlying cause needs to be addressed. There is a possibility that water is dripping into the sink due to a lack of silicone sealant where the sink meets the wall.

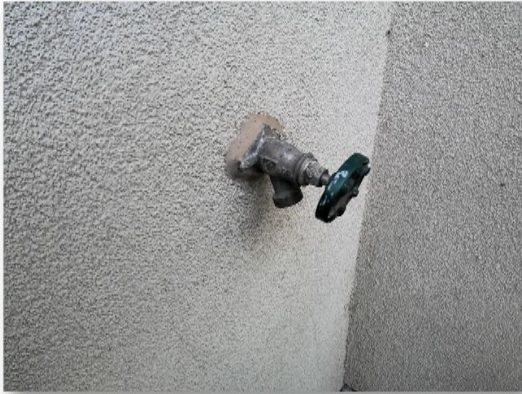
33.
 Exterior hose bibs do not have back-flow prevention

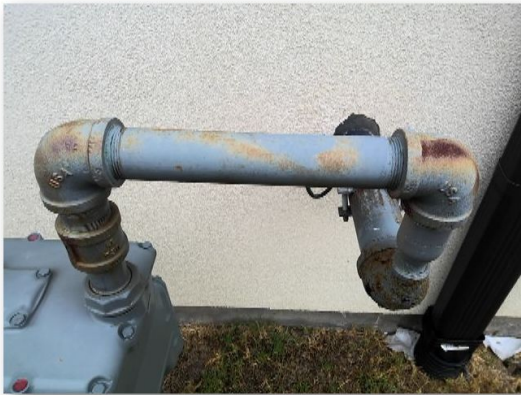
34.
Gas pipes in the exhibited minor general corrosion. Need to be painted.

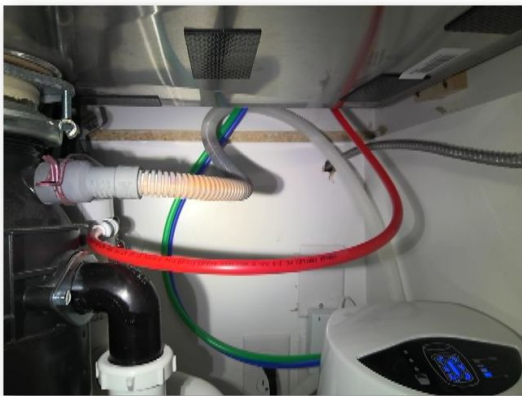
- 35.

The dishwasher did not appear to have an anti-siphon device installed in the drain line.

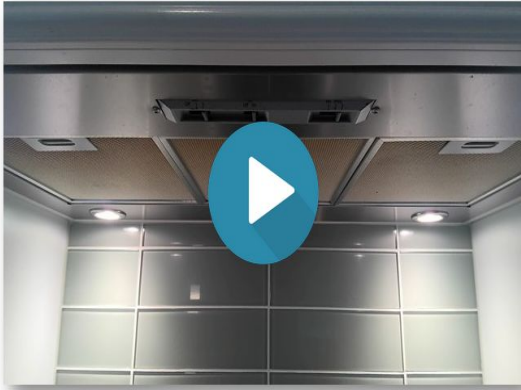
36. When the range hood fan is set to high speed, the noise level is excessively high. The fan's power settings may need adjustment, or the external duct cover should be inspected.

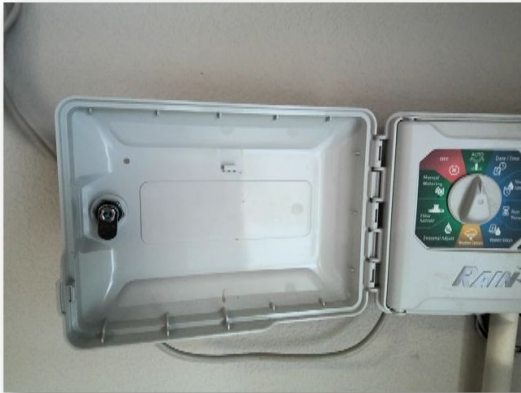
37. The landscape sprinkler control panel has no labels, making it difficult to identify the zones.

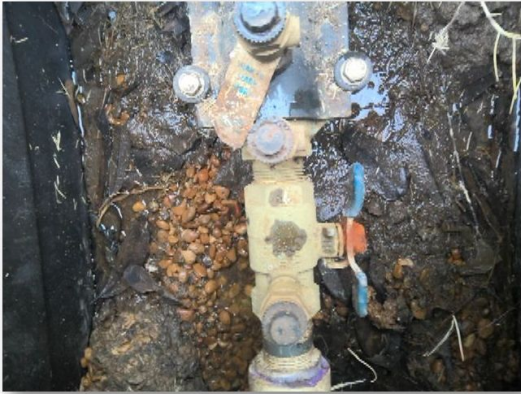
38. There is rust on the irrigation system backflow prevention valve. To prevent the valve handle from malfunctioning due to the rust, it is recommended to replace the valve.

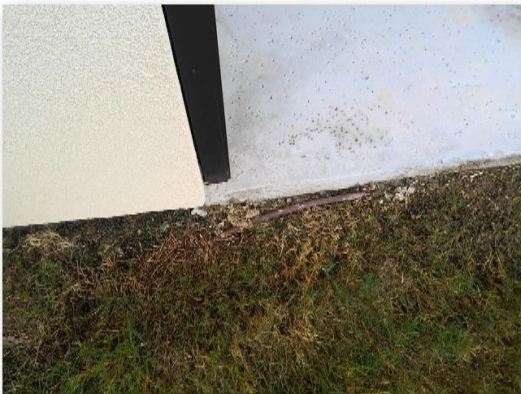
39. The foundation drip hose is exposed on the ground surface. To prevent accidental damage, it should be buried underground if possible.

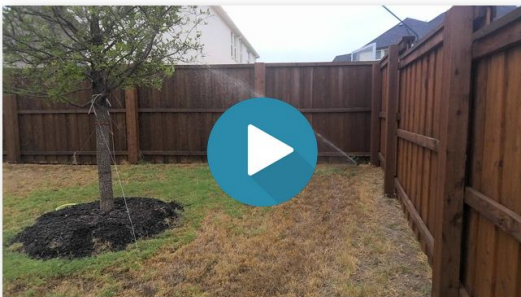
40. Zone 14, The direction of the head needs adjustment.

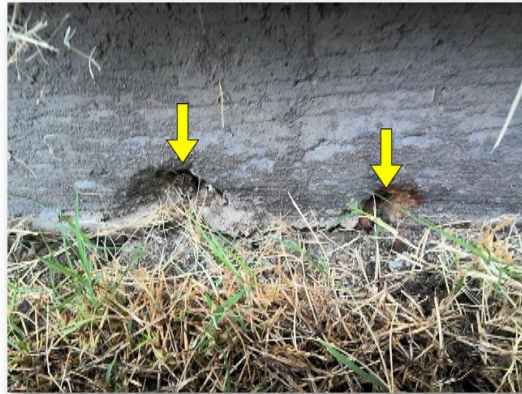
Unfinished foundation hardware, tie rods or snap ties observed at the time of inspection. The location is west side of front on the corner. Metal snap-ties protruding from the foundation were sharp and may cause injury. Snap-ties should be broken off at the foundation surface.

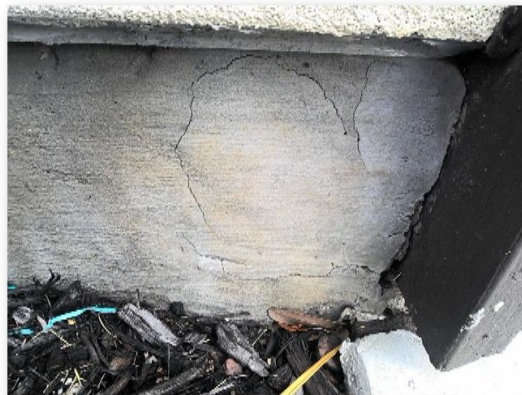
The portions of the concrete foundation wall surfaces minor crack in parge coat around bottom of garage door. No structural damage related to this condition was visible at the time of the inspection. This condition can be caused by pouring concrete under excessively cold conditions. Consider application of a parge coat to help prevent future freeze damage. A parge coat is a layer of cementitious material such as mortar that is applied to concrete to protect its weather surface.

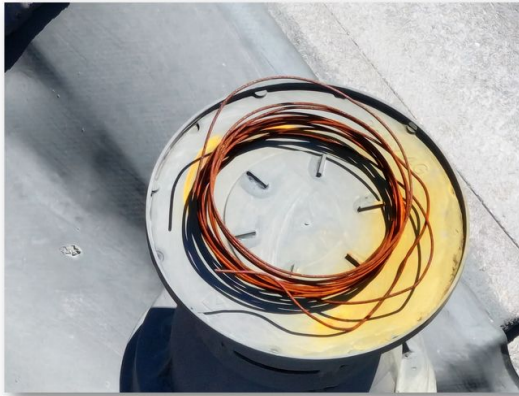
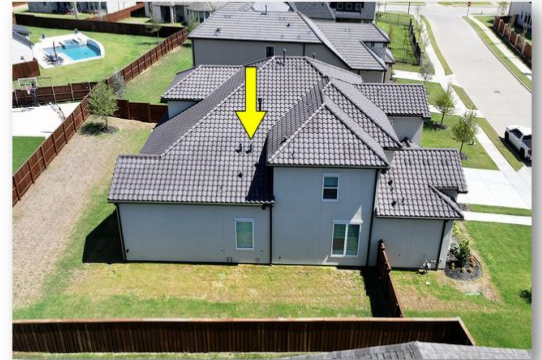
When the house was being built, for some unknown reason, the roofer placed a piece of wire from the roofing materials on top of the water heater duct cover. Now, a year later, rust has formed around the area. The wire needs to be removed, and the water heater duct cover should be painted.

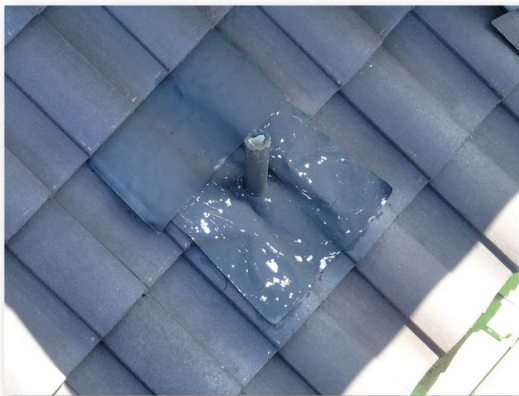
The flashing for the stack vents needs to be reinstalled.

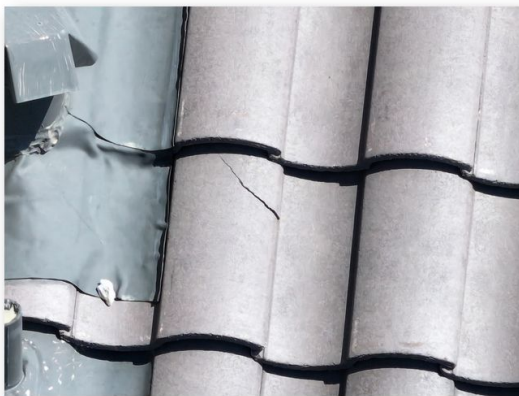
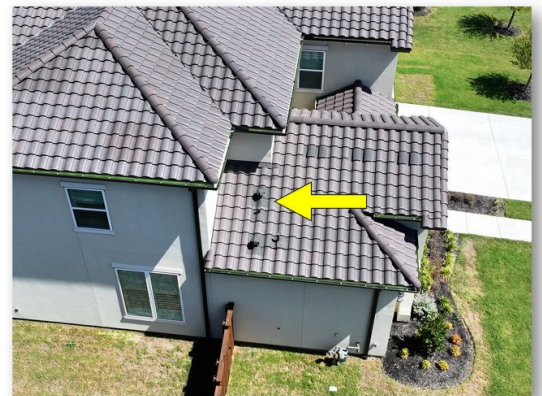
The roof had cracked and/or broken clay roof tiles that should be replaced to help prevent damage from roof leakage. We recommend consult with a qualified roofing contractor to discuss options.

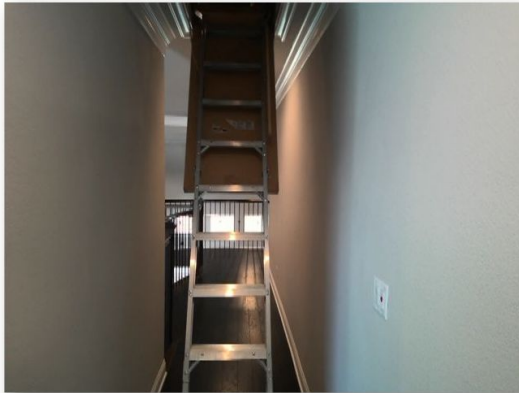
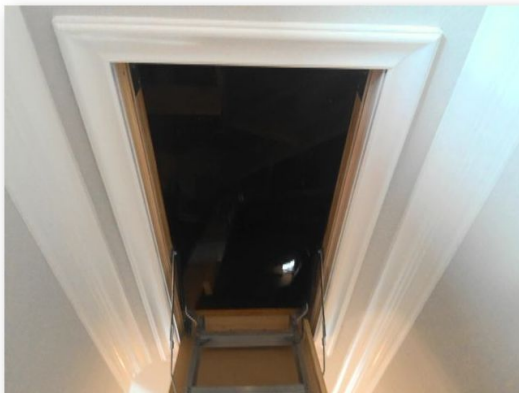
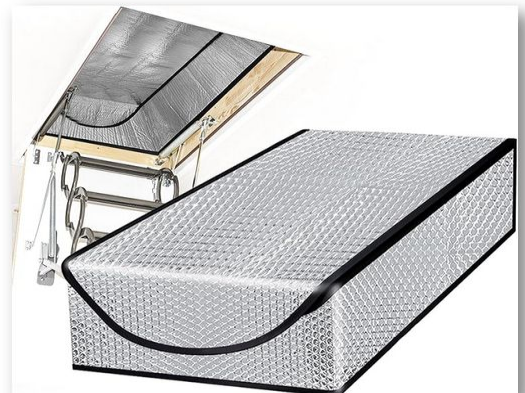
To improve insulation and energy savings between the attic space and living space, it is recommended to install an attic cover.

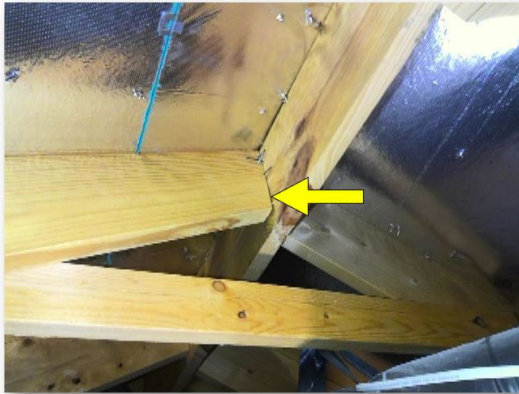
One or more rafters appeared to be separated from the ridge board. This could be correlated to evidence of structural movement. This can be repaired by nailing a supporting rafter to the existing rafter, forming a tight fit at the ridge. The supporting rafter should be the same width as the existing rafter and should be mitered at the end.

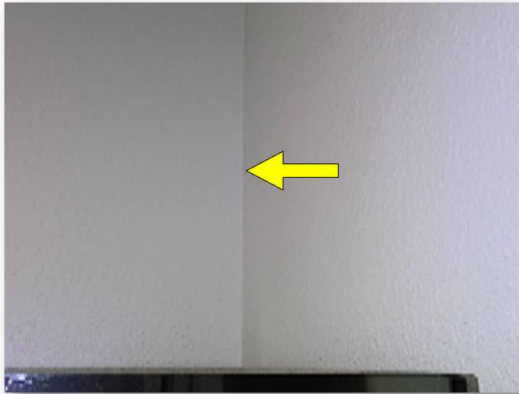
A hairline crack was found at the corner of the master bedroom closet entrance. It appears to be due to the movement of the structure caused by temperature changes. It does not seem to be a sign of structural damage.

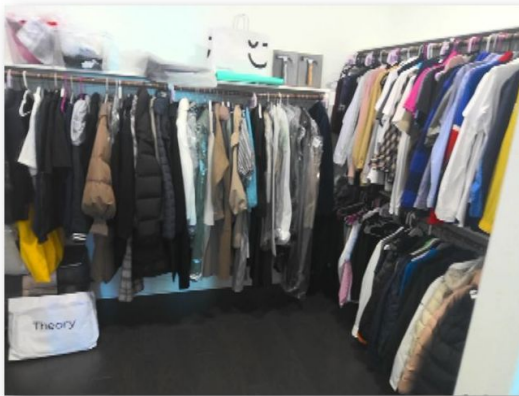
The closets are obstructed by the owner's belongings. The inspector is unable to access the inside of the wall closet to identify any deficiencies.

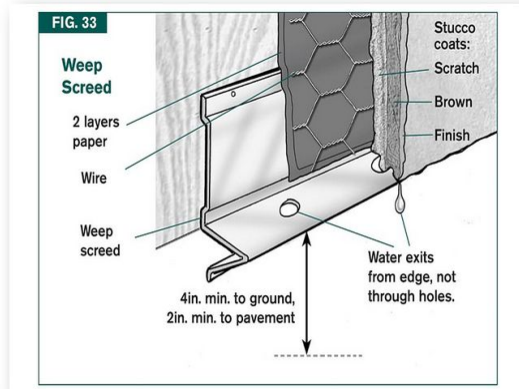
The weep screed on the house's exterior stucco requires evaluation by the builder. The area of concern is around the garage door, as shown in the photos.

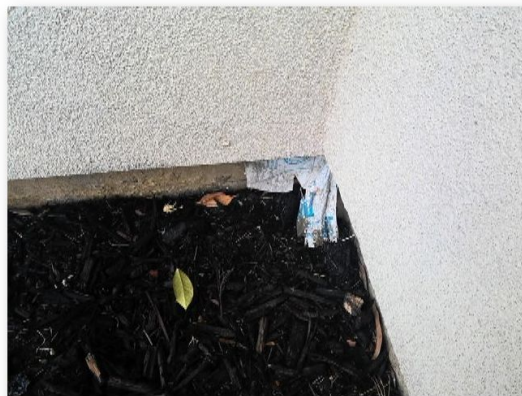
A piece of the vapor barrier house wrap has shifted out at the lower corner of the front of the house, creating an unsightly appearance. Removal is recommended.

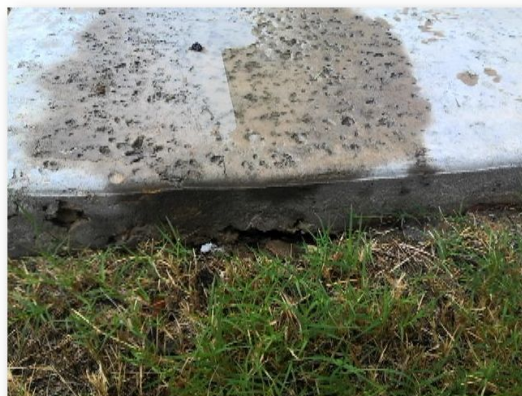
At the northeast corner of the house, there is a visible gap at the edge of the concrete pad due to insufficient concrete pouring. This hole could allow vermin to enter and nest. It is recommended to seal the hole.

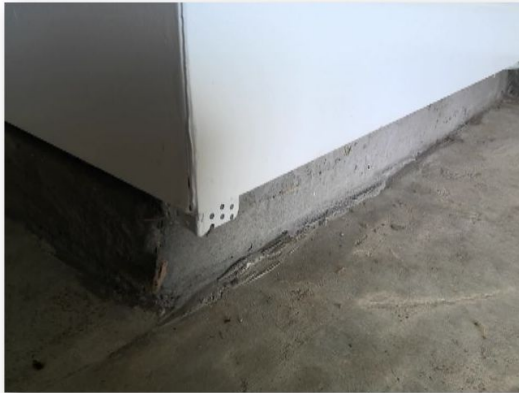
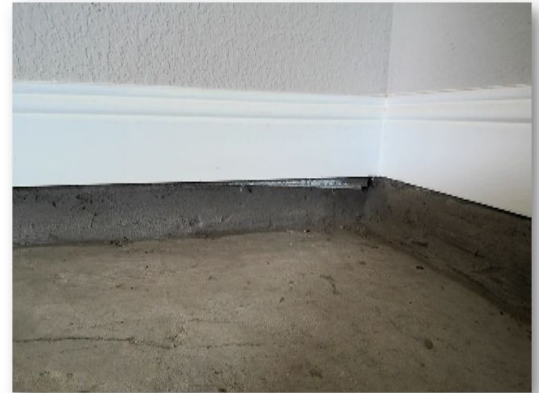
The lower trim materials in the corner of the garage are exposed, making it appear as though the installation is incomplete. It is recommended to either remove or reinstall the trim properly.

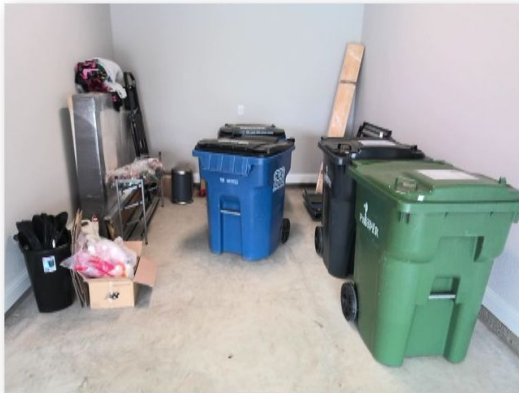
During the inspection of the property, it was noted that the some of garage space was obstructed by the owner's personal items. The presence of these items limited the ability to fully assess the condition and functionality of the garage.

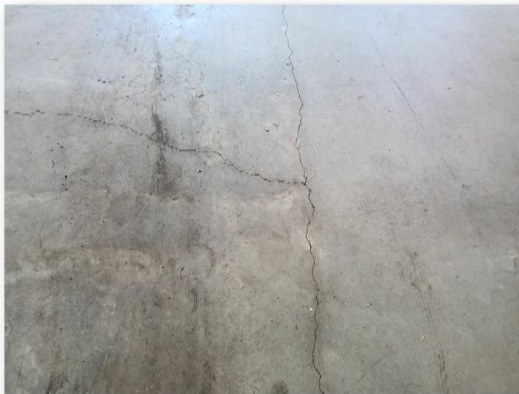
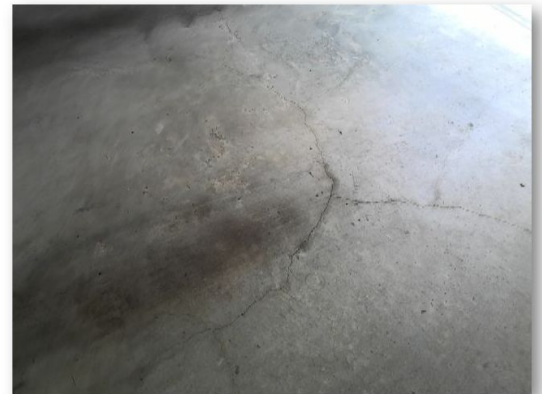
The garage floor had common shrinkage hairline cracks. These cracks are not a structural concern.

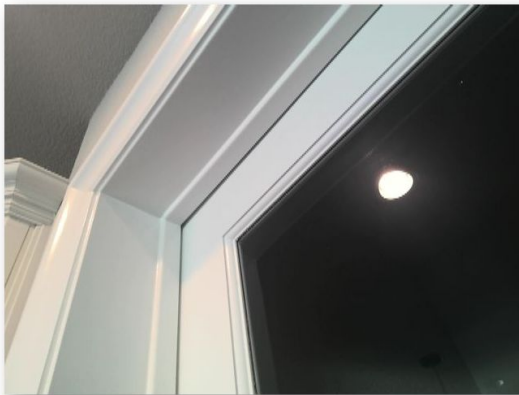
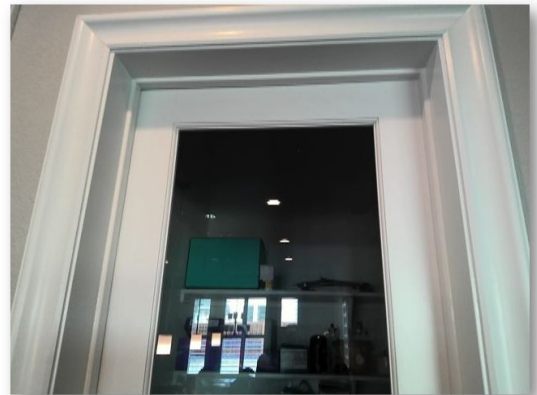
The hardware hinges on the kitchen pantry door need adjustment. There is a gap at the top.

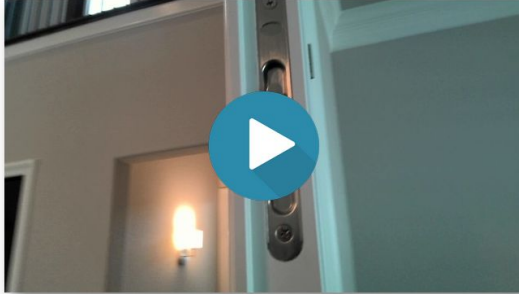
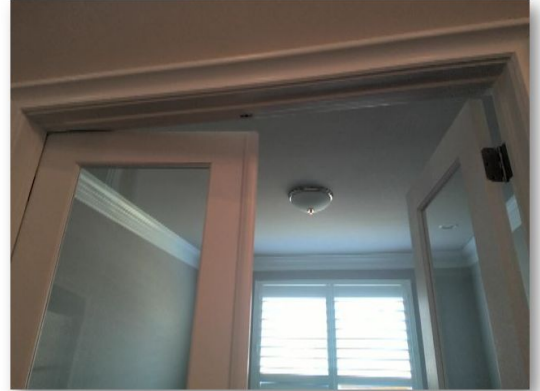
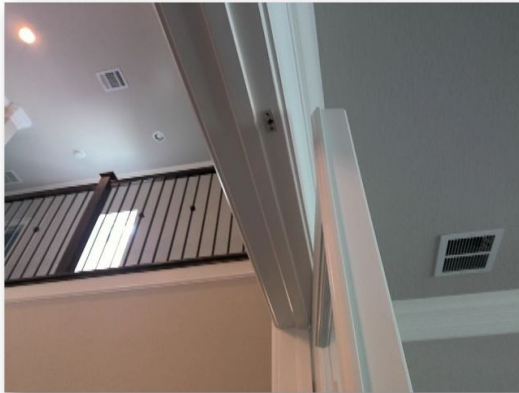
The lock hardware on the office door is not functioning. It needs to be repaired or replaced.

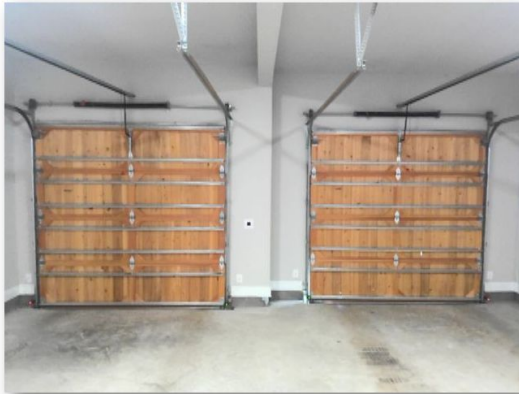
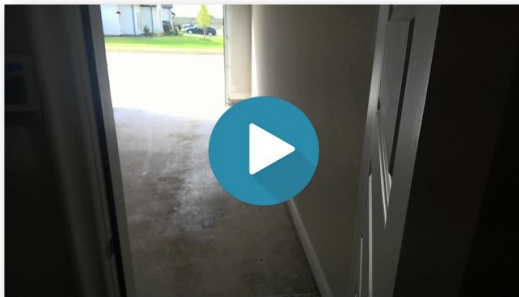
The door in the wall between the garage and the home living space did not have operable self-closing or automatic-closing device installed as is required by modern safety standards. Self- or automatic-closing doors are designed to slow the spread of fire starting in the garage and to prevent toxic exhaust fumes from entering indoor air. An operable self- or automatic-closing device should be installed by a qualified contractor.

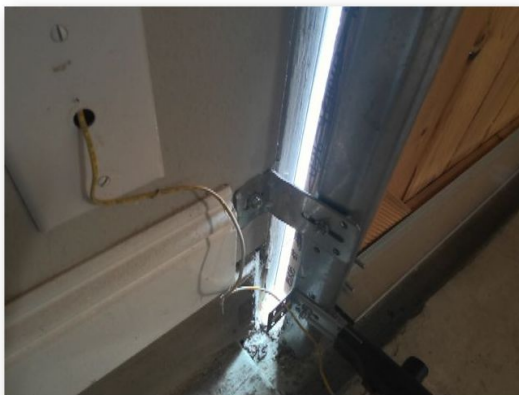
The garage door has a gap on the side where it leaves the interior exposed to allow animals or the elements to enter the garage, we recommend that this be sealed with a piece of trim or that the garage door be adjusted.

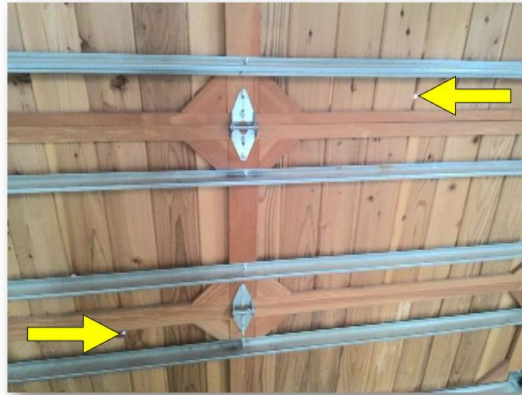
An air gap has been identified in the interior panel of the garage door. It is recommended to fill the gap with a wood filler.

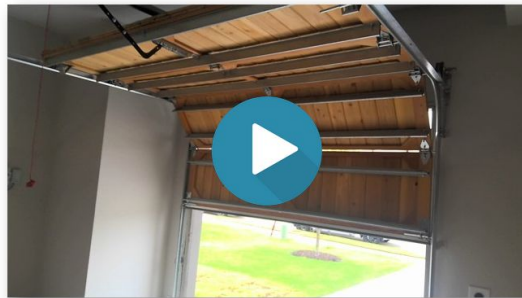
It was noted that the eastern garage door makes significantly more noise compared to the other doors. It is recommended to adjust the garage door's hockey stick to the 1 o'clock position.

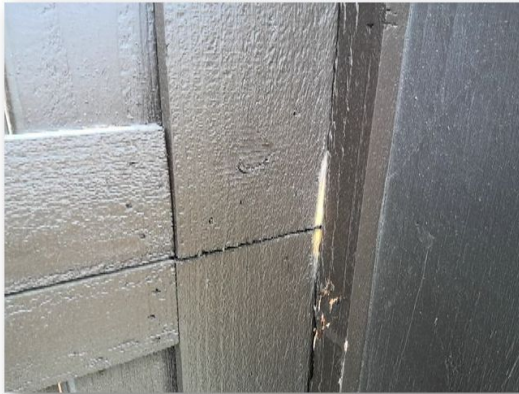
A garage vehicle door had peeling paint. Timely maintenance will help extend its lifespan.

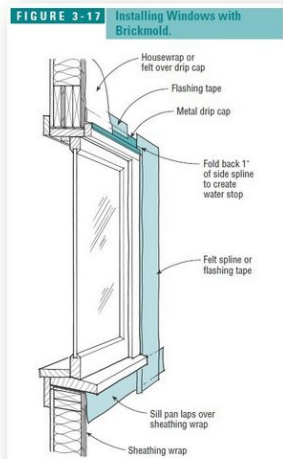
Components of window sill exteriors were loose, damaged or deteriorated and needed maintenance to help prevent damage from moisture intrusion to the home materials, the exterior wall structure and to prevent development of microbial growth such as mold. All work should be performed by a qualified contractor.

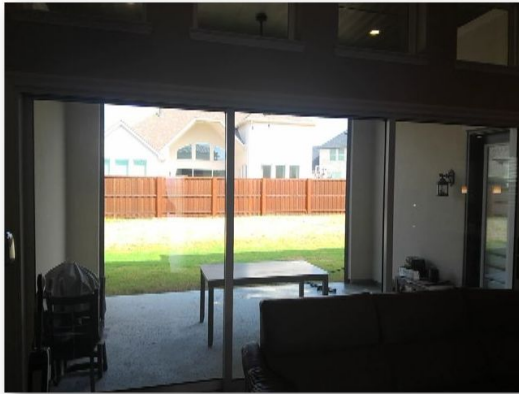
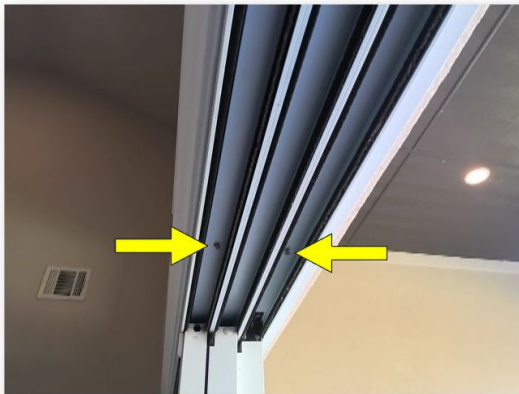
The rail mounting bolts for the main sliding door in the living room have loosened and are coming down. The bolts need to be tightened securely to prevent damage to the door during operation.

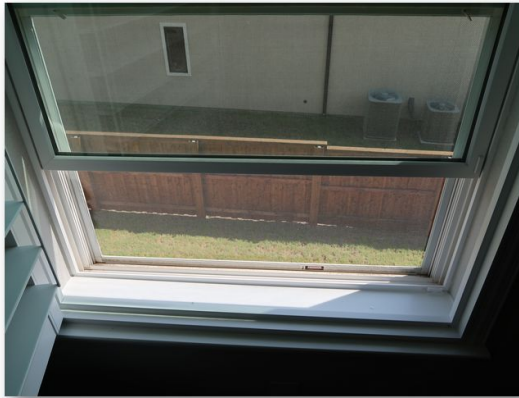
Absence fall protection at window

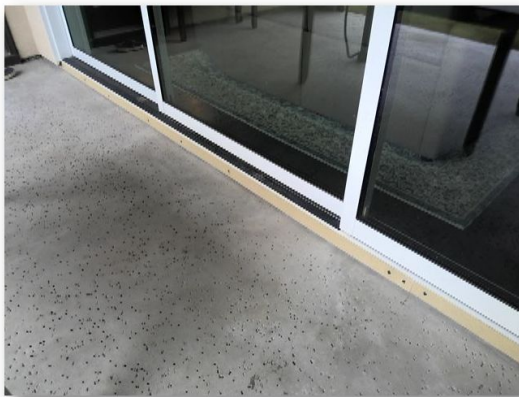
The trim work under the backyard patio is incomplete. Prompt action is needed to finish it.

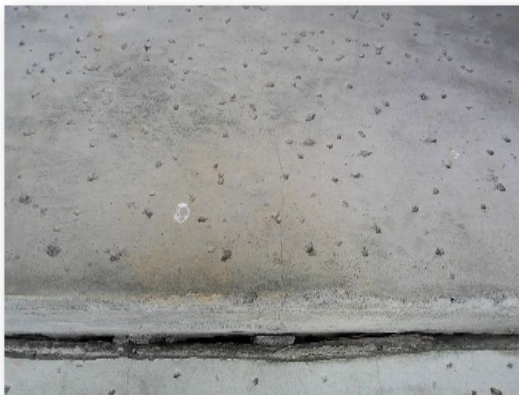
A hairline crack has been found on the floor of the front porch.

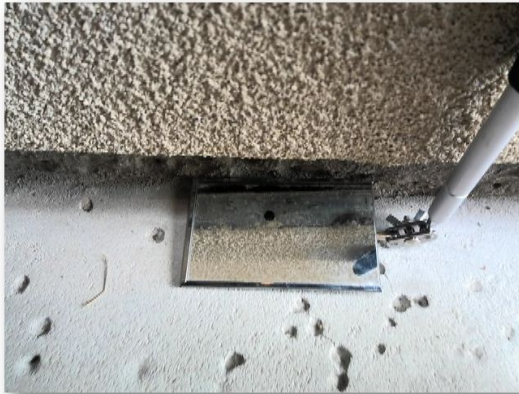
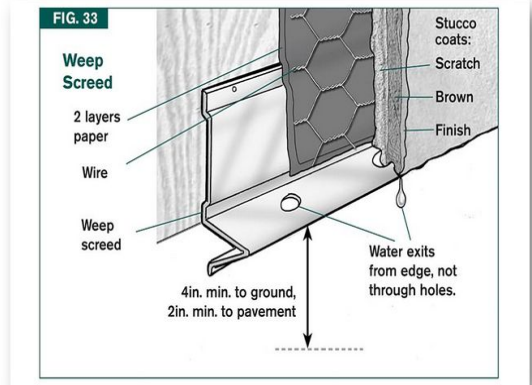
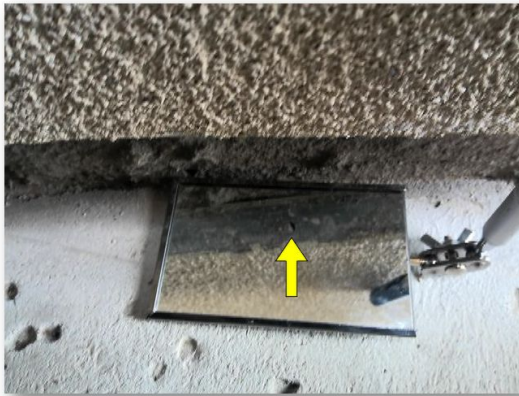
The drain hole in the lower weep screed of the front porch stucco is clogged. A thorough evaluation of the lower weep screed is needed.
