PrimeVue
HOME INSPECTIONS

HOME AND TERMITE INSPECTIONS
254-727-0900
TX

Inspected by Jude Hwang TREC #25266

DEFICIENCY SUMMARY

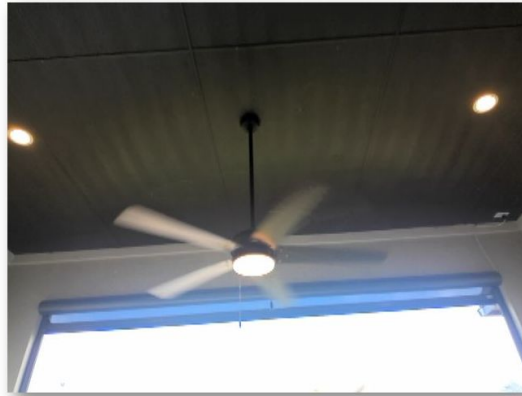
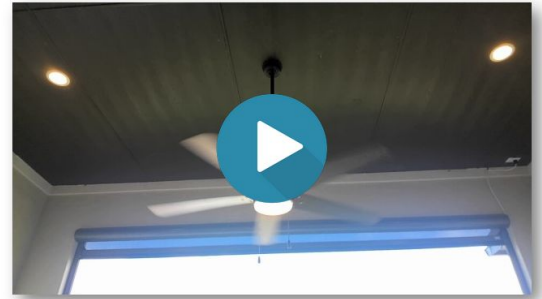
A ceiling fan in the Backyard Patio was noisy during operation. This condition is typical of deteriorated fan components. It should be serviced or replaced as necessary by a qualified contractor.

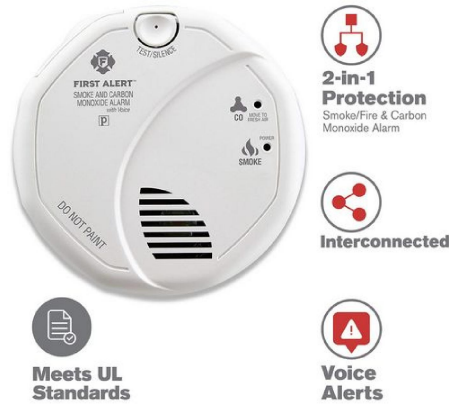
There are missing carbon monoxide alarms in the home. Carbon monoxide alarms should be installed in accordance with current standards, as follows: 2009 International Residential Code R315.2.1 New construction. Carbon monoxide alarms shall be provided in dwelling units when either or both of the following conditions exist. 1. The dwelling unit contains a fuel- fired appliance. 2. The dwelling unit has **an attached garage with an opening that communicates with the dwelling unit.** R315.3 Location. Carbon monoxide alarms in dwelling units shall **be installed outside of each separate sleeping area in the immediate vicinity of the bedrooms.** When a fuel-burning appliance is located within a bedroom or its attached bathroom, a carbon monoxide alarm shall be installed within the bedroom. Carbon monoxide is an odorless, colorless, and tasteless gas that is near impossible to identify without a proper detector. It is caused by fuels not burning completely, including wood, gasoline, coal, propane, natural gas, gasoline, and heating oil. This unburned fuel can come from anything from clothes dryers, water heaters, and ovens to ranges, a fire-burning fireplace, or a car left running in a closed garage.

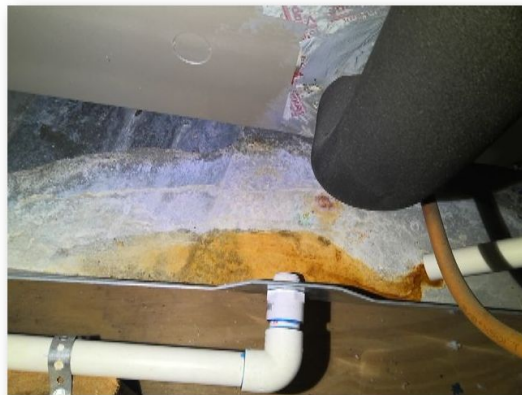
Rust-colored water is visibly present on the drain pan of Furnace #2 in Cooling Unit #2. It appears to be leaking from the secondary drain pipe. Evaluation by an HVAC professional is needed.

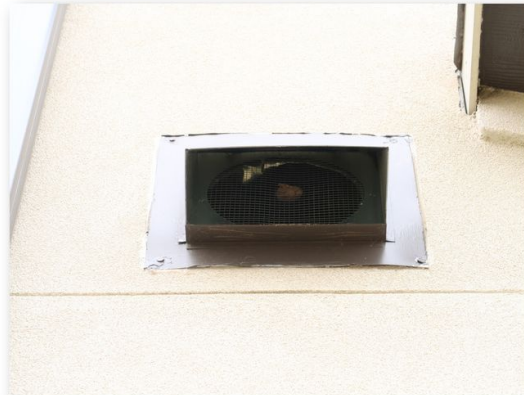
A beehive is forming inside the mesh grill vent on the exterior Northside wall. It needs to be removed.

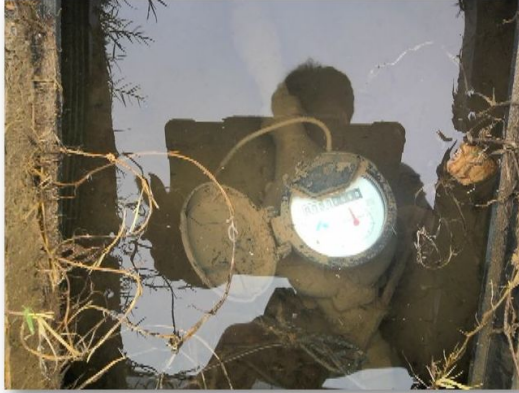
The water meter box is continuously submerged in water. Over time, this could lead to issues such as corrosion of electronic components or metal valves. Measures should be taken to address drainage and prevent such problems.

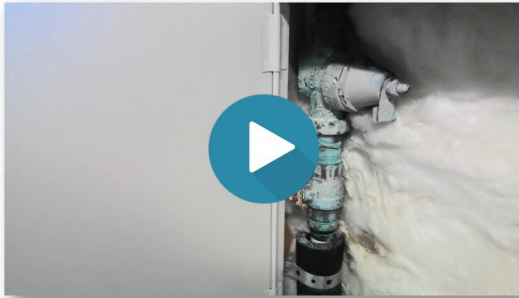
The main water valve on the garage wall interferes with the access door, causing inconvenience. The location of the door needs adjustment.

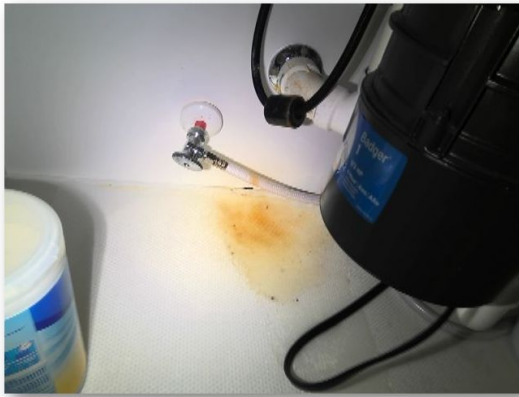
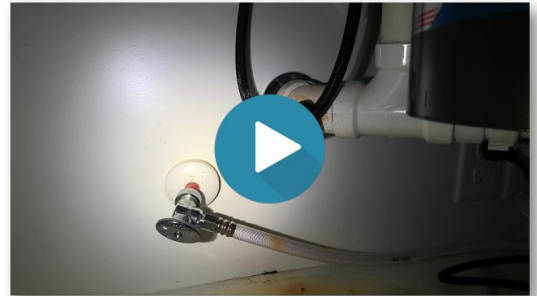
Sink leaks into cabinet below

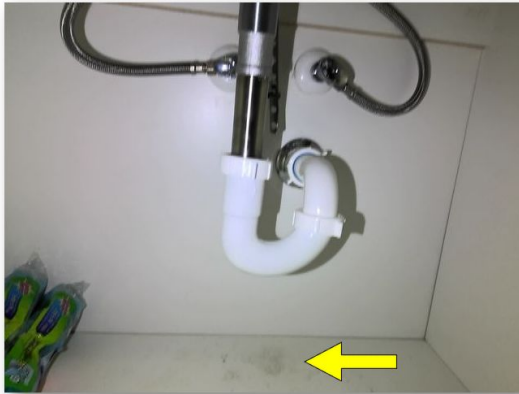
Mold has been observed on the floor of the sink cabinet in the bathroom with the upstairs drum. While there is no active leak at the moment, the underlying cause needs to be addressed. There is a possibility that water is dripping into the sink due to a lack of silicone sealant where the sink meets the wall.

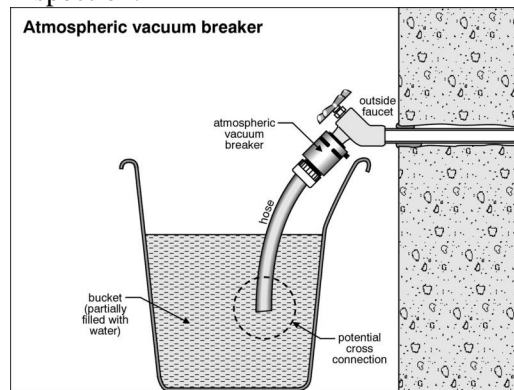
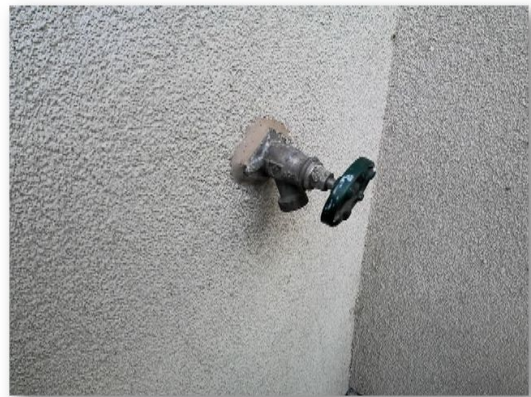
- Exterior hose bibs do not have back-flow prevention

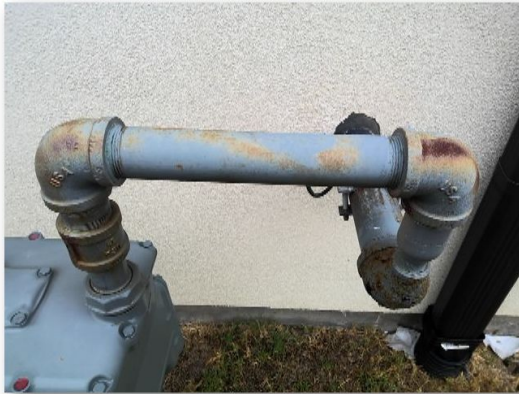
Gas pipes in the exhibited minor general corrosion. Need to be painted.

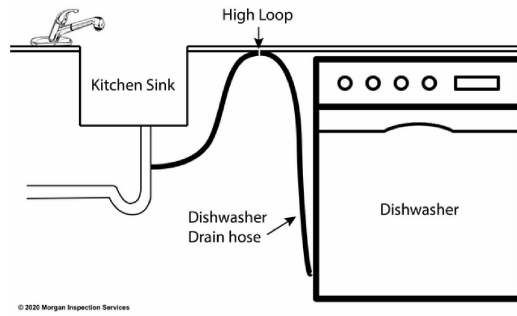
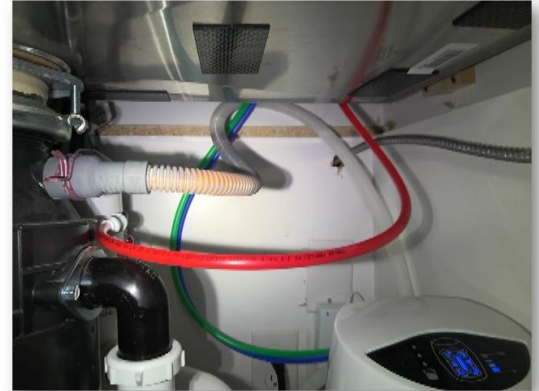
The dishwasher did not appear to have an anti-siphon device installed in the drain line. Anti-siphon devices are installed to prevent wastewater from the dishwasher from being siphoned back into the dishwasher and contaminating its contents. An anti-siphon device should be installed by a qualified technician.

- No anti-siphon loop at the drain line

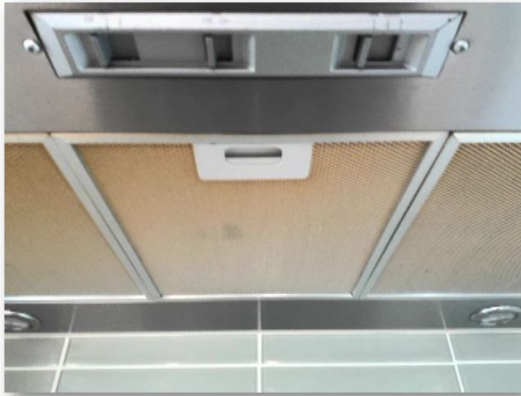
Filter need to be cleaned

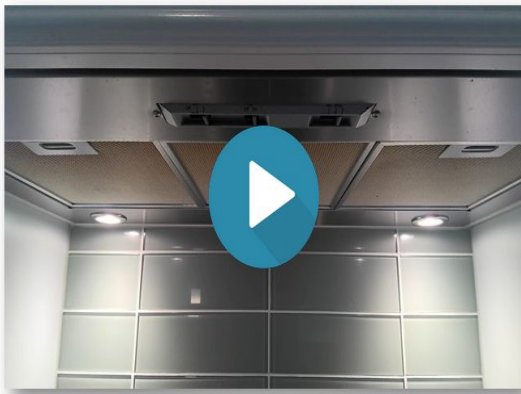
When the range hood fan is set to high speed, the noise level is excessively high. The fan's power settings may need adjustment, or the external duct cover should be inspected.

Filter is dirty / greasy

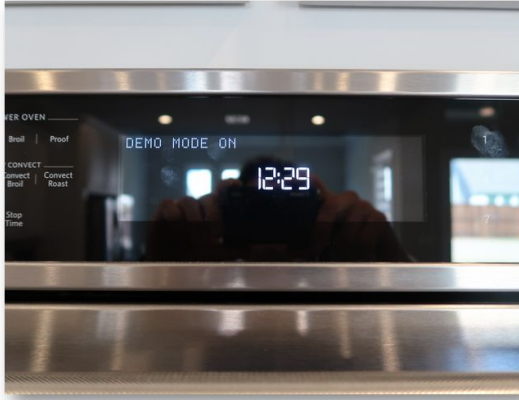
To test the oven, the demo mode needs to be deactivated.

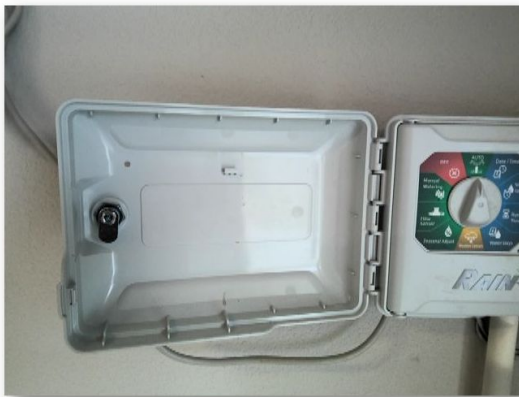
The landscape sprinkler control panel has no labels, making it difficult to identify the zones.

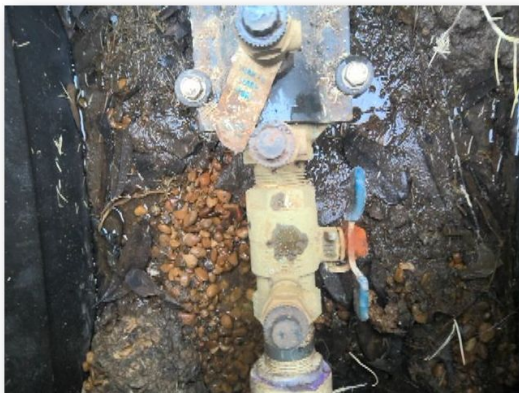
There is rust on the irrigation system backflow prevention valve. To prevent the valve handle from malfunctioning due to the rust, it is recommended to replace the valve.

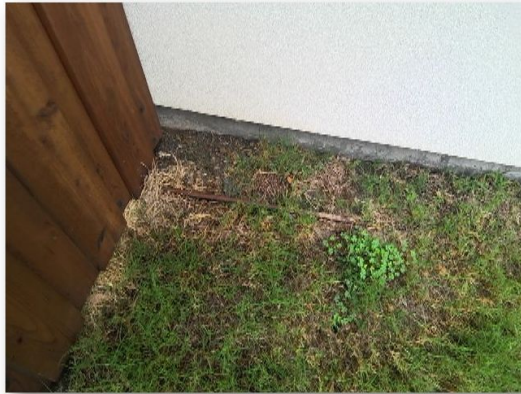
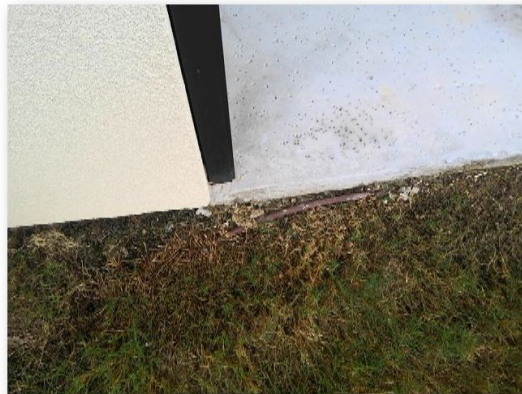
The foundation drip hose is exposed on the ground surface. To prevent accidental damage, it should be buried underground if possible.

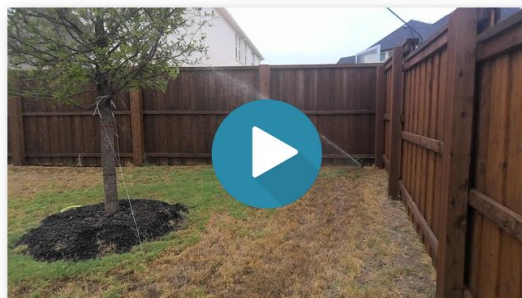
Zone 14, The direction of the head needs adjustment. Currently, it is directly spraying the wooden fence, which could eventually cause water damage or discoloration to the fence.
