HOME AND TERMITE INSPECTIONS
254-727-0900
1234 DALLAS

Inspected by Jude Hwang TREC #25266

DEFICIENCY SUMMARY

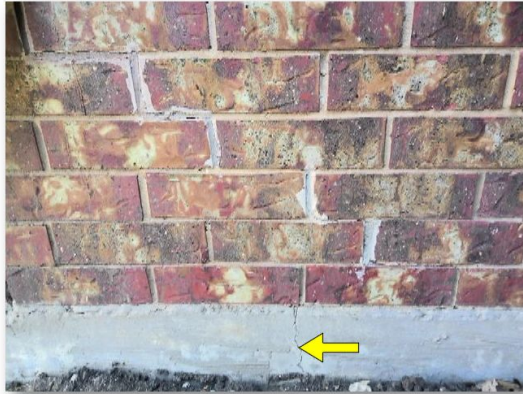
2. Minor cracking was noted at the foundation. This is common as concrete ages and shrinkage surface cracks are normal. Recommend monitoring for more serious shifting/displacement.

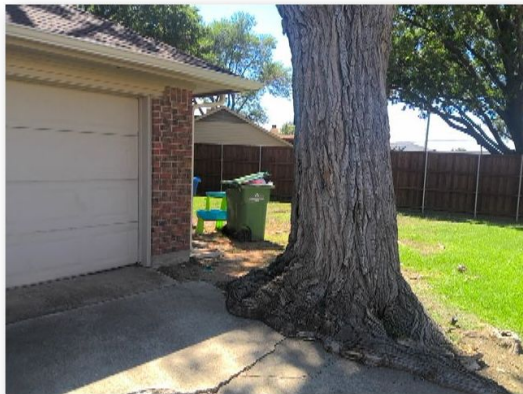
3. [Minor Concerns/Maintenance Items/FYI](#)
Tree(s) in close proximity of the foundation was observed. Client should consider the installation of a root barrier to reduce the possibility of damage to the foundation from tree roots and moisture removal, or have the trees taken down so that they do not damage the property over time.

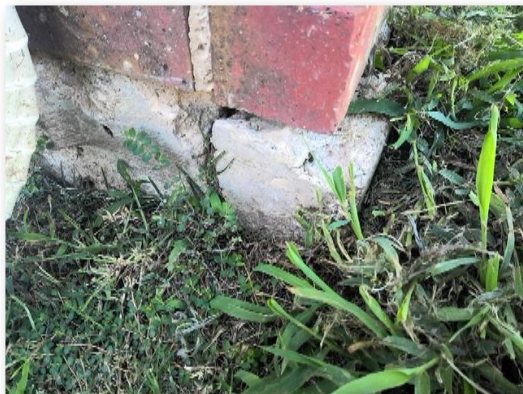
4. East Back

Some exterior corners of the concrete foundation walls were cracked or broken. Exterior corners are high-stress areas and this condition is not unusual in some older homes. The foundation appeared to be adequately supporting the exterior wall structure in these areas.

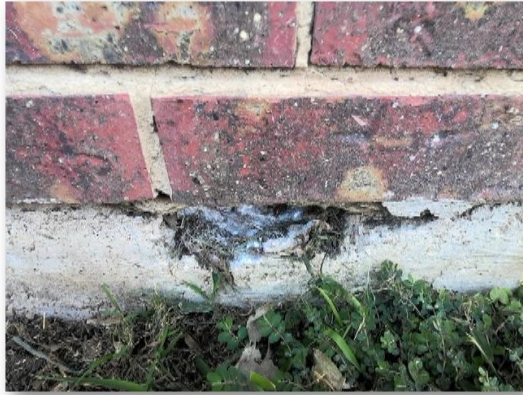
5.

Unfinished foundation hardware, tie rods or snap ties observed at the time of inspection.

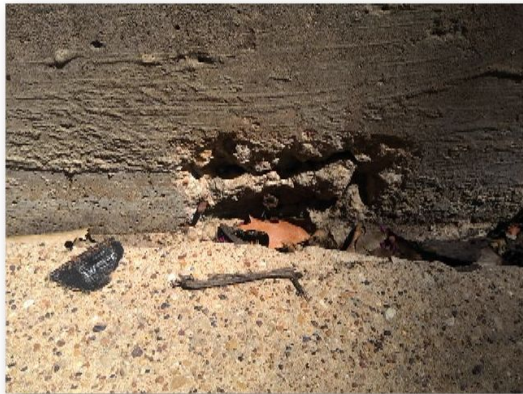
6.

One or more of the post tension cable ends / fasteners are exposed and need to be properly sealed on the side of the structure.

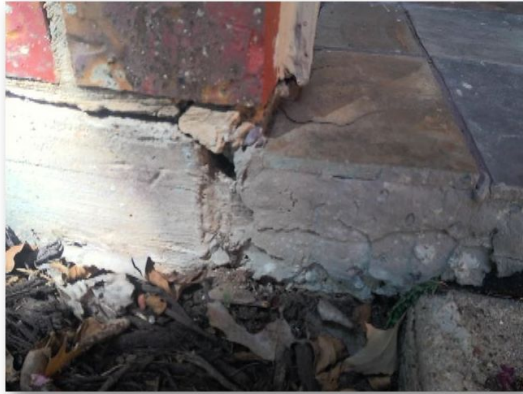
7.

The portions of the concrete foundation wall surfaces minor crack in parge coat.

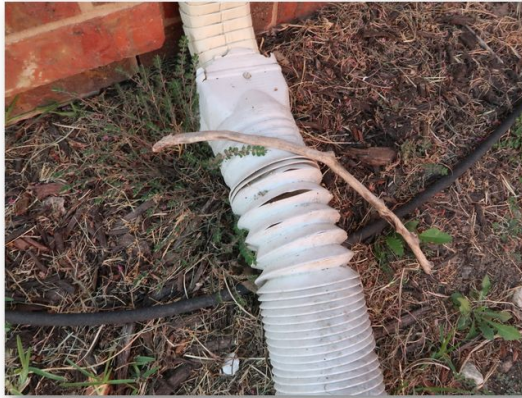
10.

The gutters of this house appear to have been recently replaced, but overall, the condition of the splash guards is poor or they are missing. Additionally, damage was found at the time of inspection where the downspouts meet the ground. Overall, the rainwater drainage system requires maintenance.

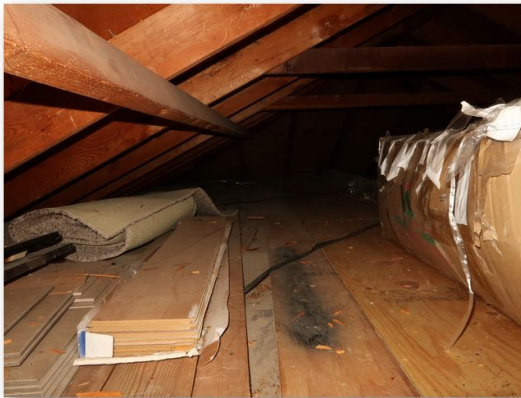
11.

Insulation is not installed in the attic over the garage.

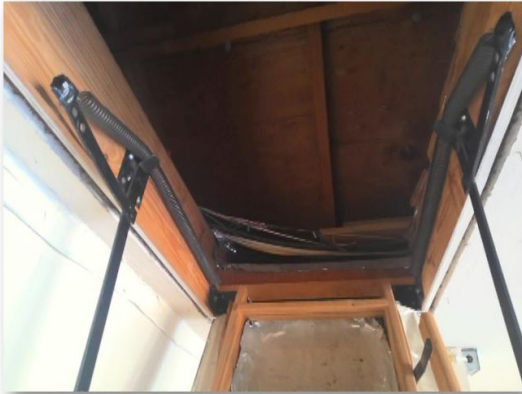
12. The pull-down ladder access is positioned in reverse, making it difficult to access the attic.

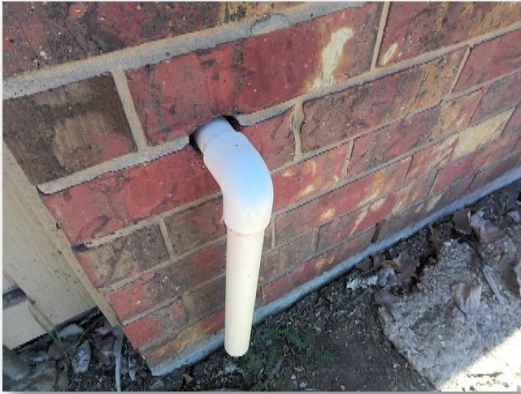
15. Pipes penetrating exterior walls left gaps that needed to be sealed by a qualified contractor with an appropriate sealant to prevent moisture and insect entry.

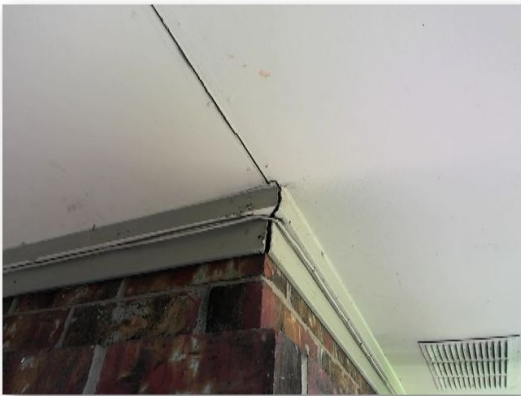
16. **The exterior wall trim had gaps that should be filled** with an appropriate sealant by a qualified contractor to help prevent moisture and insect entry.

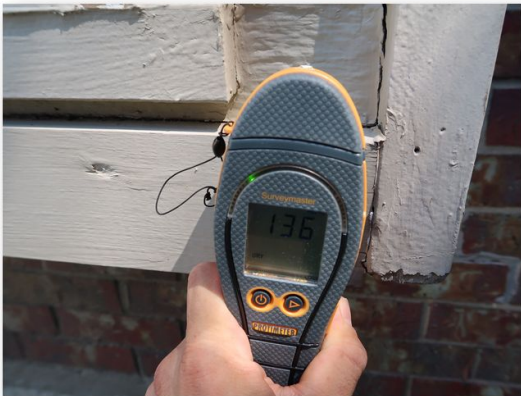
17. Wet and rotten wood draw increases the possibility of insect's invasion.

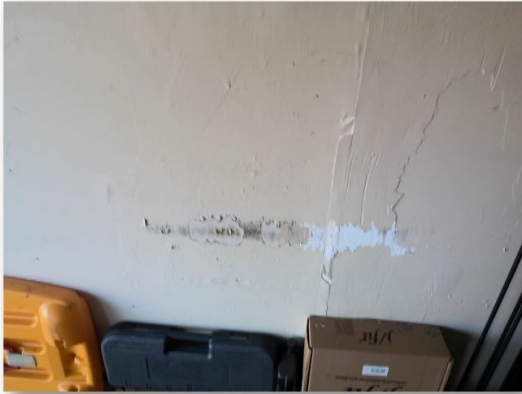
18. Drywall patches installed in the garage were poorly executed. Drywall seams visible in the walls of the garage were typical of poor installation.

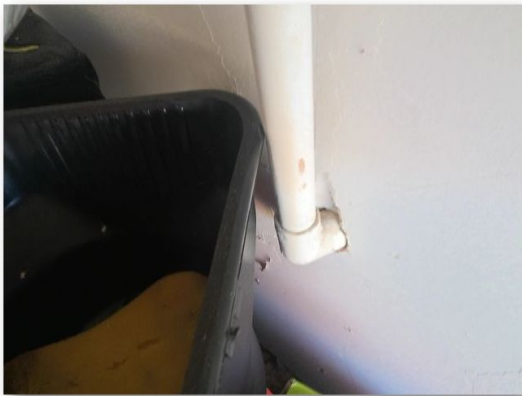
19. Caulking is needed around the electrical conduit for the sprinkler system on the garage interior

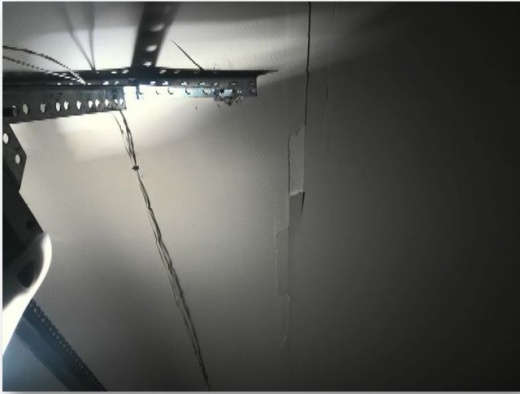
20.

There are several areas where the ceiling and walls of the garage meet that show signs of chipping.

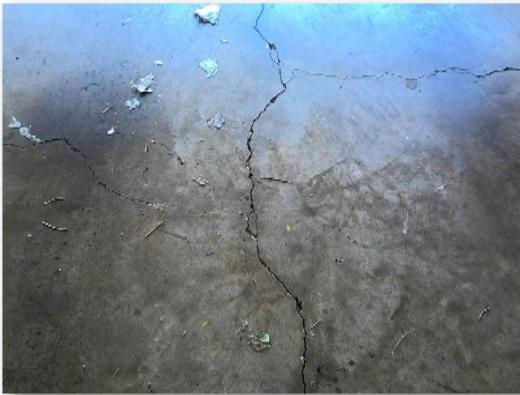
21.

The garage floor appears to have cracks that exceed the standard threshold, likely due to the influence of the roots from the large tree in front.

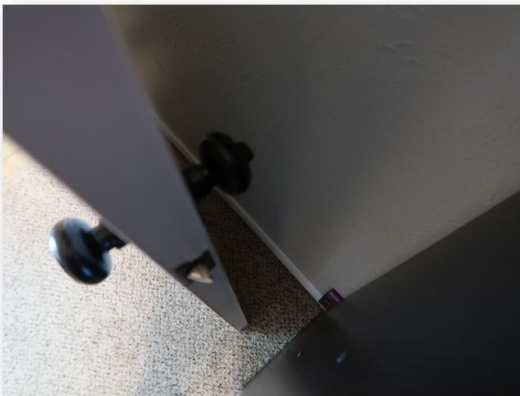
22.

An interior doors were missing a stopper. This condition is may result in wall and door

damage. A stop be installed to protect the wall.

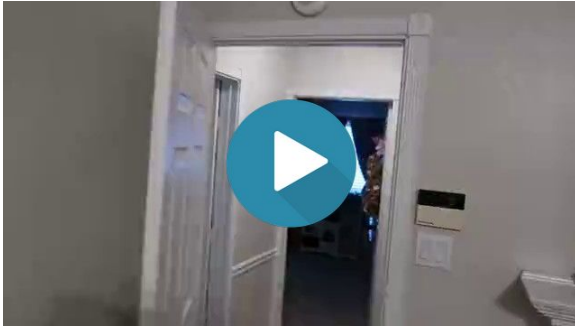
23. The interior door of the master bedroom automatically closes due to the floor being out of level.

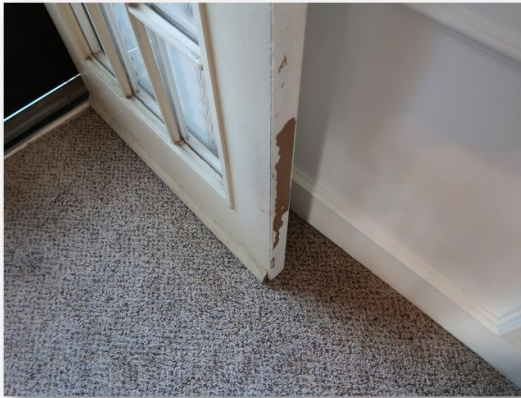
24. The exterior paint on the door is damaged and looks unappealing. It is recommended to adjust the hardware so it does not contact the door case, and then repaint the door.

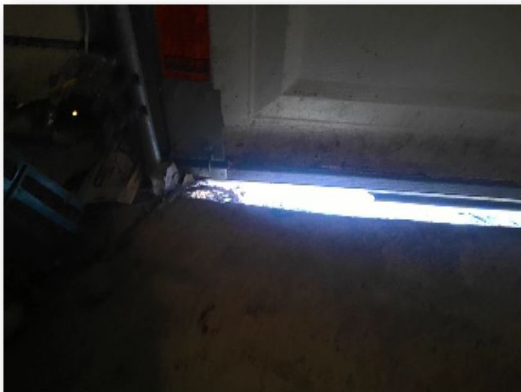
26. Garage door was observed penetrations had gaps indicate at time of inspection

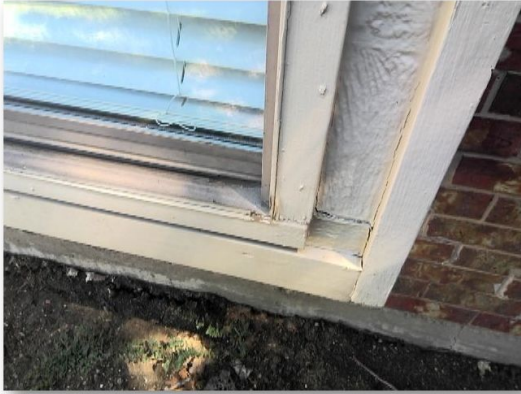
27. Windows and trim outside the house require caulking to prevent possible moisture damage

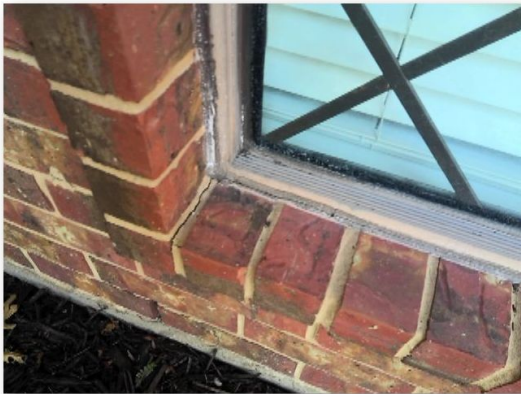
28. Outside window brick wall was observed hairline crack, require patch to prevent possible moisture damage

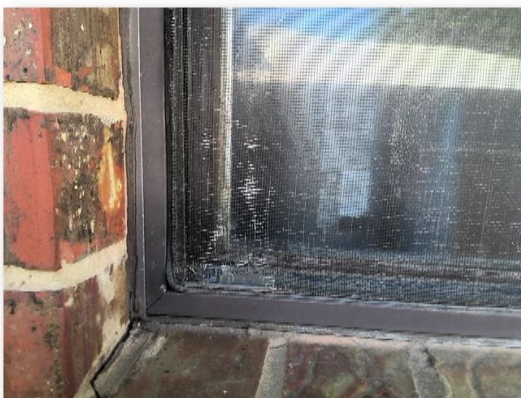
- 29.

East wall Window screen was damaged

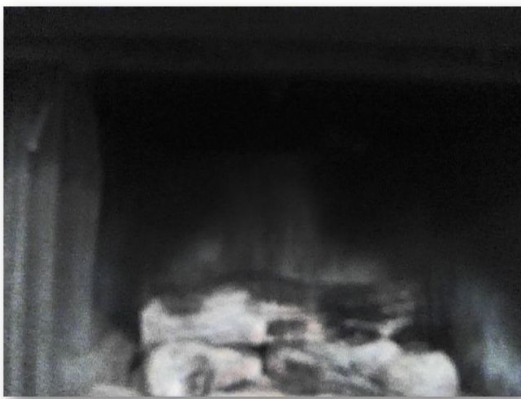
32. The firebox of the fireplace in the living room needed cleaning.

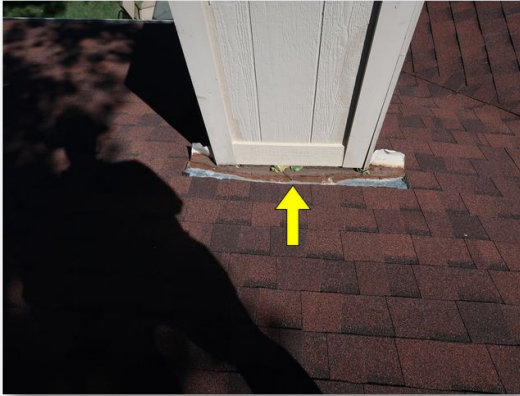
33. The chimney had no cricket.

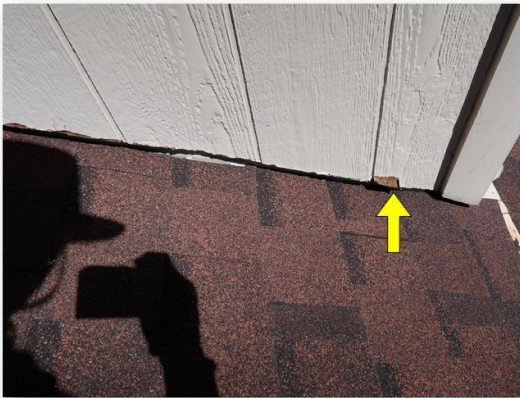
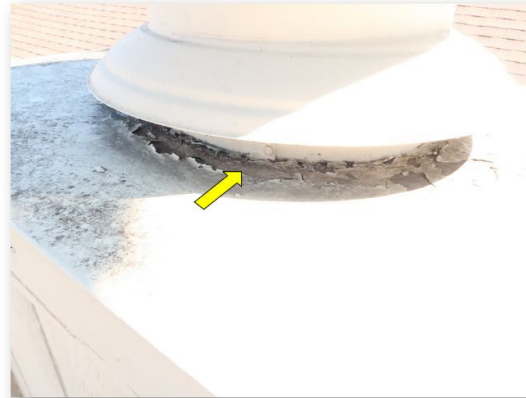
34. There is paint chipping on the chimney sidewall, and paint is peeling around the rain cover.

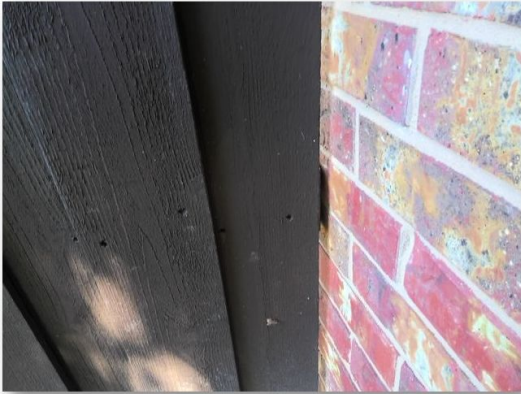
39. The wood fence is in contact with the exterior wall of the structure.

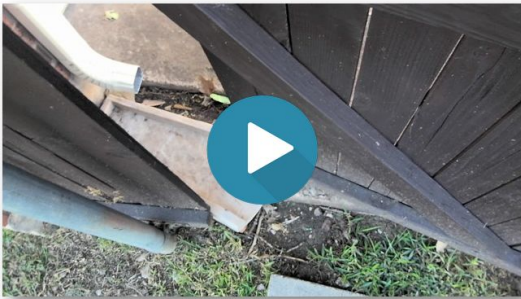
40. The fence door is obstructed by the downspout splash guard, interfering with its operation. This issue needs to be resolved.

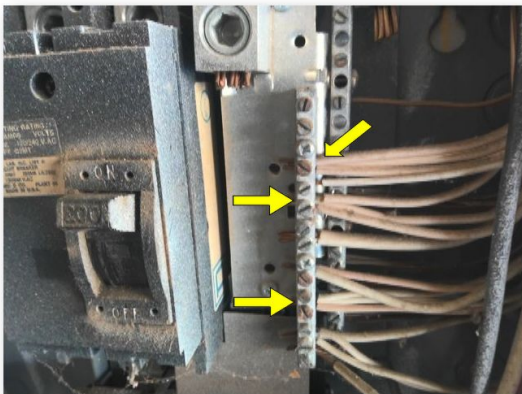
45. There are double tapped neutral conductors in the electric service panel.

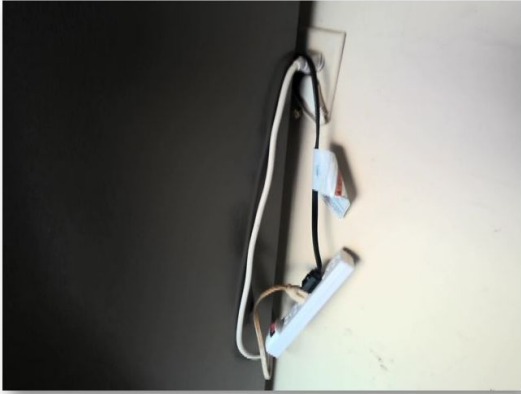
46. Extension cord used as permanent wiring was visible at the garage.

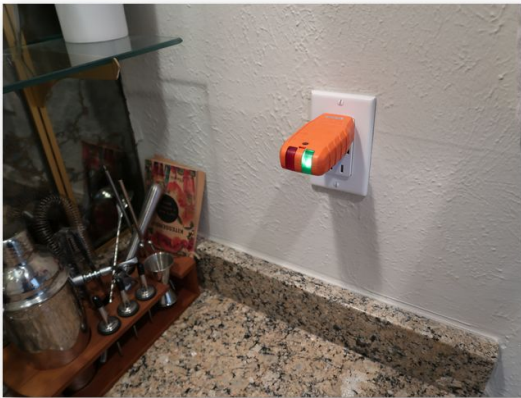
47. Electrical receptacles in the wet bar was installed upside down, with the ground holes above the neutral and hot slots.

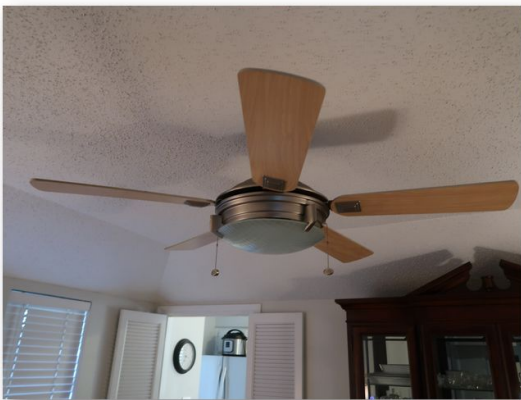
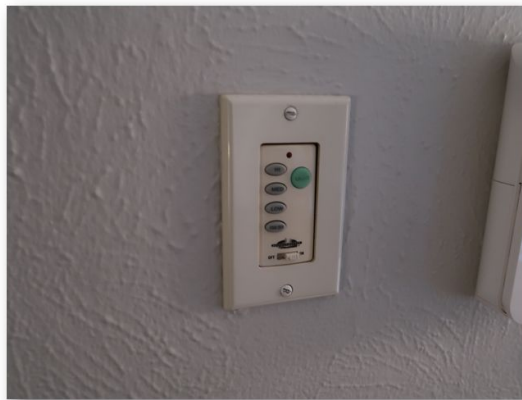
- 48.

- Ceiling fans inoperable or in need of repair

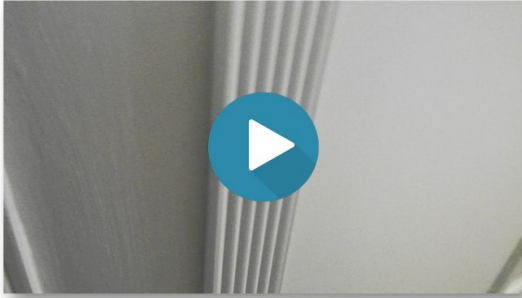
51. **When the furnace is operating and the blower is running, the noise is excessively loud.**

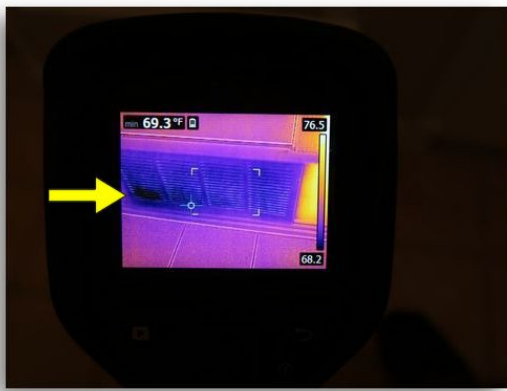
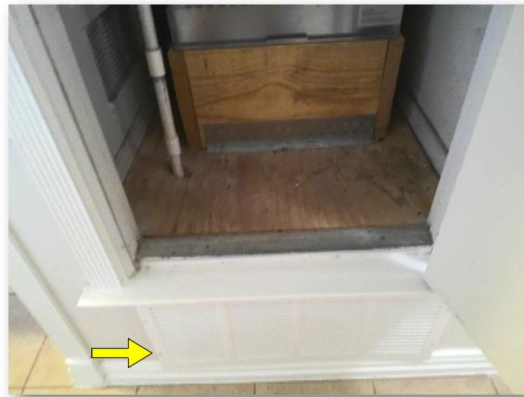
52. Moisture was detected by an infrared camera near the lower condensate drain line of the furnace return.

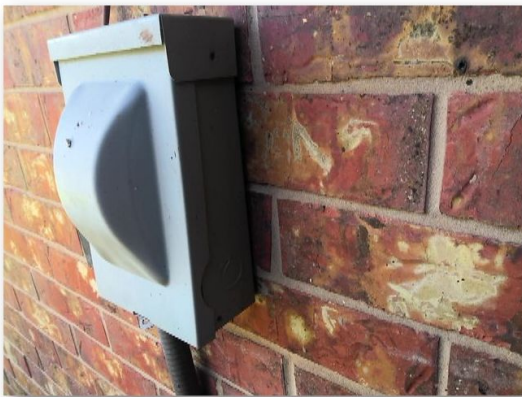
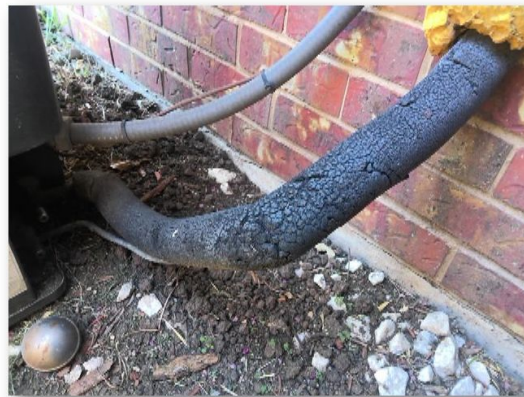
53. The insulation on the suction line of the outdoor AC unit is old and heavily worn. Replacement is recommended. Additionally, silicone sealing is needed around the area between the exterior wall and the fuse case.

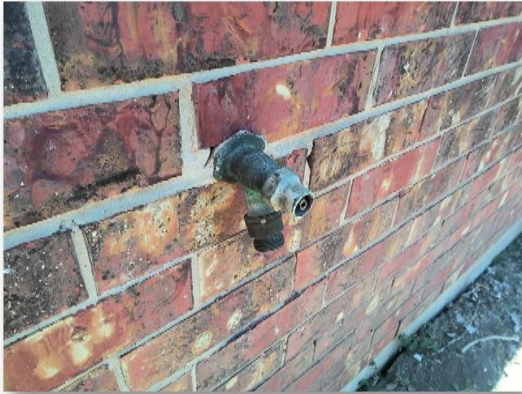
54. One of exterior faucet missing the handle.

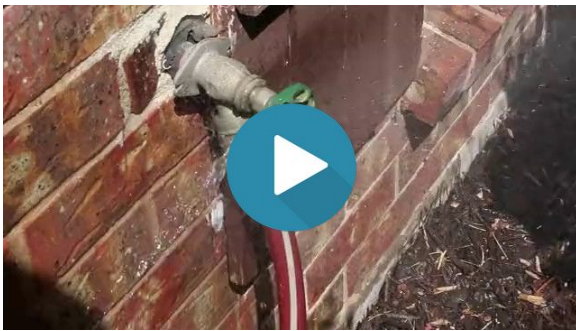
55. An exterior faucet near the front of the home was leaking.

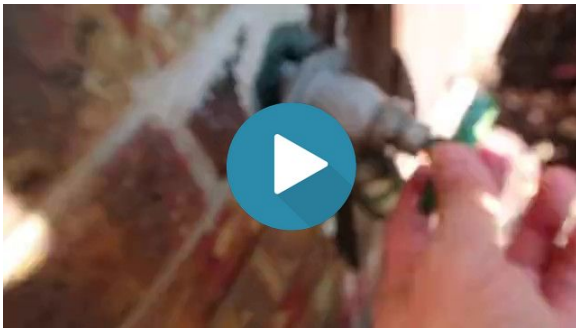
56. One of the exterior hose bibs is severely loose. It should be secured to prevent damage to the pipe.

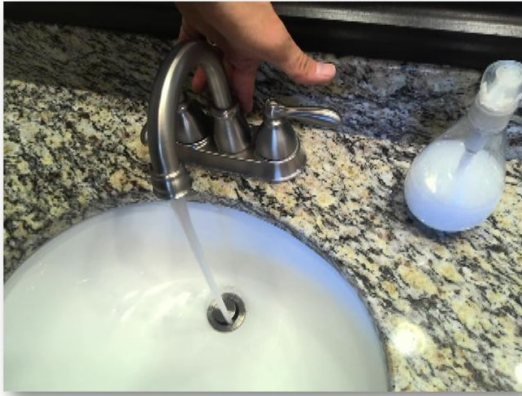
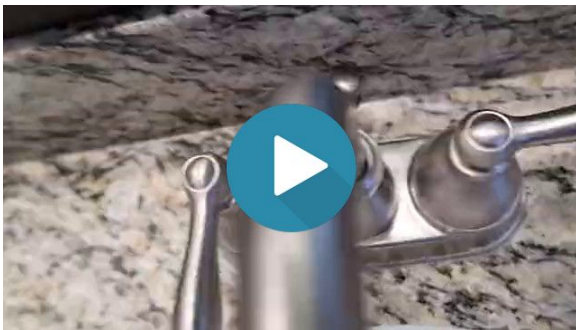
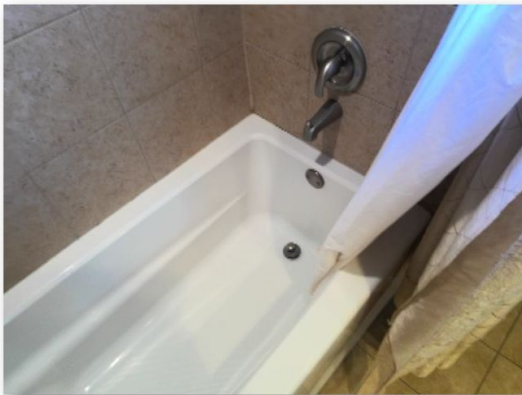
Several sinks and bathtubs have drain stoppers that are not functioning properly.

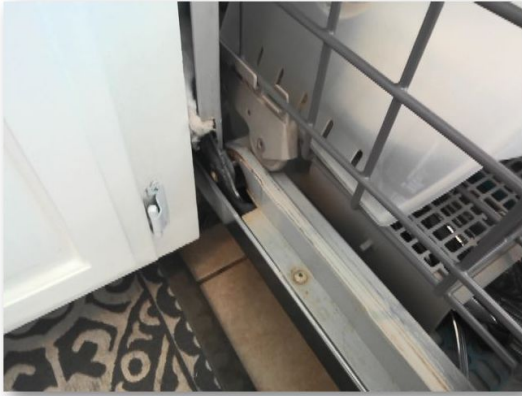
62.

- Rust present in interior of unit

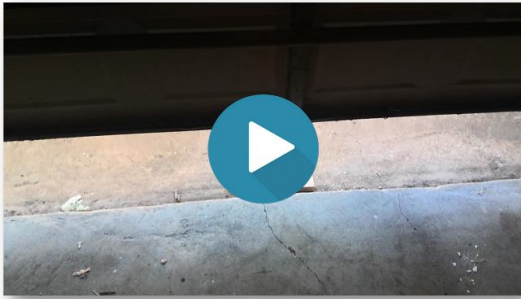
65. The pressure-activated automatic reverse feature was tested and appeared not to be operating in a satisfactory manner at the time of the inspection.

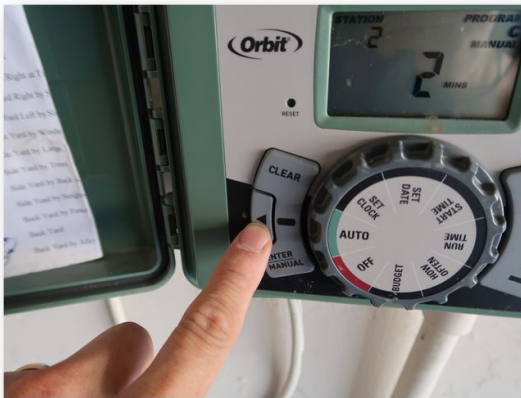
66. The 'Back' button on the landscape sprinkler controller is unresponsive.

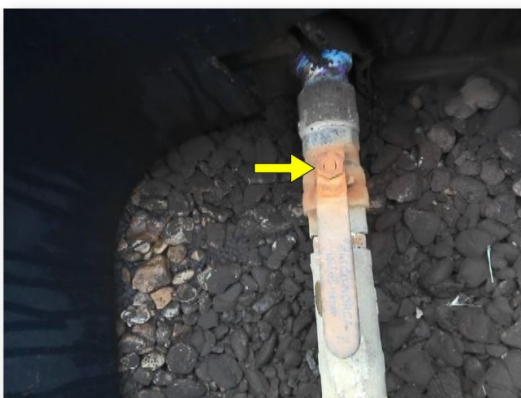
67. The city backflow prevention valve handle has rust on it.

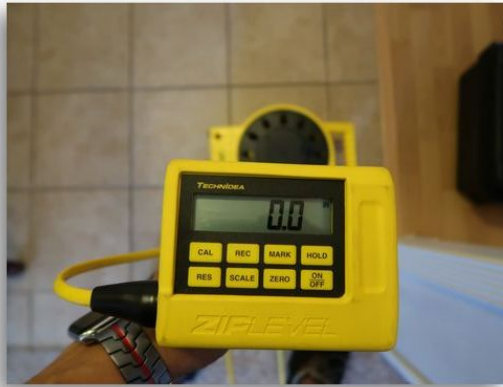
Foundation Elevation Test by ZipLevel

During the foundation elevation test, the area around the southwest corner showed a negative slope. The zero reference point is around the main entrance door. A certified foundation engineering precision evaluation is recommended.

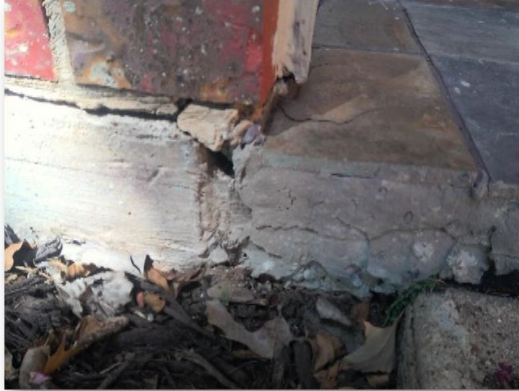
The portions of the concrete foundation wall surfaces minor crack in parge coat. No structural damage related to this condition was visible at the time of the inspection. This condition can be caused by pouring concrete under excessively cold conditions. Consider application of a parge coat to help prevent future freeze damage. A parge coat is a layer of cementitious material such as mortar that is applied to concrete to protect its weather surface.

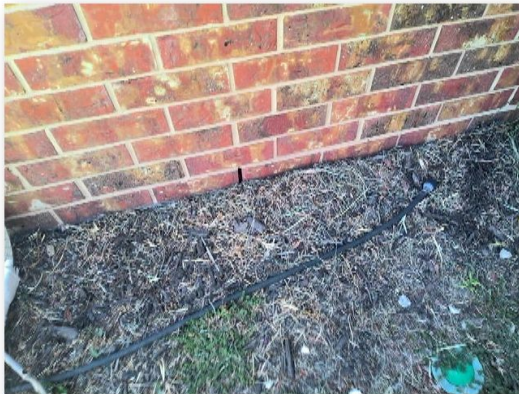
The top of the foundation wall of almost west side had inadequate clearance from grade at time of inspection. The top of the foundation wall should be a minimum of six inches above soil. Inadequate clearance may result in moisture intrusion of the structure. Excessively high moisture levels can result in damage to the home structure or materials. We recommend consult with a qualified contractor.

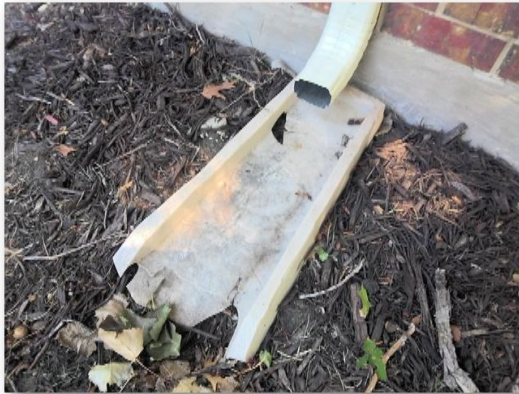
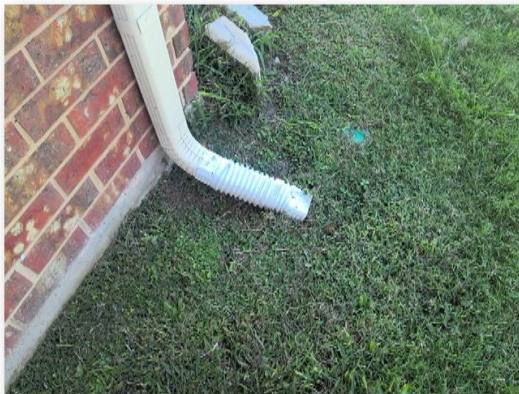
The gutters of this house appear to have been recently replaced, but overall, the condition of the splash guards is poor or they are missing. Additionally, damage was found at the time of inspection where the downspouts meet the ground. Overall, the rainwater drainage system requires maintenance.

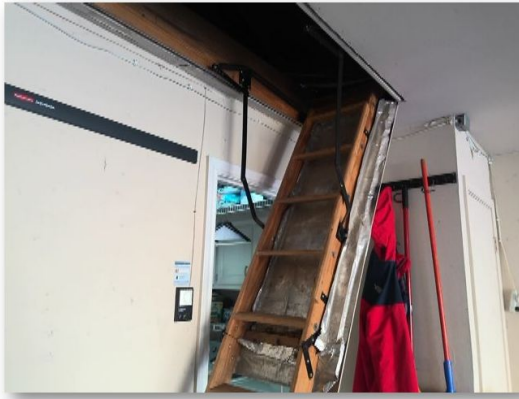
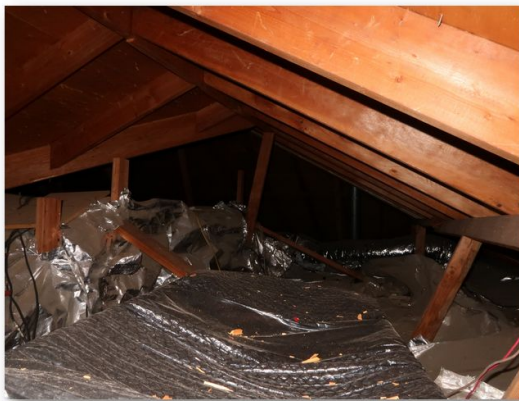
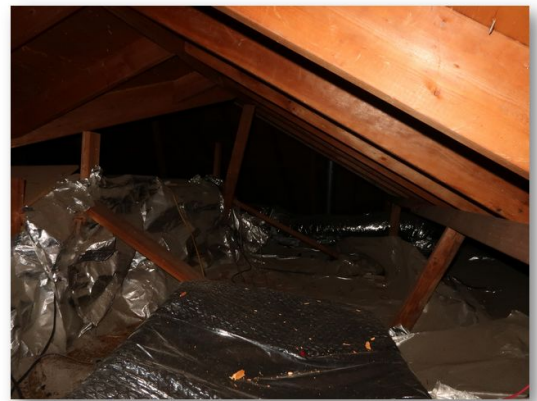
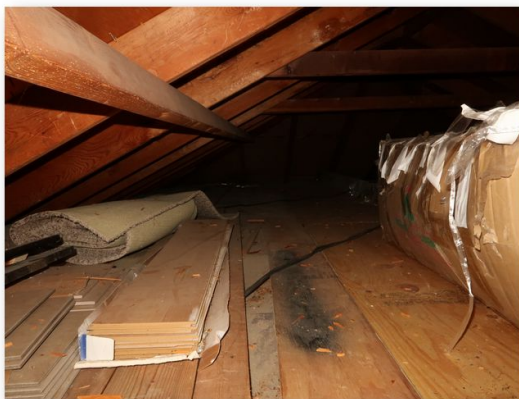
Insulation is not installed in the attic over the garage. Although we understand in theory people think why to insulate the ceiling of garage area, but if it is connected as part of the attic it would be a good to add insulation to this areas. If cold or warm air can get through these areas it will affect the whole home.

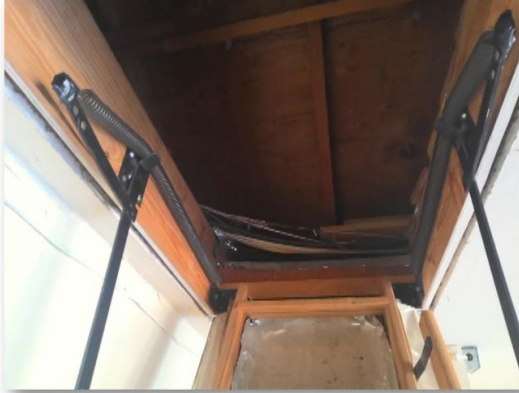
The pull-down ladder access is positioned in reverse, making it difficult to access the attic.

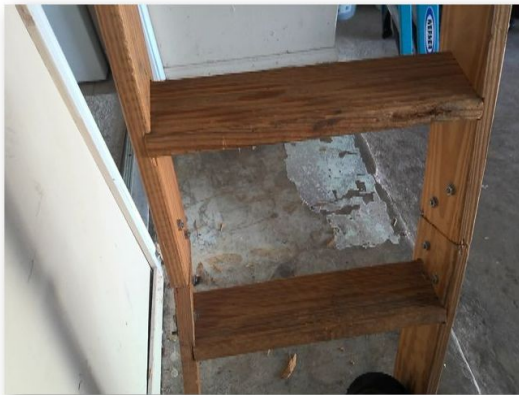
Attic staircase should be tighten a hardware. When step on the ladder, unstable balance from stair. **This is safety hazard.**

Damaged access ladder

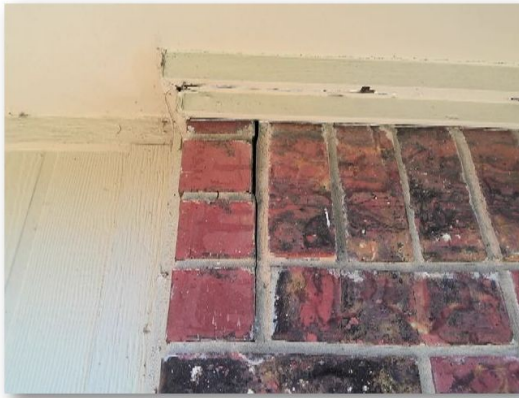
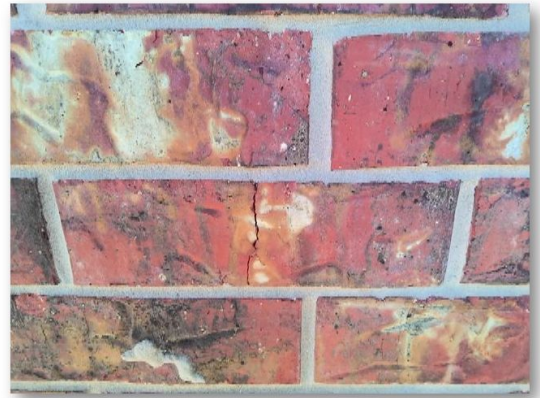
One or more common cracks were observed on the brick/stone veneer. This may be due to normal settling and/or thermal movement of the building materials. These areas should be sealed to prevent moisture penetration and monitored for further signs of movement.

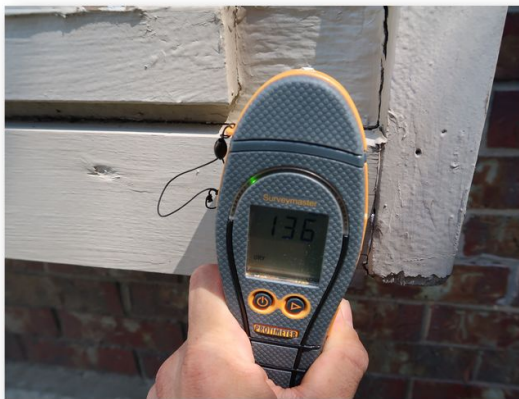
Wet and rotten wood draw increases the possibility of insect's invasion. By repairing these areas you reduce the possibility of infestation. When replacing this wood we recommend using a man made material such as a James Hardi board. It more resistant to moisture and insects.

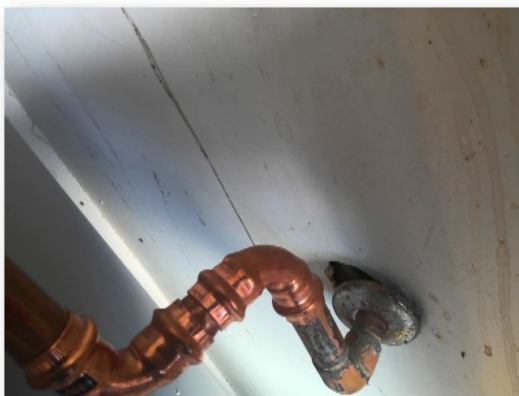
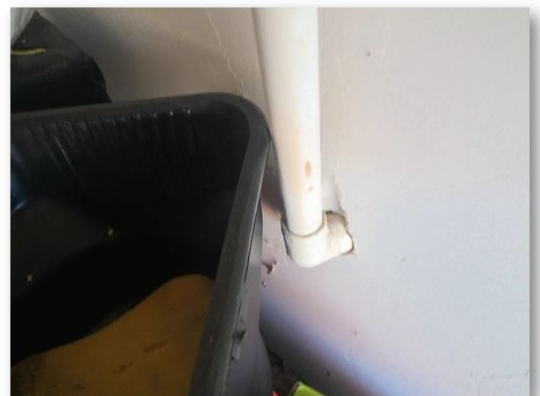
Caulking is needed around the electrical conduit for the sprinkler system on the garage interior

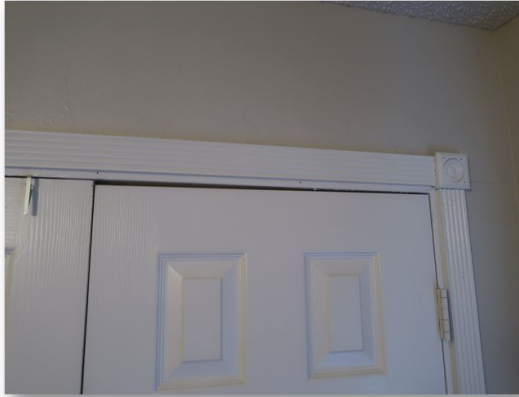
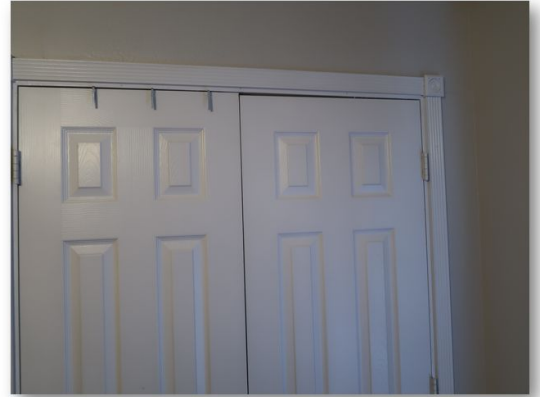
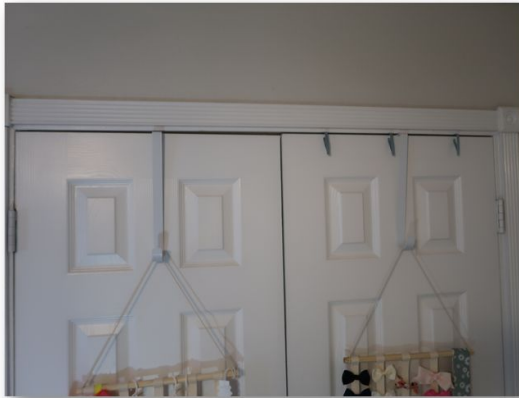
The double doors of the closets in the smaller rooms are out of square, but this does not affect their ability to open and close properly.

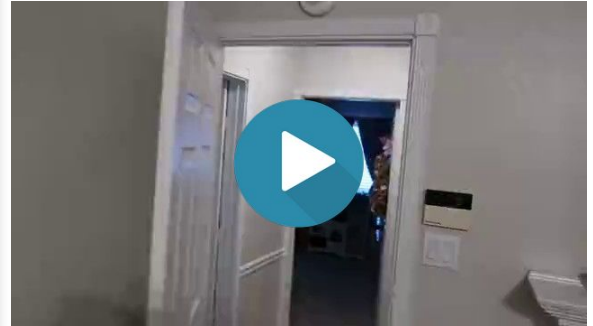
The interior door of the master bedroom automatically closes due to the floor being out of level. This could be related to structural movement. However, this issue can be corrected with door hardware adjustments.

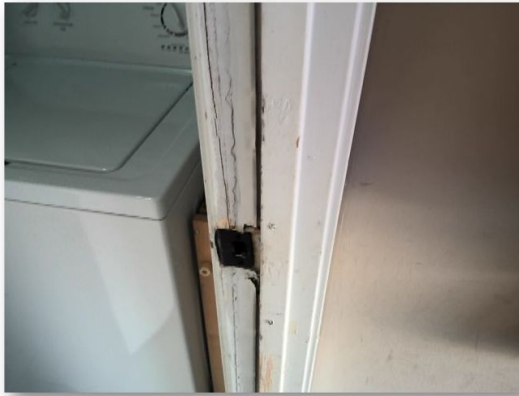
The surface of the door case between the garage and living space requires maintenance.

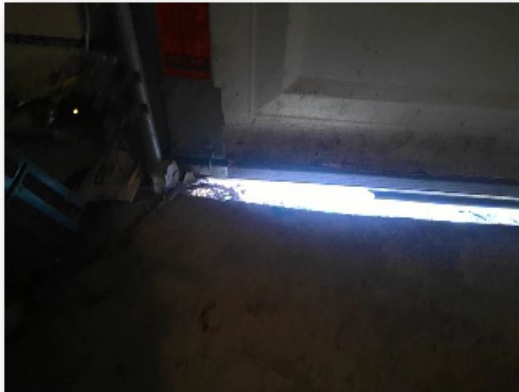
Garage door was observed penetrations had gaps indicate at time of inspection that should to be sealed by a qualified contractor with an appropriate weather seal to prevent moisture, vermin and insect entry. Correction should be made as necessary by a builder.

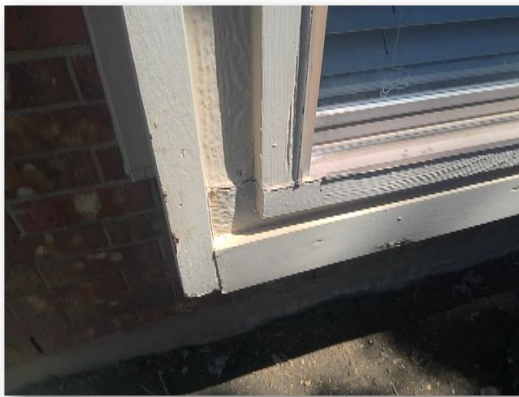
Windows and trim outside the house require caulking to prevent possible moisture damage

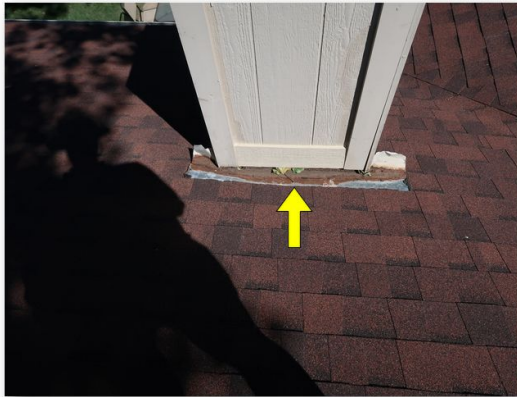
The chimney had no cricket. A cricket is a small roof built on the uphill side of the chimney to prevent roof drainage from pooling and causing damage from roof leakage.

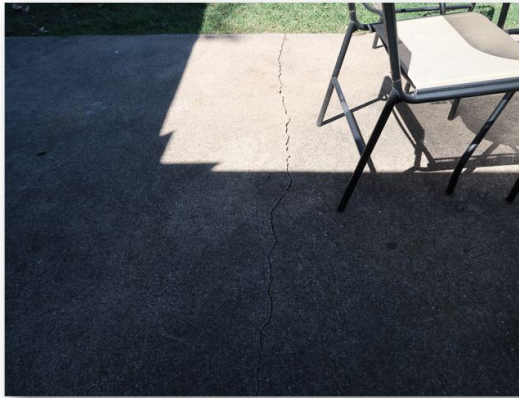
There are tile cracks and hairline cracks in the floors of the front porch and backyard patio.

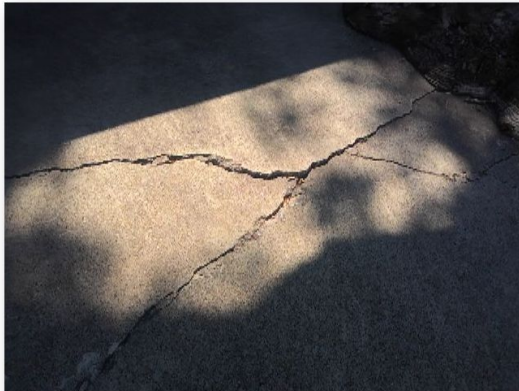
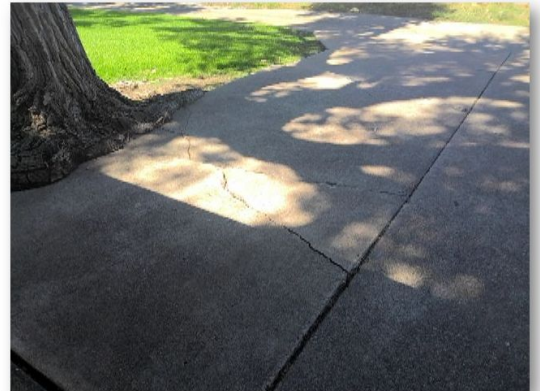
The driveway at the back of the house shows significant cracking due to tree roots.

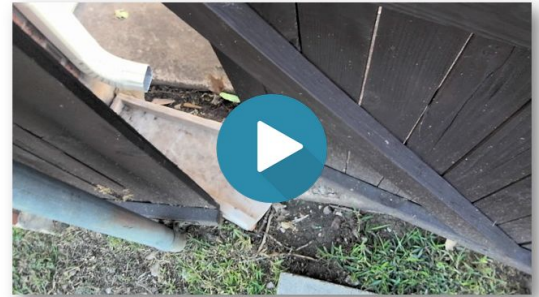
The fence door is obstructed by the downspout splash guard, interfering with its operation. This issue needs to be resolved.

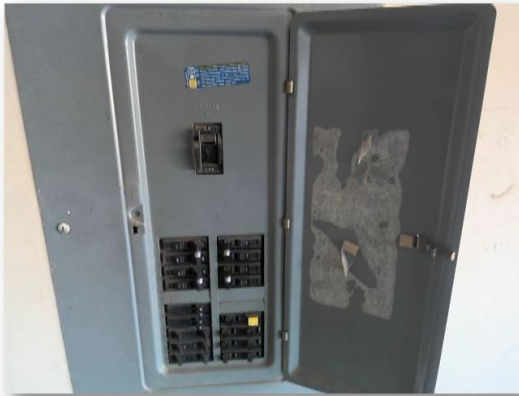
The Circuit Directory label identifying individual electrical circuits was missing from the service panel. The service panel should contain a clearly-marked label identifying individual circuits so that in an emergency, individual circuits can be quickly shut off. Branch circuits should be traced and identified with a properly marked Circuit Directory label installed by a qualified electrical contractor.

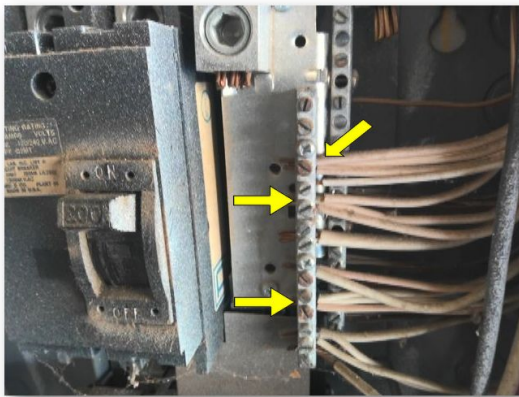
There are double tapped neutral conductors in the electric service panel. Multiple neutral conductors in a single termination create a problem when the circuit needs to be isolated. In order to isolate the circuit, the branch breaker is turned off and the neutral is disconnected by removing it from the terminal. If the terminal is shared with another circuit, the connection on the other (still energized) circuit will be loosened as well. Loosening of the second neutral (loss of neutral) under load is a safety hazard, and may establish an over voltage condition on lighting and appliances if the neutral is part of a 120/240 Volt AC multi-wire branch circuit. Also, the neutral assemblies are not evaluated with multiple neutral conductors in the same terminal. 2002 NEC Art. 408-21 Grounded Conductor Terminations. Each grounded conductor shall terminate within the panel board in an individual terminal that is not also used for another conductor.

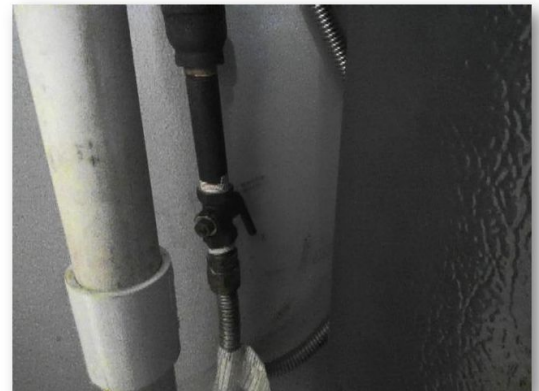
The direction of the gas line valve handle supplying the furnace is reversed, making it difficult to operate. It needs to be replaced. Additionally, the gas line sediment trap is missing.

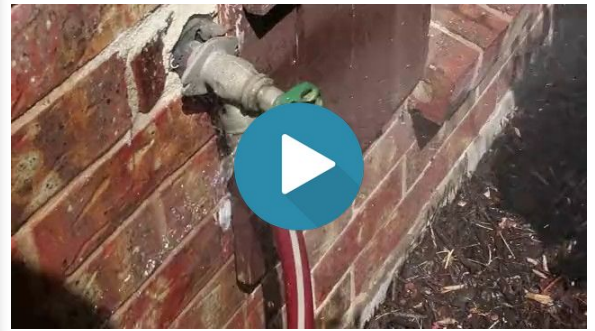
An exterior faucet near the front of the home was leaking. Leakage can result in a significant amount of wasted water each month. This leak should be fixed by a qualified plumbing contractor.

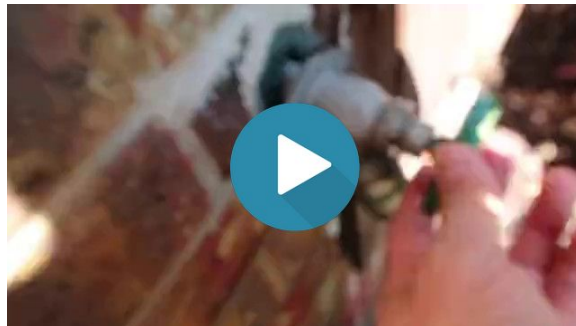
One of the exterior hose bibs is severely loose. It should be secured to prevent damage to the pipe.

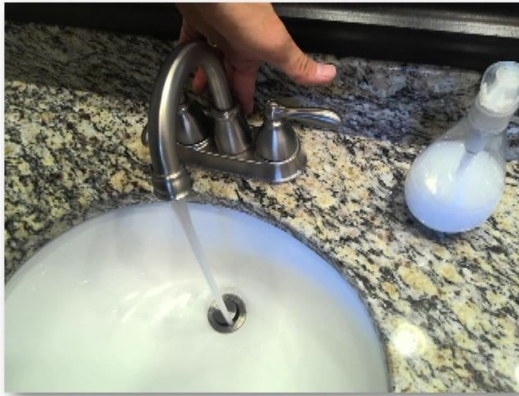
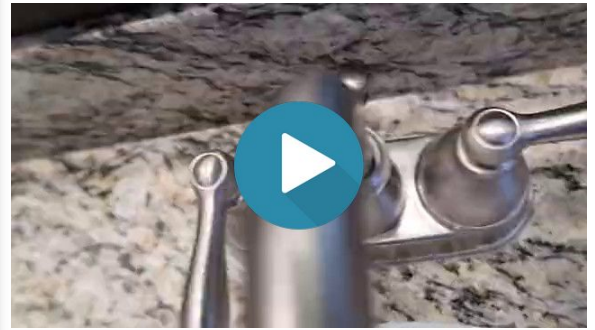
Several sinks and bathtubs have drain stoppers that are not functioning properly. Repairs are needed to ensure the drain stoppers work smoothly.

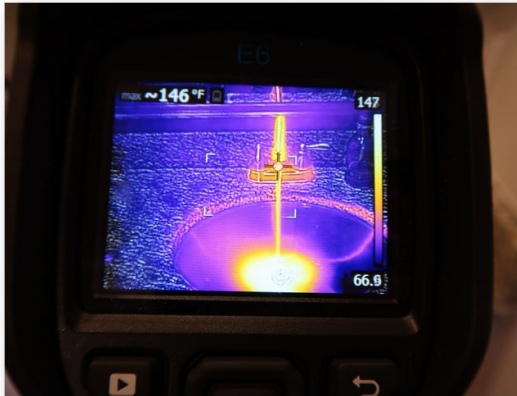
Water Temp: 145~148°F Recommended Hot Water setting should between 115°F – 120°F

The water temperature is generally set too high. The recommended maximum temperature is 120°F to prevent the risk of burns, especially to children's hands.

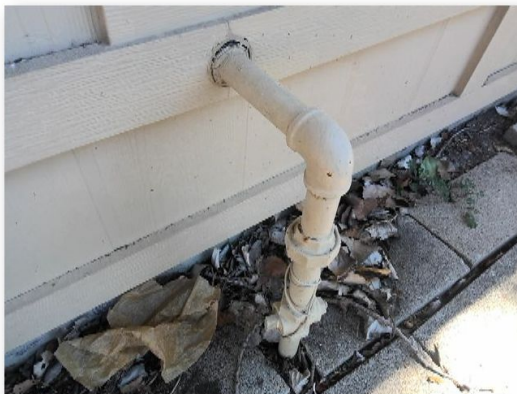
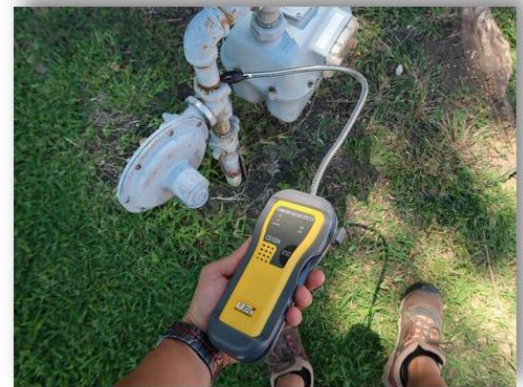
Visible sediment traps not present at some or all of the gas lines connected to appliances.

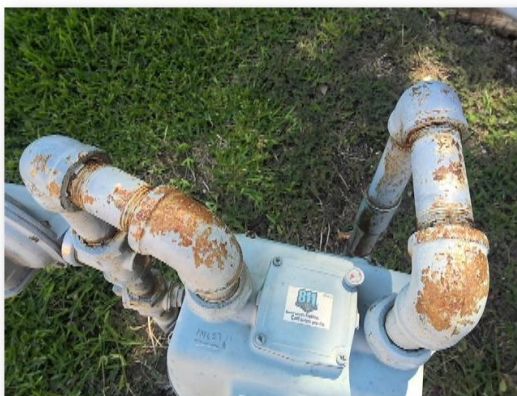
Gas pipes at the meter exhibited corrosion. This condition has the potential for an eventual gas leak. This condition should be evaluated by the public utility responsible for supplying gas to the property.

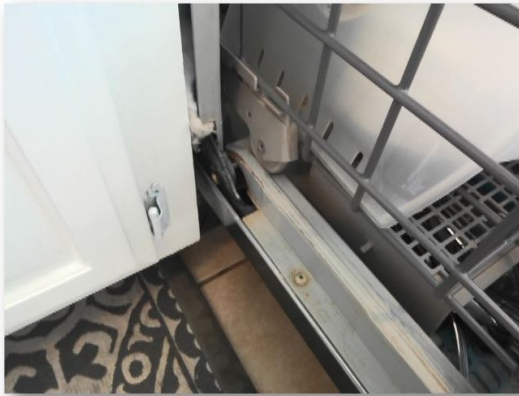
- Rust present in interior of unit

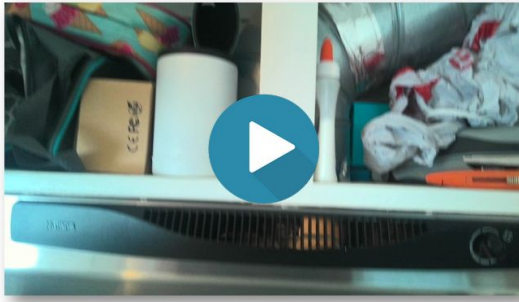
The fan noise of the exhaust hood is excessively loud. The hood uses an updraft system, but the airflow is circulating instead of functioning properly. A check by an appliance expert is needed to correct the system's operation.

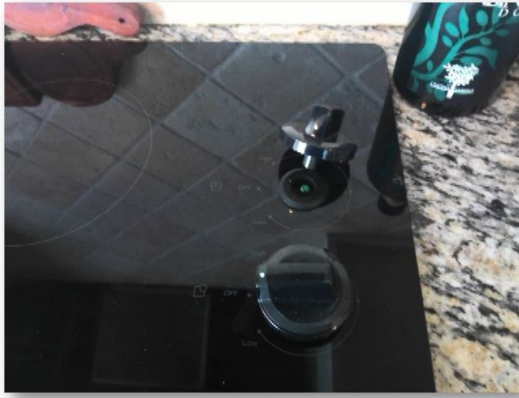
- Control knobs are loose and/or missing

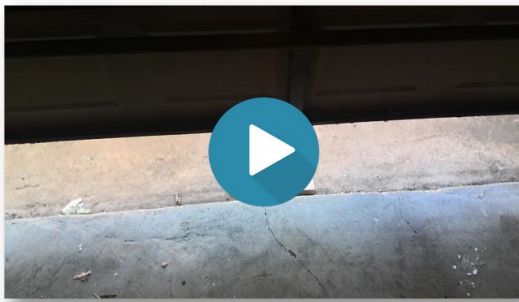
The pressure-activated automatic reverse feature was tested and appeared not to be operating in a satisfactory manner at the time of the inspection. Garage doors are not tested by the Inspector using specialized equipment and this inspection will not confirm adherence to manufacturer's specifications. This inspection is performed according to the Inspector's judgment from past experience.

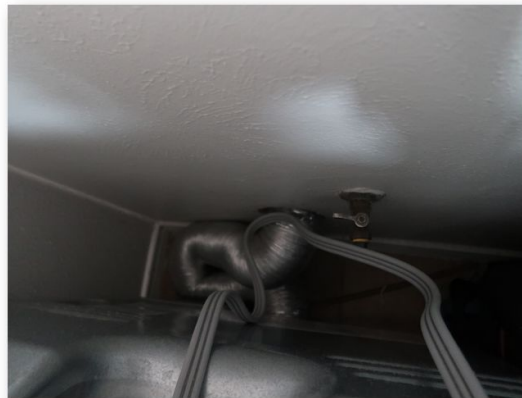
The dryer vent should be cleaned at least annually if not more frequently. Cleaning your dryer vent piping will allow the dryer to vent properly and work more efficiently. Dryer vents that are not cleaned regularly can be a fire hazard.

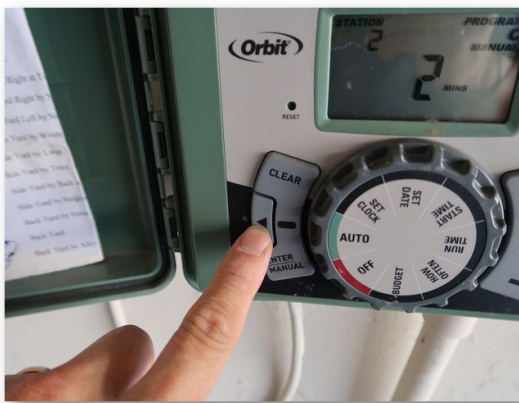
The 'Back' button on the landscape sprinkler controller is unresponsive.
