**PrimeVue**  
HOME INSPECTIONS

**HOME AND TERMITE INSPECTIONS**  
**254-727-0900**

*Inspected by Jude Hwang TREC #25266*

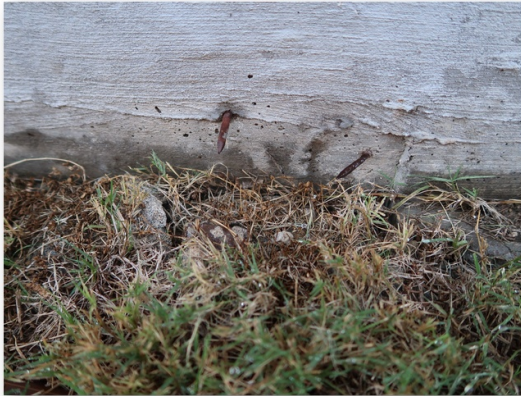
1.

D-Nails are embedded in the foundation wall. If they rust, the surrounding area may expand, and rust stains may run down the wall, negatively impacting its appearance. Additionally, there is a potential safety risk, as the rusted nails could cause injury. It is recommended that they be removed.

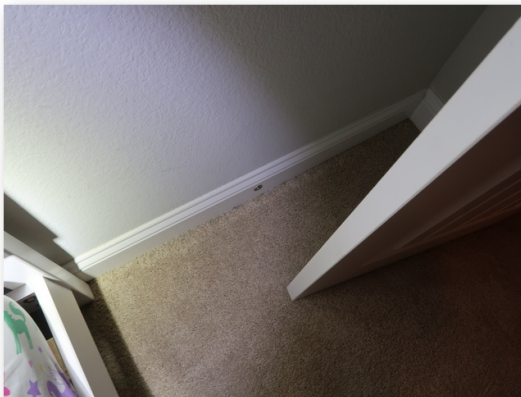
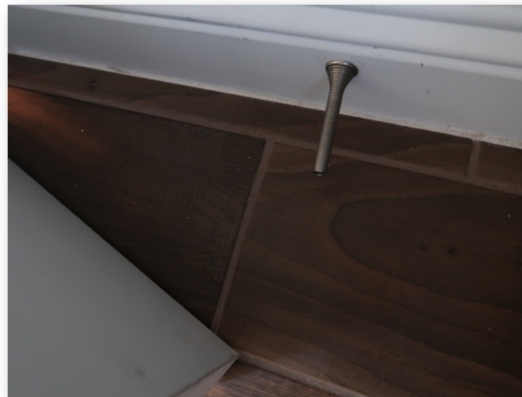
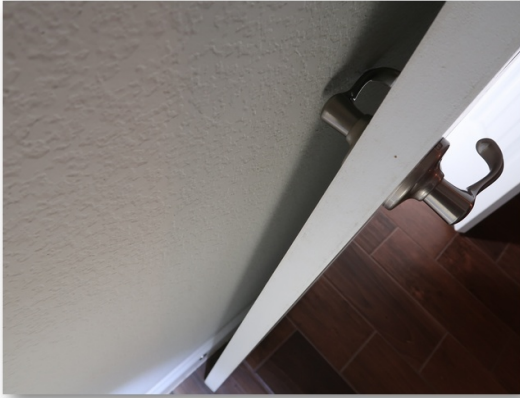
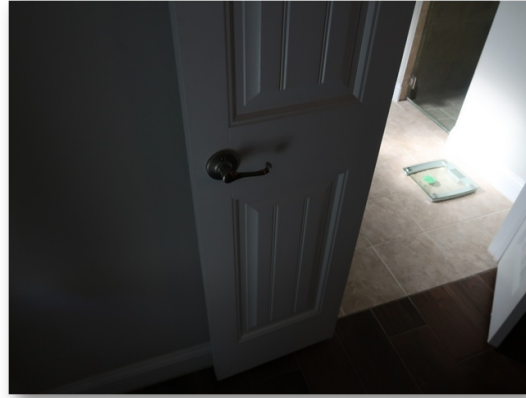
2.

D-An interior doors were missing or pull off a stop. This condition is may result in wall and door damage. A stop be installed to protect the wall.

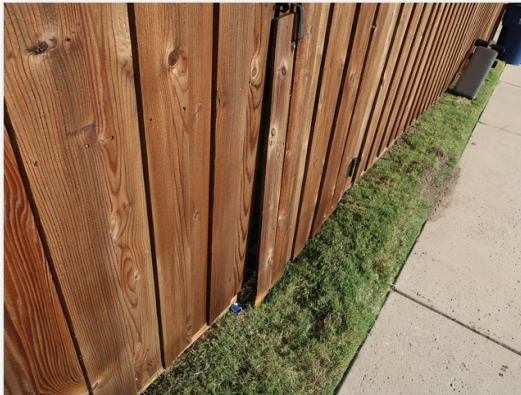
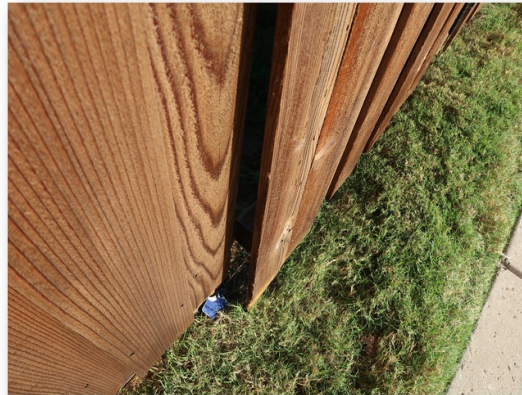
3.

D-The gate on the fence by the garage does not close completely. Adjustment or repair is recommended to ensure proper functionality.

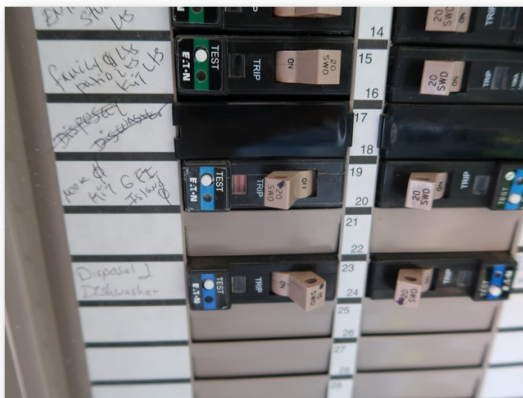
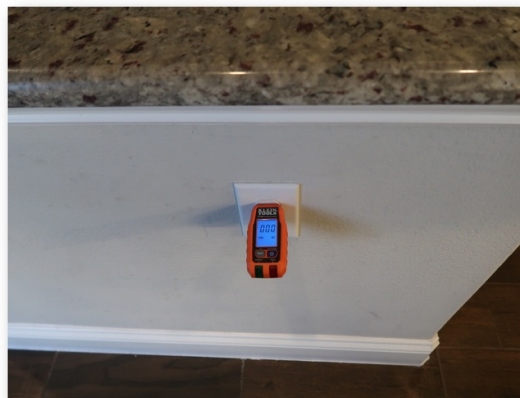
D-The GFCI outlet associated with the kitchen island sink receptacle is frequently tripping, which could indicate an issue with the outlet itself or a potential underlying electrical problem; it is recommended to have this outlet evaluate and, if necessary, replaced by a certified electrician to ensure safety and consistent functionality.

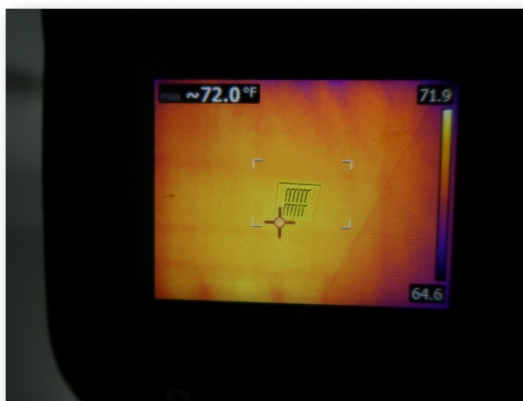
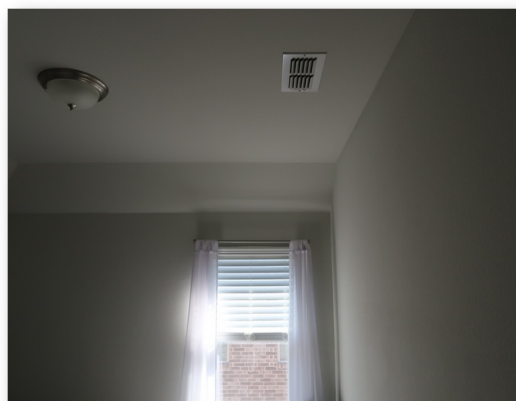
5.

D-The HVAC supply in the second-floor guest room is not delivering air from the air handler, potentially due to a blockage or system malfunction; observation and evaluation by a certified HVAC technician are recommended to diagnose and restore proper airflow and functionality.

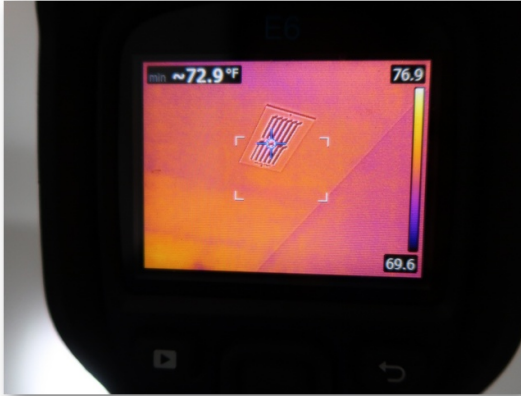
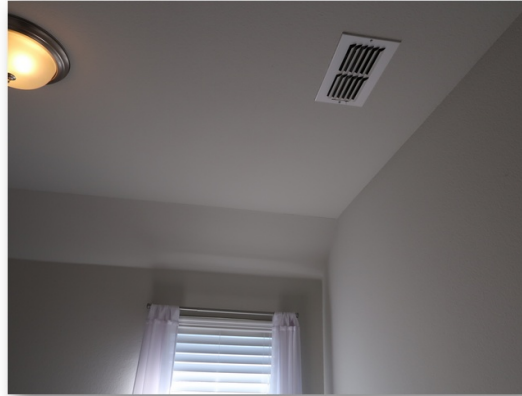
6.

D-The HVAC supply in the second-floor guest room is not delivering air from the air handler, potentially due to a blockage or system malfunction; observation and evaluation by a certified HVAC technician are recommended to diagnose and restore proper airflow and functionality.

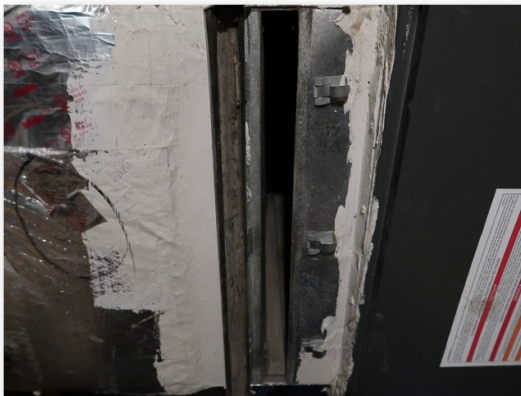
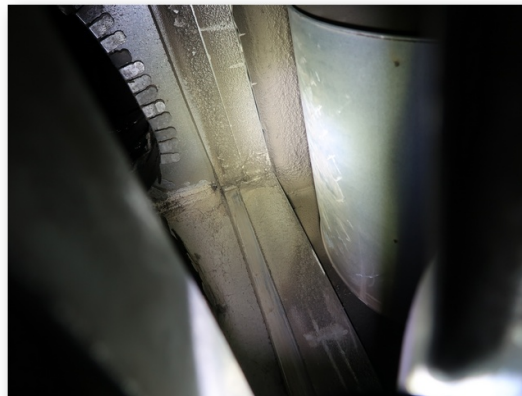
7.

D-The furnace is currently missing an air filter, which can lead to decreased efficiency and potential buildup of dust and debris within the system; installing the appropriate filter is recommended to ensure optimal performance, protect internal components, and maintain air quality.

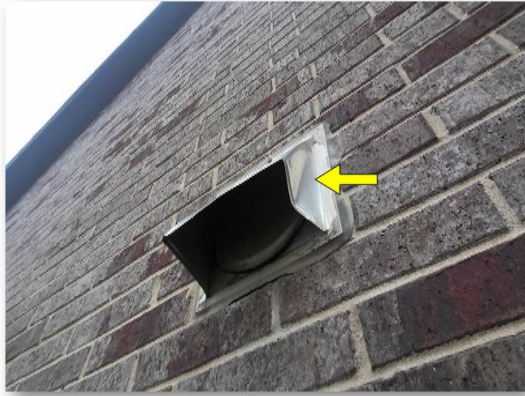
8. D-The exterior hood fan cover is dented, which may affect its appearance and functionality; repair or replacement is recommended to maintain proper ventilation and aesthetics.

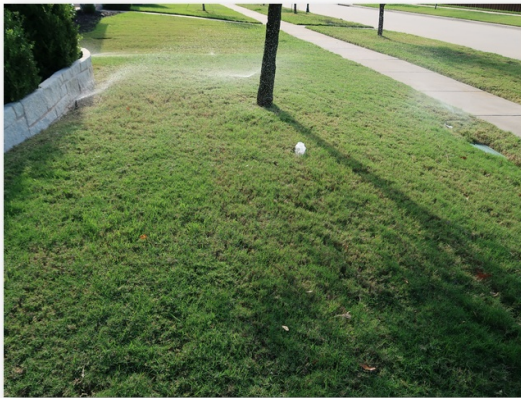
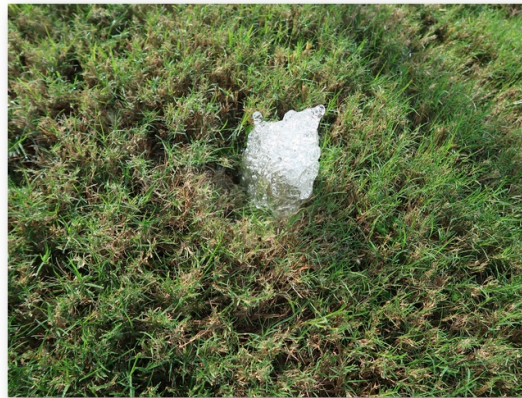
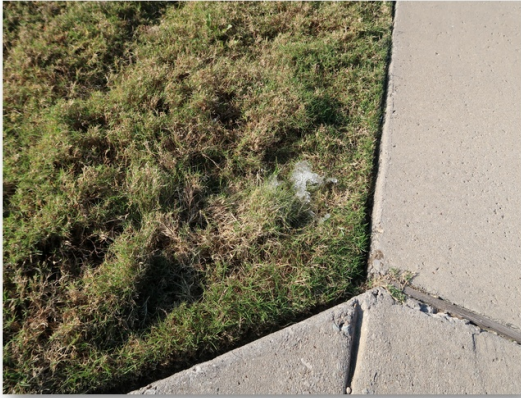
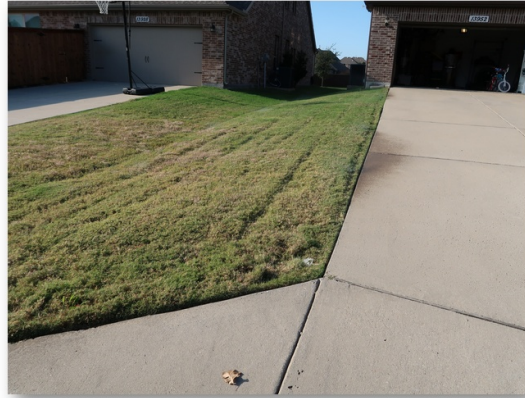
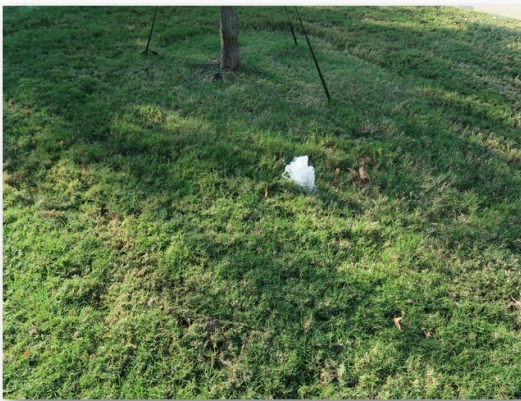
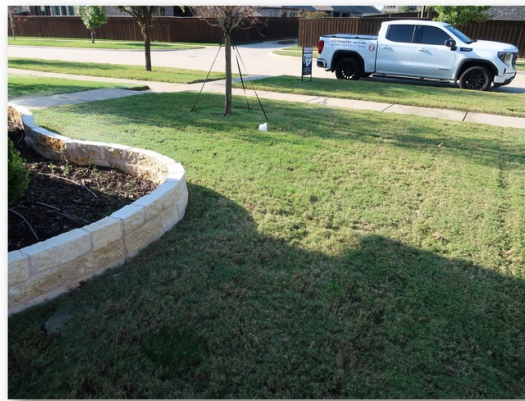
- 9.

D-In sprinkler zones 2, 4, and 7, one of the heads is damaged, causing water to spray around the lawn area; repair or replacement of the affected sprinkler heads is recommended to ensure efficient water distribution.

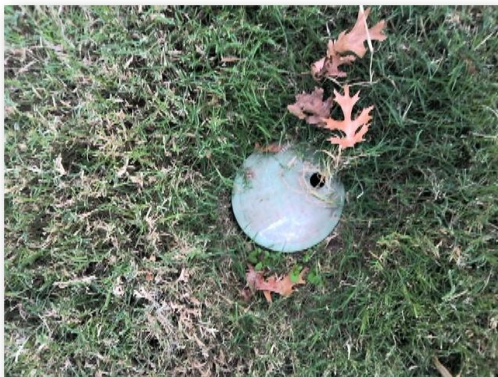
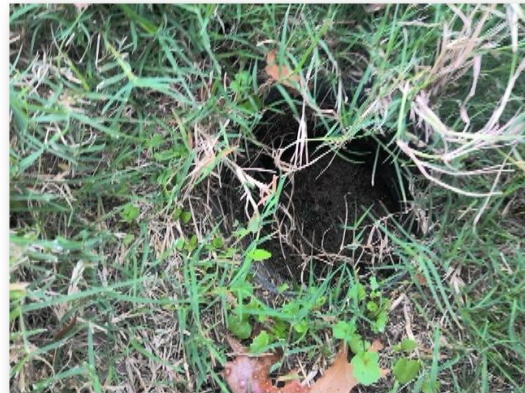
10.

D-The main valve next to the irrigation backflow prevention box is buried in the ground, making it difficult to access in case of emergency; it is recommended to keep the valve visible at all times for easy access and quick shutoff if needed.

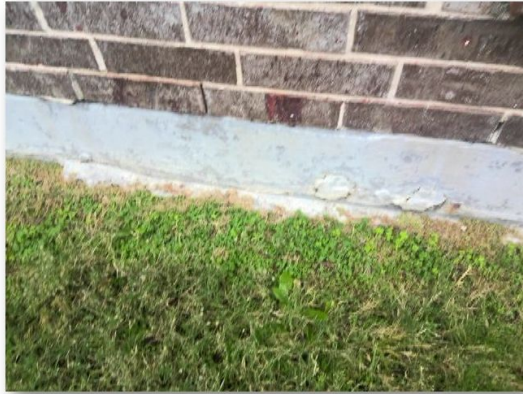
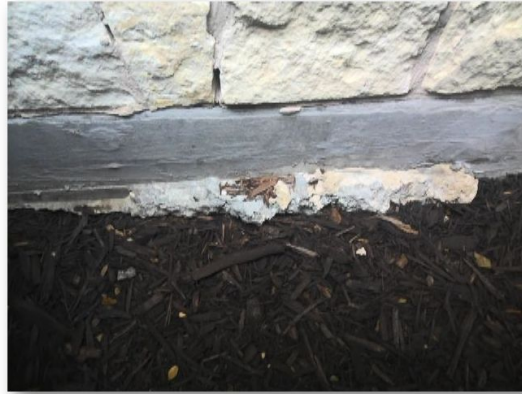
1.

M-The foundation footing is partially exposed at one or more locations. Those areas should be backfilled, leaving 4 to 6 inches of the foundation exposed, and the soil sloped away from the foundation for proper moisture runoff.

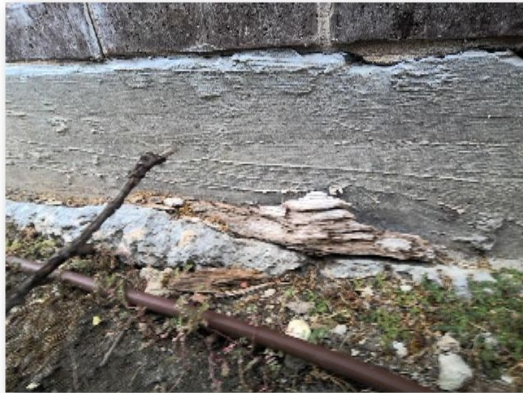
2.

M-Exposed wood on the foundation wall should be properly treated and sealed to prevent any further damage or wood destroying insect infestation.

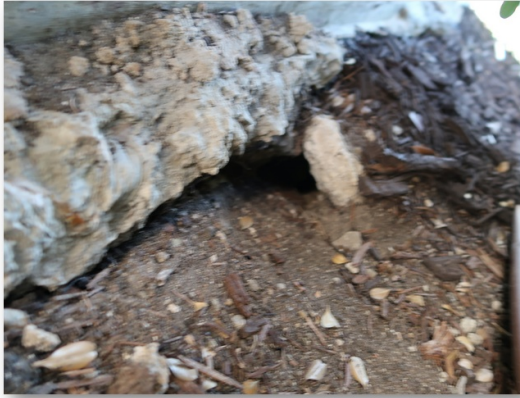
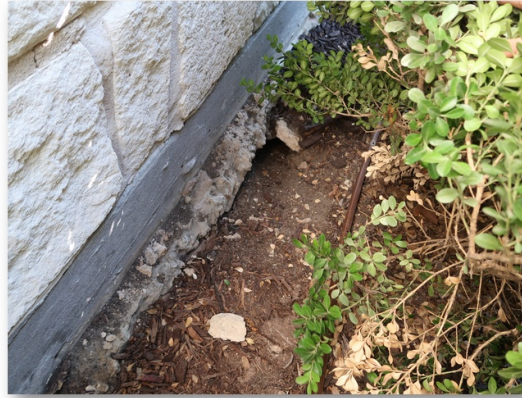
3. M-Sinkholes are observed around the front of the house. These depressions in the soil indicate poor drainage management, which can lead to water pooling near the foundation. Left unaddressed, these areas can attract vermin and potentially compromise the integrity of the foundation. It is recommended to fill these sinkholes with soil to prevent further erosion and to enhance the foundation's protection against moisture intrusion.

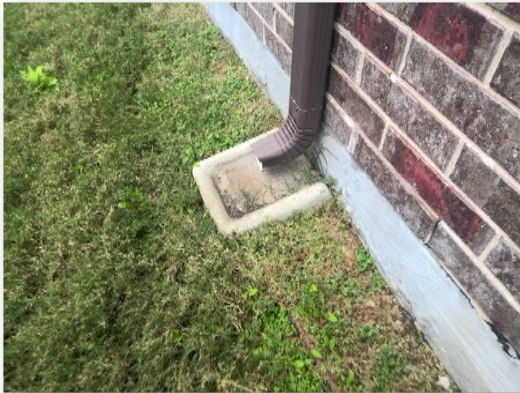
4. **M- A complete gutter system with extensions is recommended on this structure.** The gutter system is designed to expedite the drainage of water away from the property. Splash plates located under the down spouts can help direct water away from the foundation and reduce soil erosion, which can reduce the effectiveness of the termite chemicals placed in the soil.

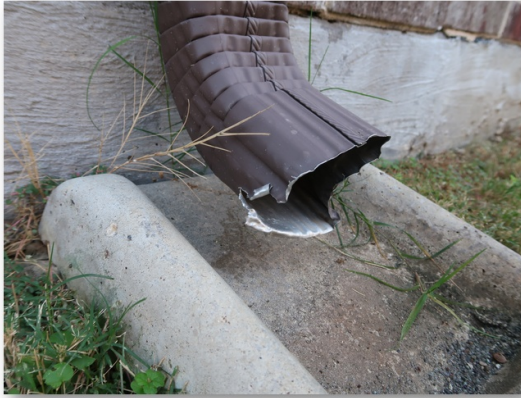
5.

M-The downspout shows damage at the end section, which may impact proper drainage functionality and should be evaluated for repair or replacement to ensure effective water flow away from the foundation.

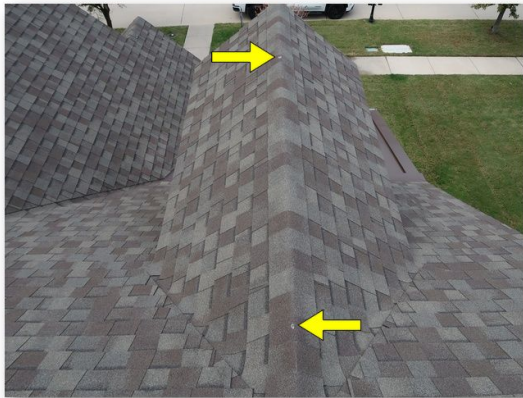
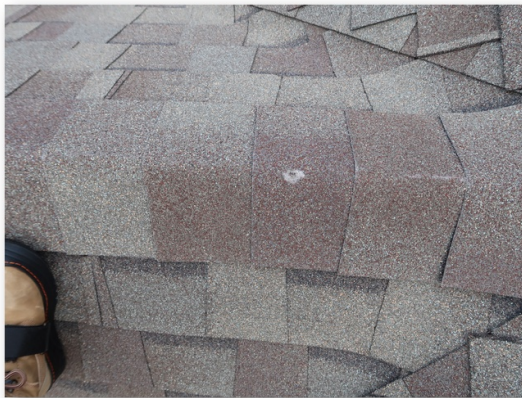
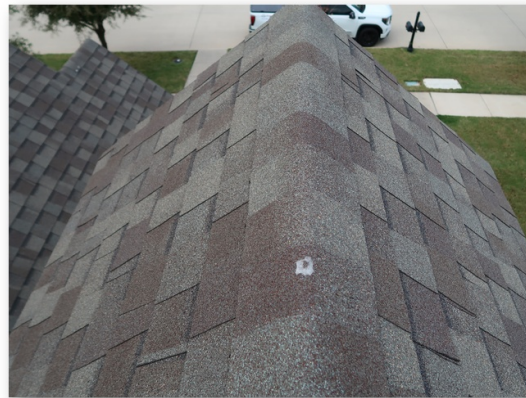
6.

**M-Mechanical damage** refers to any damage caused installing shingles or equipment, cleaning gutters, making repairs, or performing construction work of other types can put people on the roof with tools or equipment capable of damaging shingles.

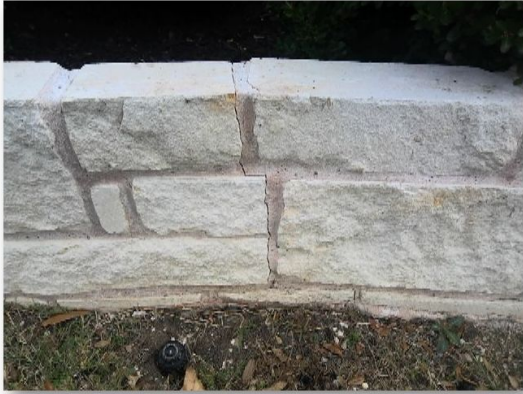
7.

M-mortar Hairline cracks were observed on the flower bed decoration wall. Monitoring is recommended to assess if further movement or deterioration occurs, as these may not impact the wall's structural integrity.

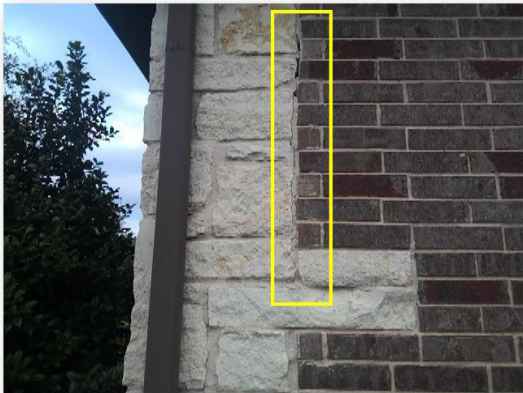
8.

M-A vertical hairline crack is present at the intersection of the stone and brick exterior walls on the front right side of the house; this crack does not indicate a structural issue.

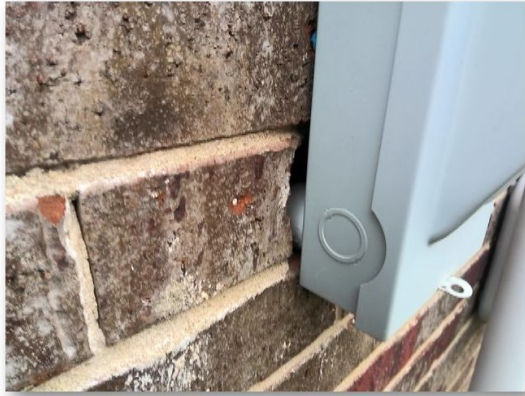
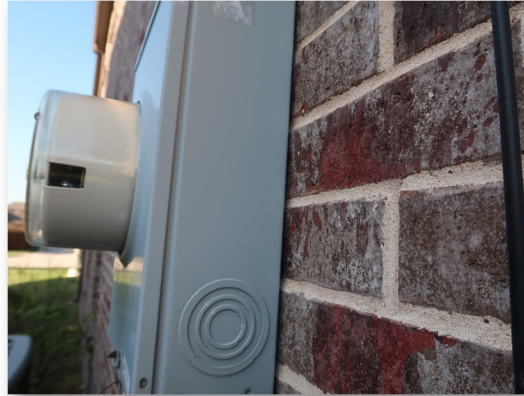
9. M-Sealant is needed around the electric box attached to the exterior wall to prevent moisture intrusion.

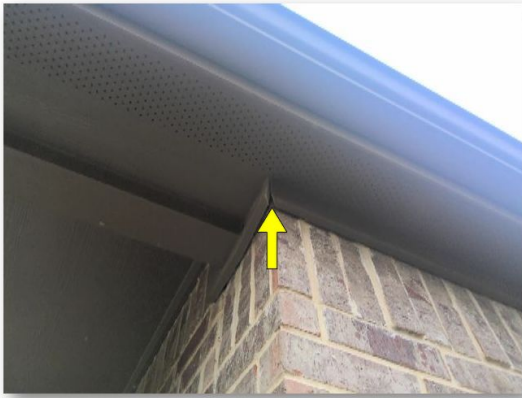
10. M-A gap was observed in the frieze board at the corner of the house. Sealing this area is recommended to prevent potential moisture intrusion and pest entry.

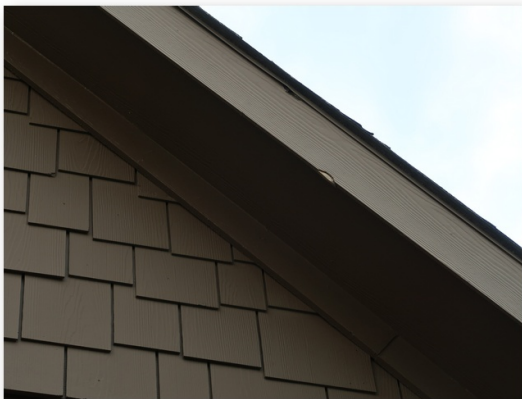
11. M-Chip damage was observed on the front eave of the house. Repair is recommended to prevent potential worsening of the damage and to maintain the integrity of the eave.

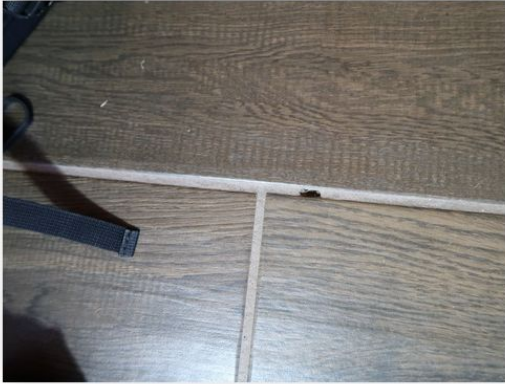
12.

M- Floor tile with a visible gap in the mortar near the front of the office room. This gap should be filled to maintain stability and prevent further damage to the surrounding tiles.

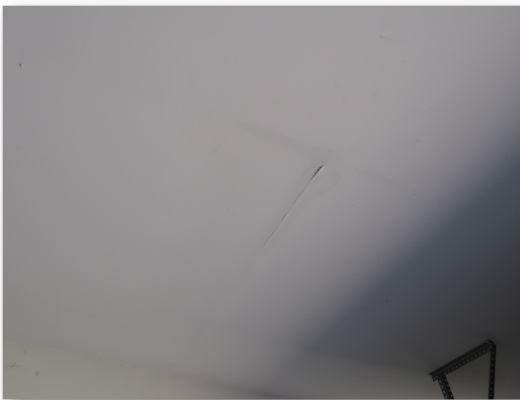
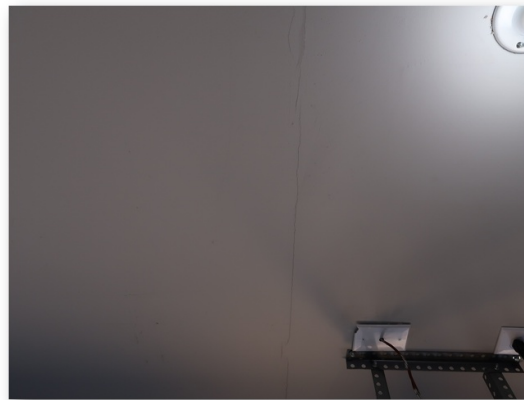
13.

M- Minor cracking was visible in the garage ceiling.

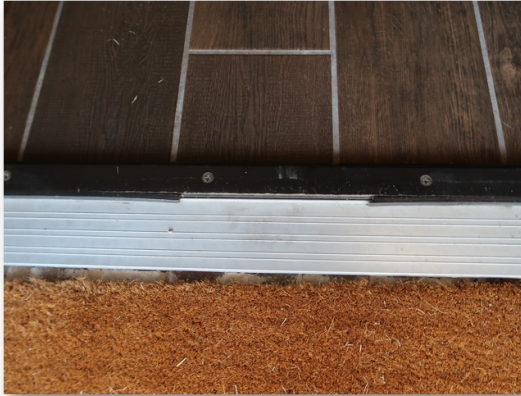
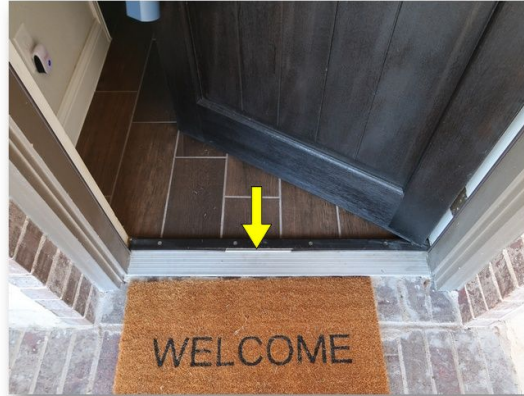
14.

M-The weather seal at the bottom threshold of the exterior door at the house entrance is damaged, which may allow air and moisture intrusion; repairing or replacing the seal is recommended to ensure proper insulation and protection against weather elements.

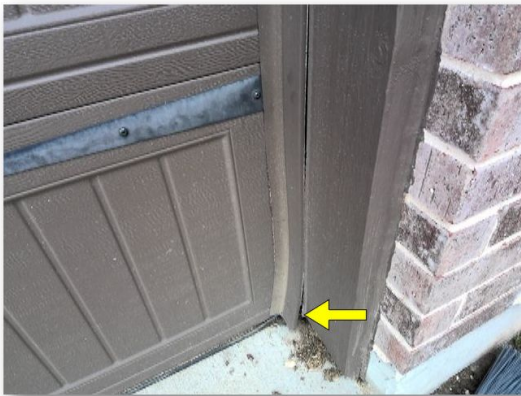
15.

M-The weather seal at the bottom of the exterior trim on the garage door has come loose, which could lead to moisture intrusion and reduced insulation; reattaching or replacing the seal is advised to maintain protection and efficiency.

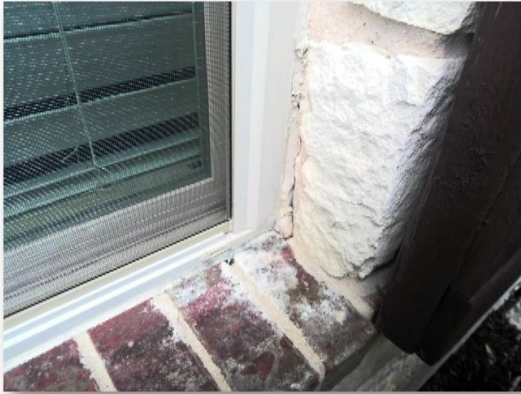
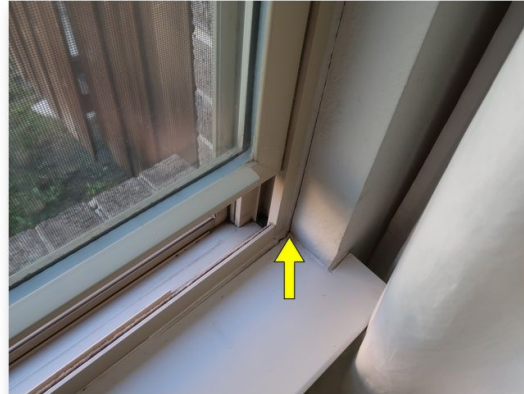
16. M-There is a gap in the silicone sealant at the corner of the exterior window frame on the front of the house, as well as at the bottom corner of one of the interior window frames. Sealing these gaps is recommended to prevent potential air and moisture intrusion.

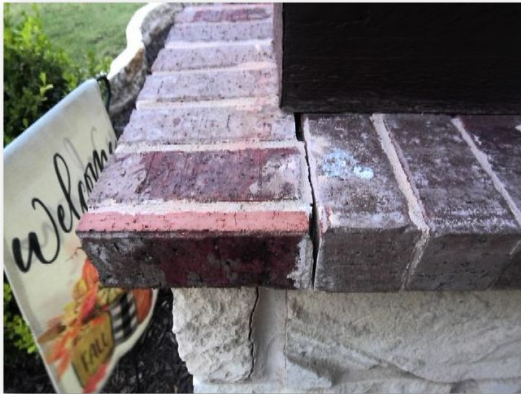
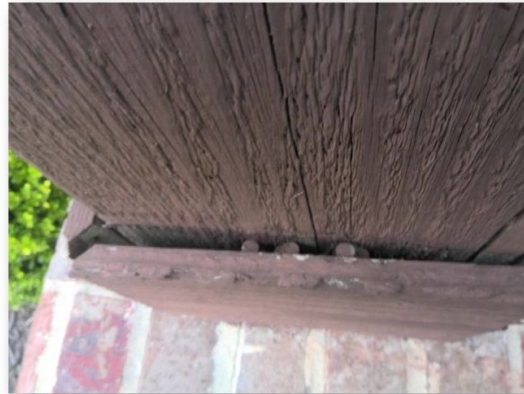
17. M-The connection at the bottom of the wooden porch column by the front door is separating, with nails visibly inserted. Repairing this area is recommended to ensure stability and prevent further separation.

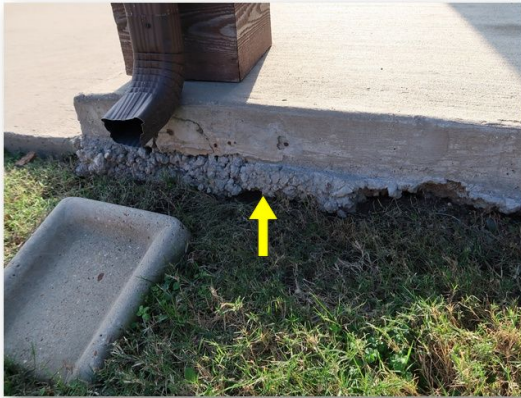
18.

Honeycombing was visible in portions of the concrete patioed wall. Honeycombing is caused by incomplete consolidation of the concrete at the time it is originally placed. Although this condition reduces the load-bearing capacity of the wall to a small degree it is more of a cosmetic issue than a structural problem.

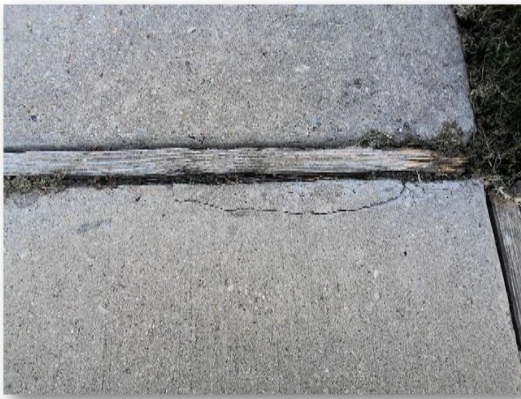
19.

M-A small common hairline crack was observed at the corner of the walkway in front of the house. Monitoring is recommended to ensure it does not expand or worsen.

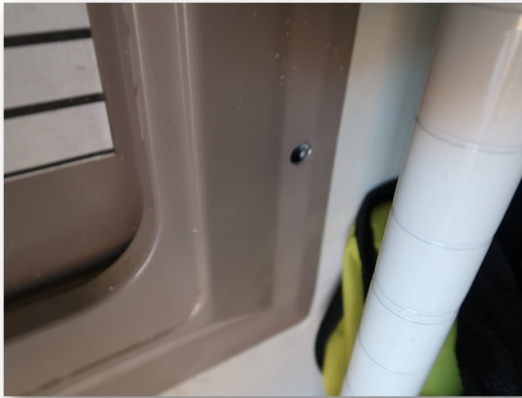
20. M-A bolt is missing from the electrical dead cover, which may compromise safety; it is recommended to replace the missing bolt to secure the cover properly.

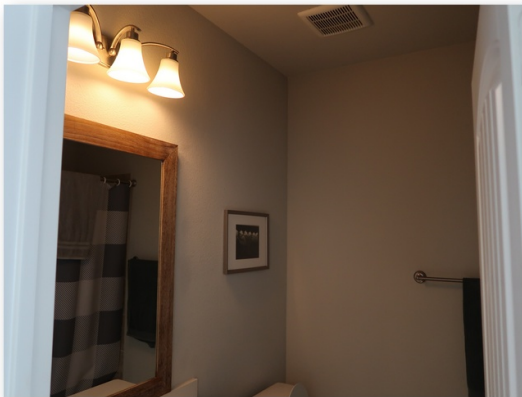
21. M-The lighting in the second-floor bathroom is noticeably dim, which may affect visibility and usability; it is recommended to assess the lighting fixtures and consider upgrading or replacing them to improve illumination in the space.

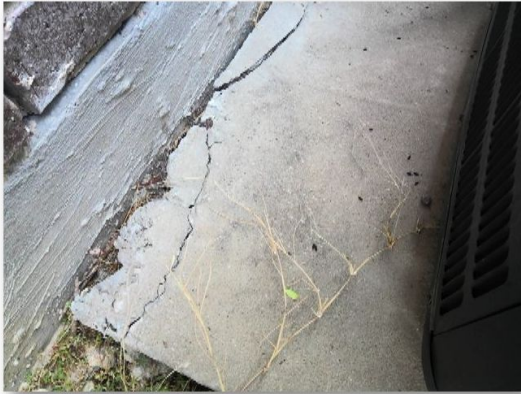
22.

M-A crack was observed at the junction where the concrete pad of the outdoor air conditioning unit meets the wall; this crack does not indicate a foundation issue.

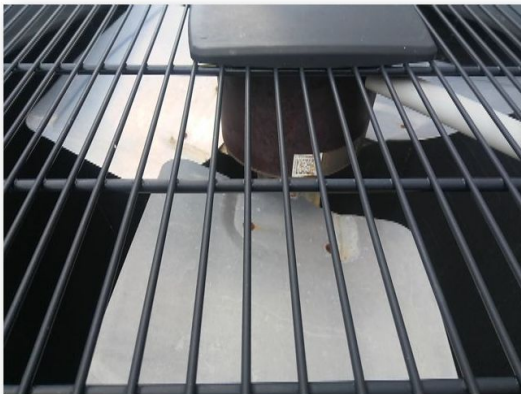
23.

M-Rust was observed on the exterior of the fan motor casing for the A/C outdoor unit, which may lead to further deterioration; monitoring and potential maintenance are recommended to prevent rust-related damage.

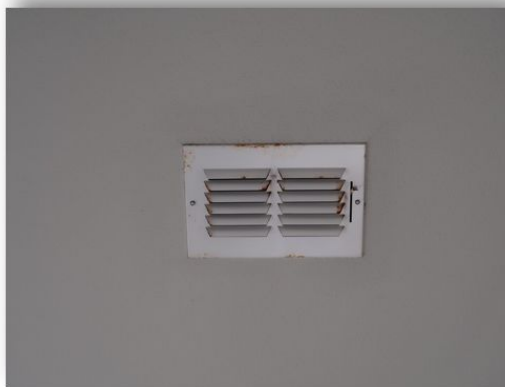
24.

M-Rust was found on the mesh cover of the supply vent in the master bathroom, which may affect air quality and appearance; cleaning or replacing or paint the cover is recommended to maintain functionality and aesthetics

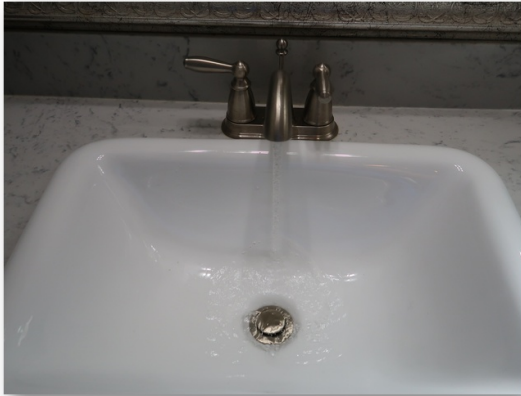
25.

M-One of the bathroom drain stoppers was not functioning properly, preventing effective operation; adjustment or replacement is recommended to restore full functionality.

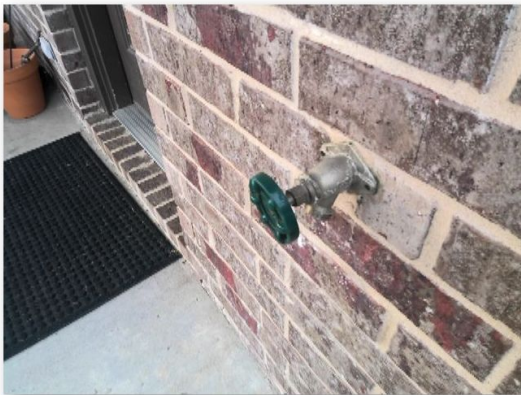
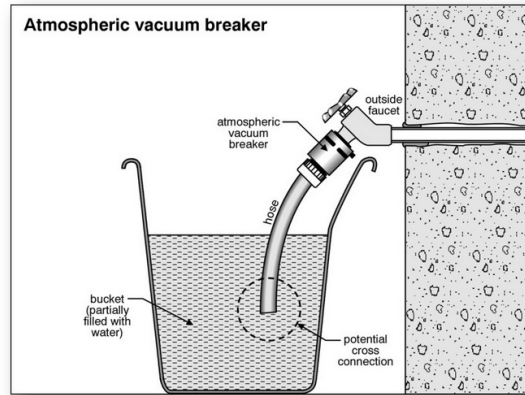
26.

M-The outdoor faucet is missing a vacuum breaker, which is essential for preventing backflow and protecting the water supply from contamination. It is recommended to install a vacuum breaker to ensure safe.

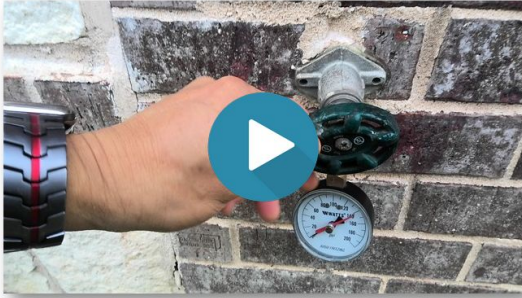
27.

M-The handle on the exterior faucet on the right side of the house is loose, which may affect its operation; securing or repairing the handle is recommended to ensure proper functionality and prevent potential leaks.

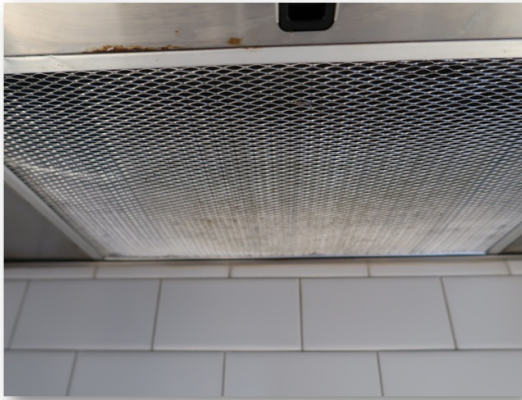
28.

M-The hood filter is dirty, which may reduce its efficiency and airflow; cleaning or replacing the filter is recommended to maintain optimal performance and air quality.

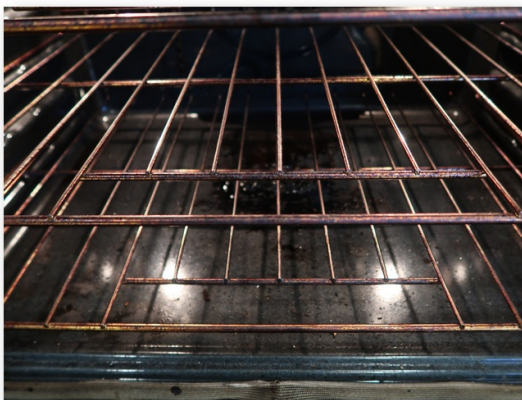
29.

M-The interior of the oven is dirty, which may impact its performance and efficiency; a thorough cleaning is recommended to maintain functionality and hygiene.

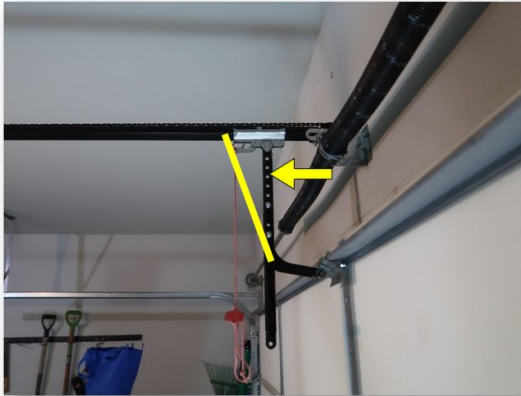
30.

M-To ensure smooth operation of the garage door, it is recommended that the hockey stick part be adjusted to the 1 o'clock position.

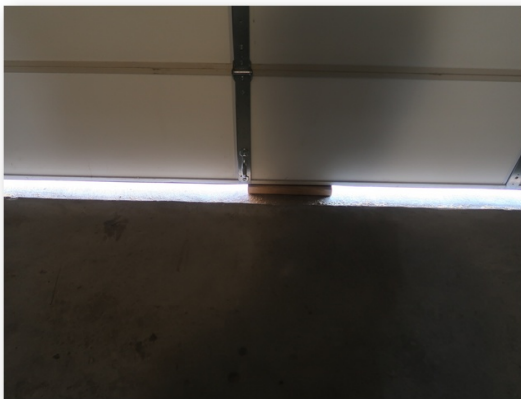
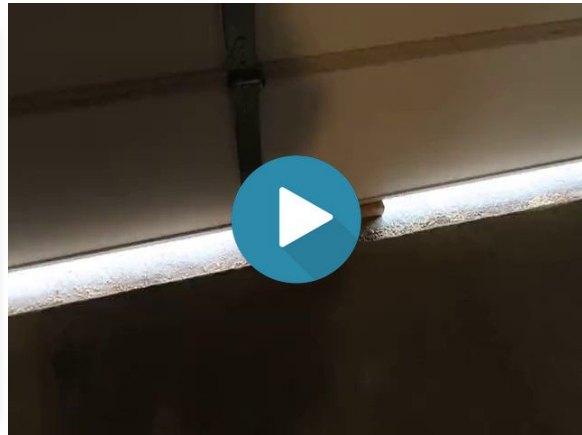
31.

The pressure-activated automatic reverse feature was tested and appeared **not to be operating** in a satisfactory manner at the time of the inspection.

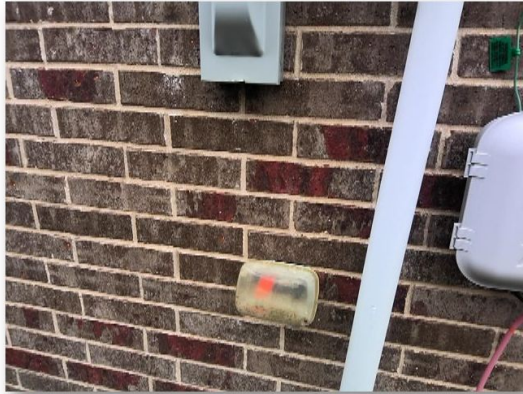
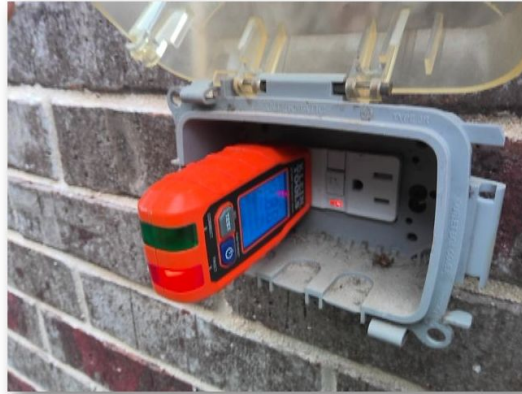
1.

S-An open ground error was detected in the GFCI outlet near the electric meter, which can pose a safety risk. Evaluation and correction by a licensed electrician are recommended to ensure proper grounding and electrical safety.

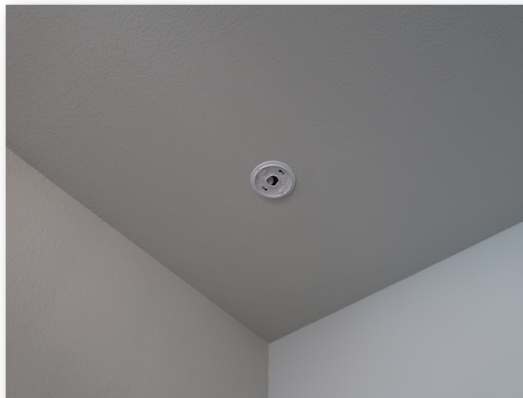
2.

S-The smoke detector is missing in the master bedroom, which is a safety concern; installing a smoke detector is recommended to ensure proper fire safety measures are in place.

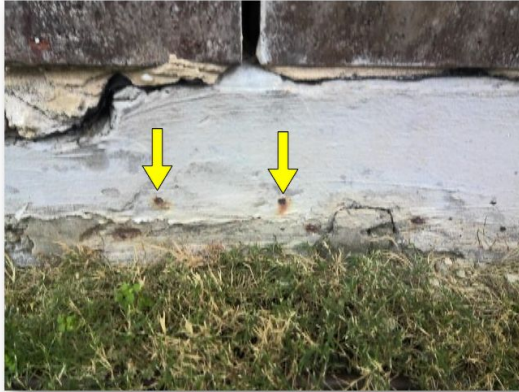
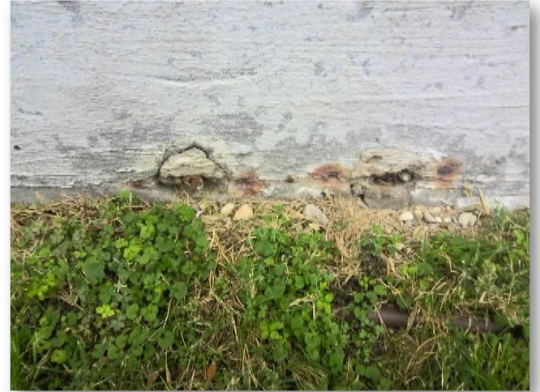
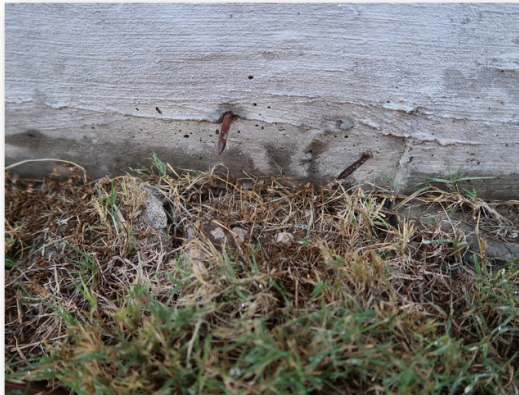
D-Nails are embedded in the foundation wall. If they rust, the surrounding area may expand, and rust stains may run down the wall, negatively impacting its appearance. Additionally, there is a potential safety risk, as the rusted nails could cause injury. It is recommended that they be removed.

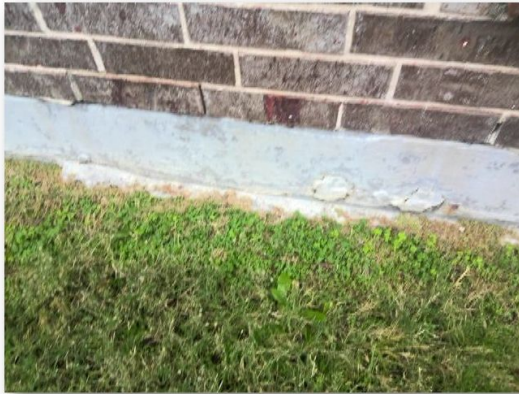
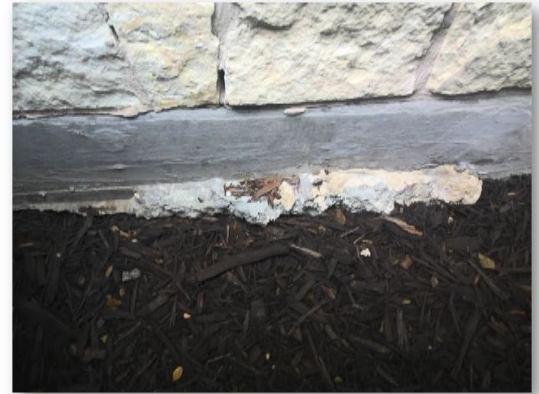
M-The foundation footing is partially exposed at one or more locations. Those areas should be backfilled, leaving 4 to 6 inches of the foundation exposed, and the soil sloped away from the foundation for proper moisture runoff.

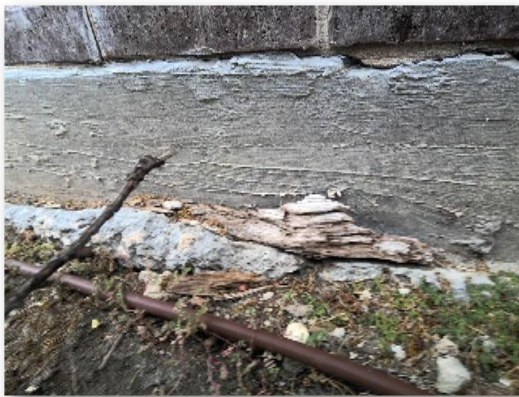
M-Exposed wood on the foundation wall should be properly treated and sealed to prevent any further damage or wood destroying insect infestation.

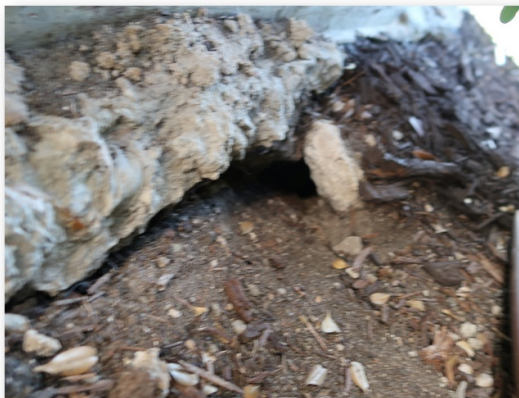
M-Sinkholes are observed around the front of the house. These depressions in the soil indicate poor drainage management, which can lead to water pooling near the foundation. Left

unaddressed, these areas can attract vermin and potentially compromise the integrity of the foundation. It is recommended to fill these sinkholes with soil to prevent further erosion and to enhance the foundation's protection against moisture intrusion.

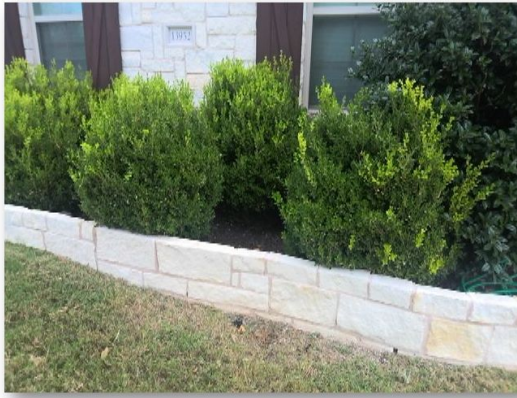
The foundation wall of the front of the house was obstructed by heavy foliage. Home Inspection is visual in nature only, the inspector disclaims responsibility for confirming the condition of any obstructed wall structure that was not readily visible.

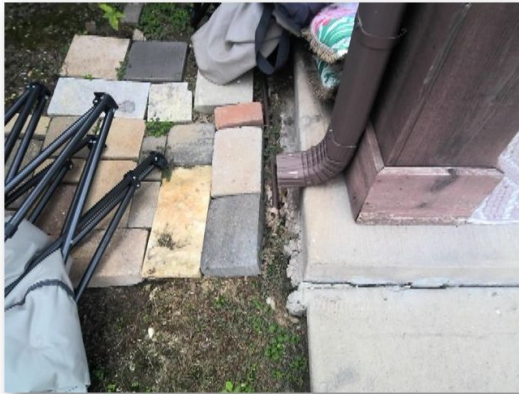
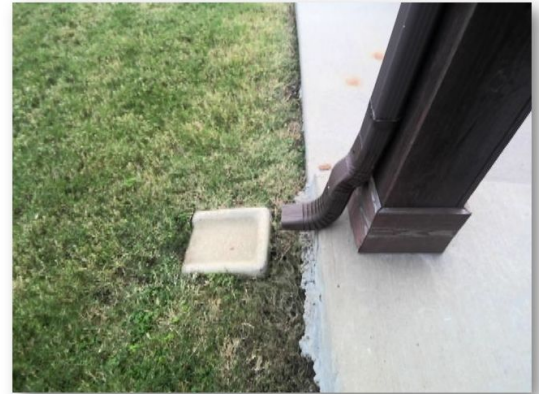
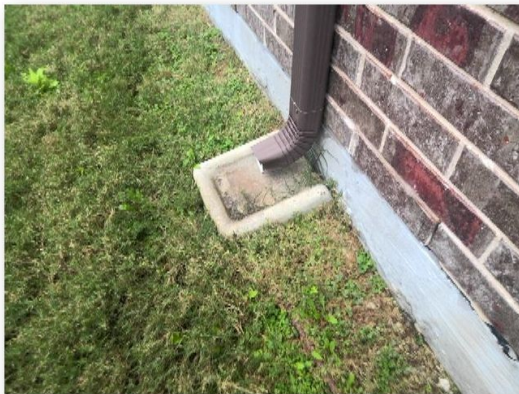
**M- A complete gutter system with extensions is recommended on this structure.** The gutter system is designed to expedite the drainage of water away from the property. Splash plates located under the down spouts can help direct water away from the foundation and reduce soil erosion, which can reduce the effectiveness of the termite chemicals placed in the soil.

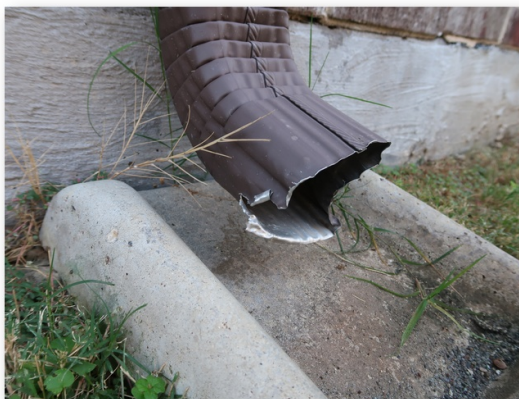
M-The downspout shows damage at the end section, which may impact proper drainage functionality and should be evaluated for repair or replacement to ensure effective water flow away from the foundation.

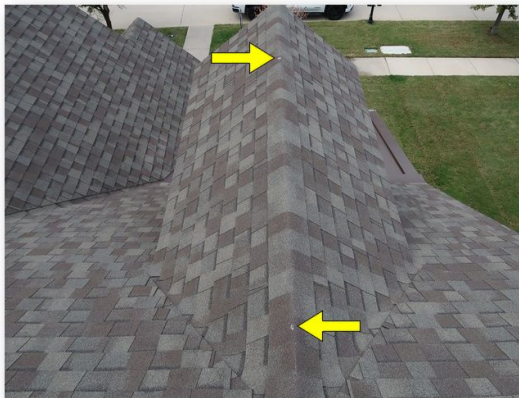
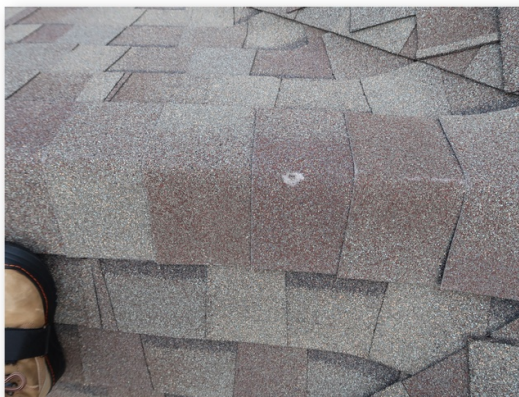
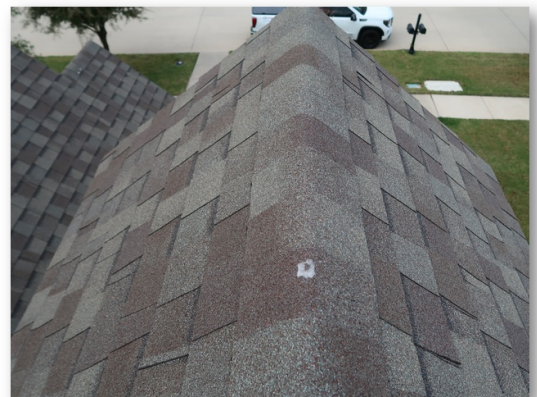
**M-Mechanical damage** refers to any damage caused Installing shingles or equipment, cleaning gutters, making repairs, or performing construction work of other types can put people on the roof with tools or equipment capable of damaging shingles.

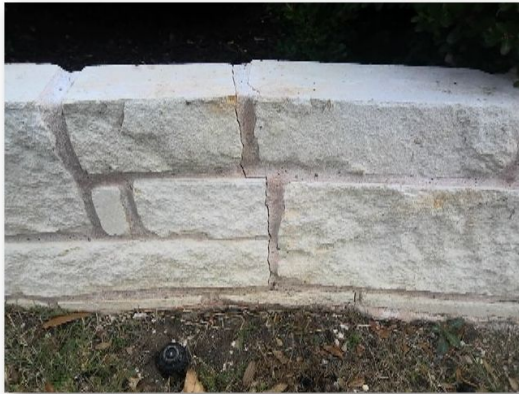
M-mortar Hairline cracks were observed on the flower bed decoration wall. Monitoring is recommended to assess if further movement or deterioration occurs, as these may not impact the wall's structural integrity.

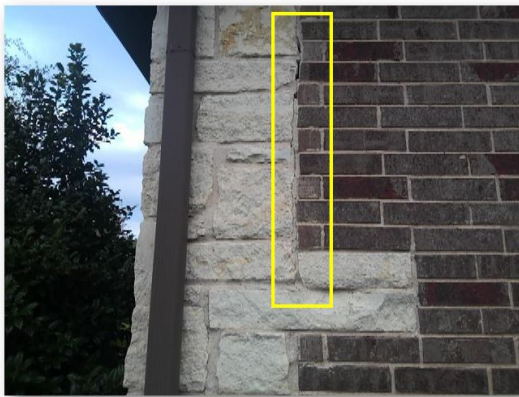
M-A vertical hairline crack is present at the intersection of the stone and brick exterior walls on the front right side of the house; this crack does not indicate a structural issue.

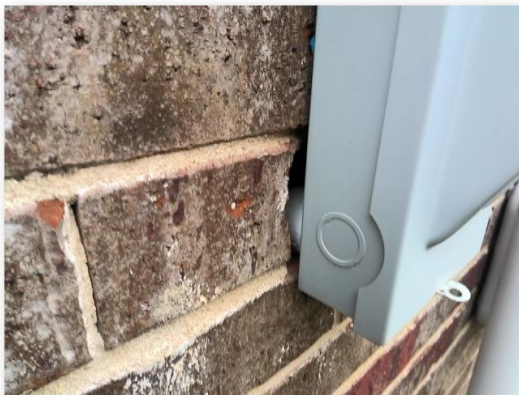
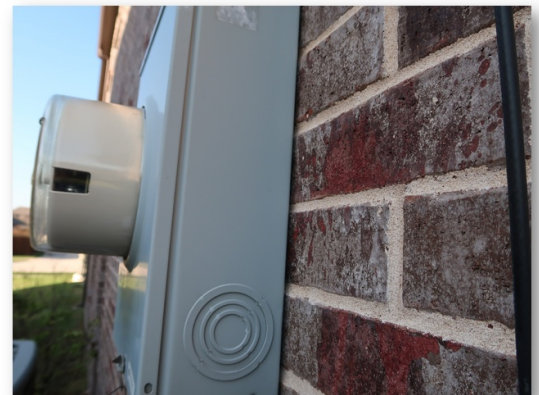
M-Sealant is needed around the electric box attached to the exterior wall to prevent moisture intrusion.

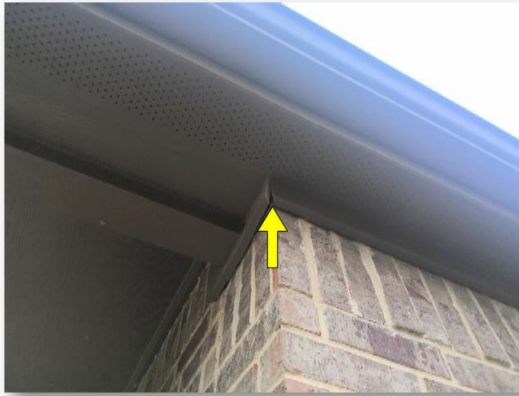
M-A gap was observed in the frieze board at the corner of the house. Sealing this area is recommended to prevent potential moisture intrusion and pest entry.

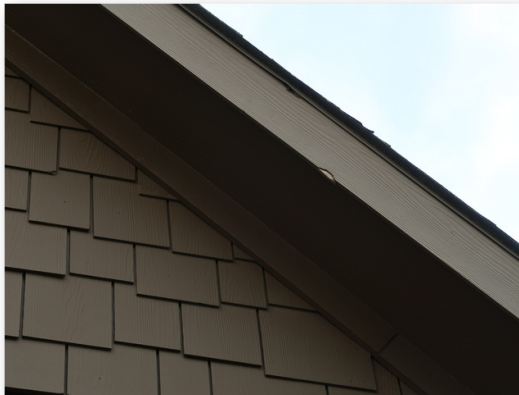
M-Chip damage was observed on the front eave of the house. Repair is recommended to prevent potential worsening of the damage and to maintain the integrity of the eave.

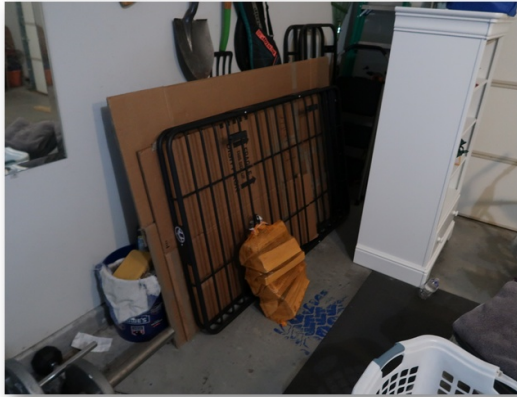
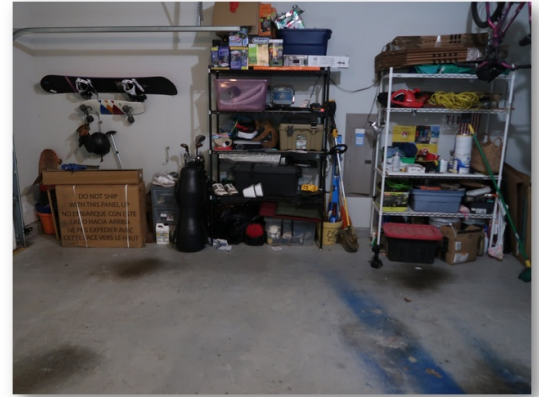
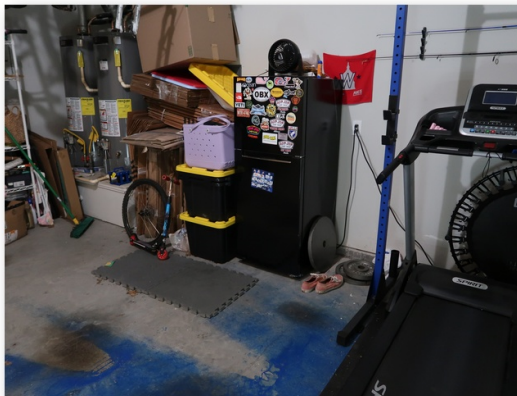
During the inspection of the property, it was noted that the some of garage space was obstructed by the owner's personal items. The presence of these items limited the ability to fully assess the condition and functionality of the garage.

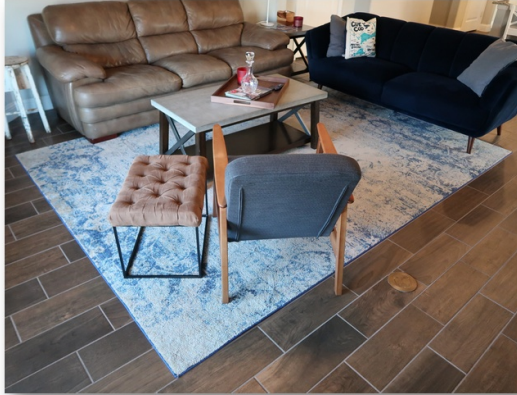
The floor areas covered by furniture and carpet were not visible for inspection.
