**PrimeVue**  
HOME INSPECTIONS

**HOME AND TERMITE INSPECTIONS**  
**254-727-0900**

*Inspected by Jude Hwang TREC #25266*

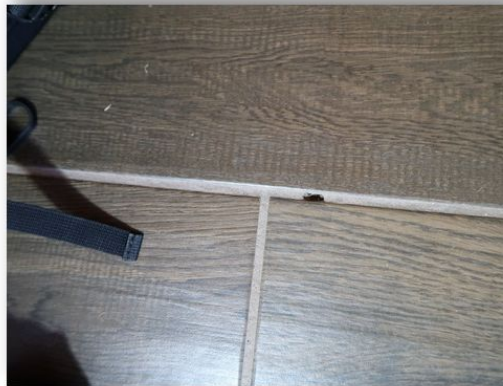
M- Floor tile with a visible gap in the mortar near the front of the office room. This gap should be filled to maintain stability and prevent further damage to the surrounding tiles.

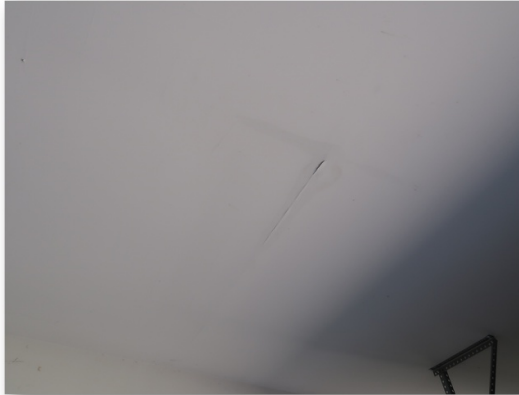
M- Minor cracking was visible in the garage ceiling.

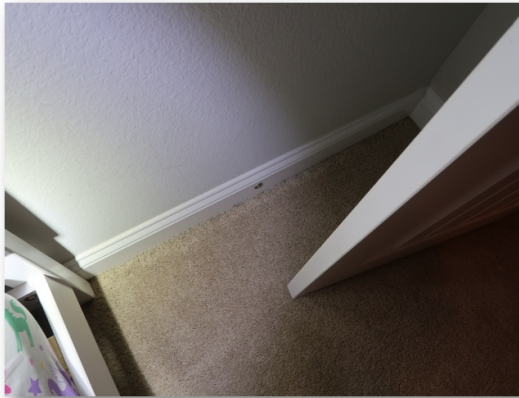
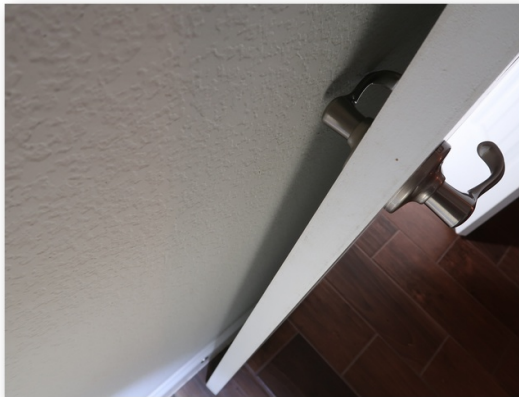
D-An interior doors were missing or pull off a stop. This condition is may result in wall and door damage. A stop be installed to protect the wall.

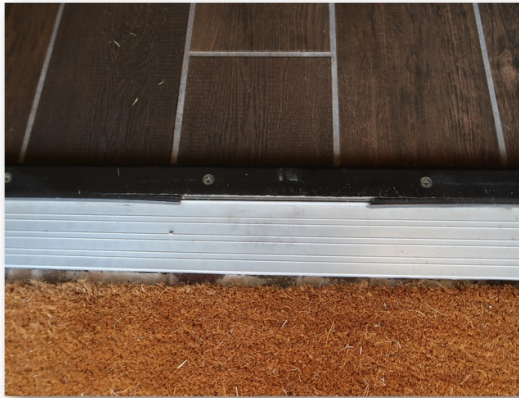
M-The weather seal at the bottom threshold of the exterior door at the house entrance is damaged, which may allow air and moisture intrusion; repairing or replacing the seal is recommended to ensure proper insulation and protection against weather elements.

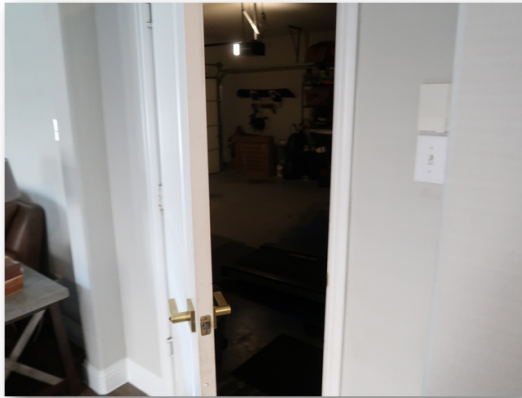
The door in the wall between the garage and the home living space operable self-closing or automatic-closing device installed as is required by modern safety standards. Self- or automatic-closing doors are designed to slow the spread of fire starting in the garage and to prevent toxic exhaust fumes from entering indoor air. An operable self- or automatic-closing device should be installed by a qualified contractor.

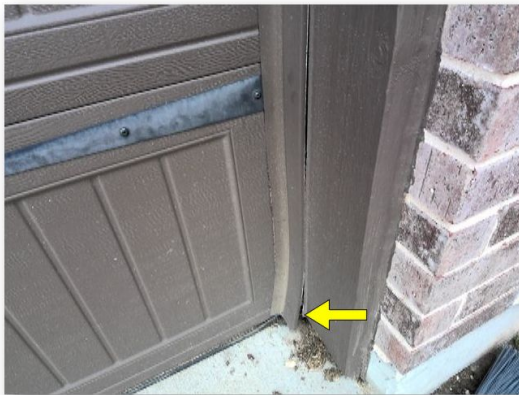
M-The weather seal at the bottom of the exterior trim on the garage door has come loose, which could lead to moisture intrusion and reduced insulation; reattaching or replacing the seal is advised to maintain protection and efficiency.

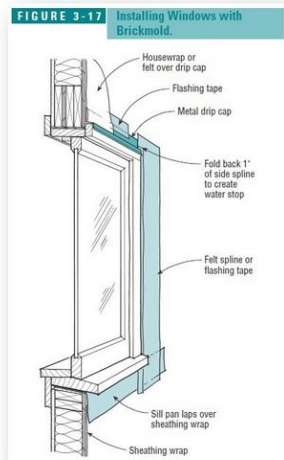
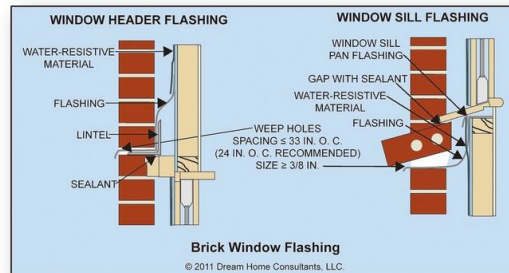
When components of the exterior window sill are loose, damaged, or deteriorated, maintenance is required. This helps prevent moisture from intruding into the home materials and exterior wall structure and prevents the development of microbial growth, such as mold. All work should be performed by a qualified contractor.

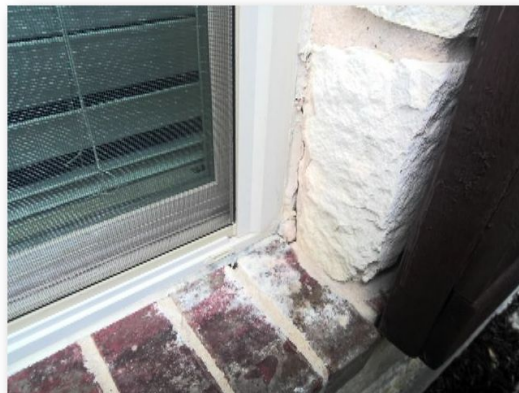
M-There is a gap in the silicone sealant at the corner of the exterior window frame on the front of the house, as well as at the bottom corner of one of the interior window frames. Sealing these gaps is recommended to prevent potential air and moisture intrusion.

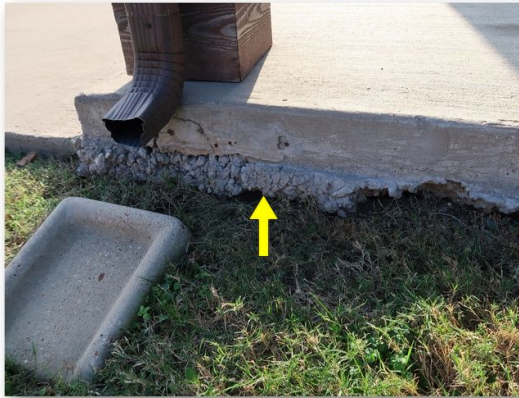
Honeycombing was visible in portions of the concrete patioed wall. Honeycombing is caused by incomplete consolidation of the concrete at the time it is originally placed. Although this condition reduces the load-bearing capacity of the wall to a small degree it is more of a cosmetic issue than a structural problem.

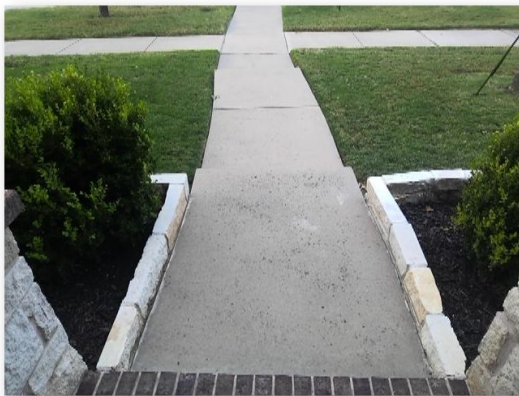
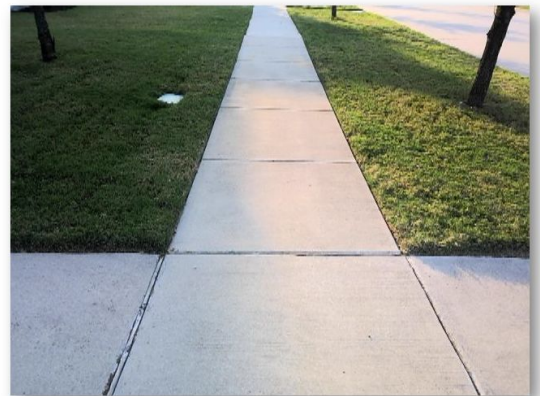
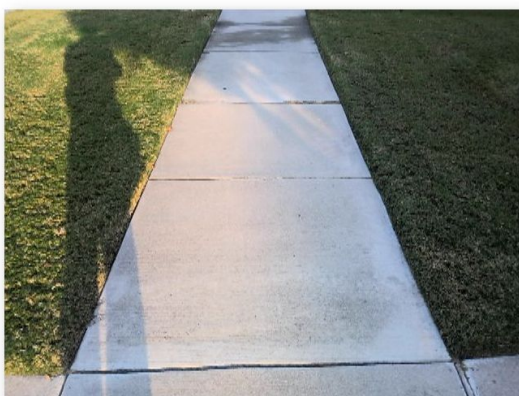
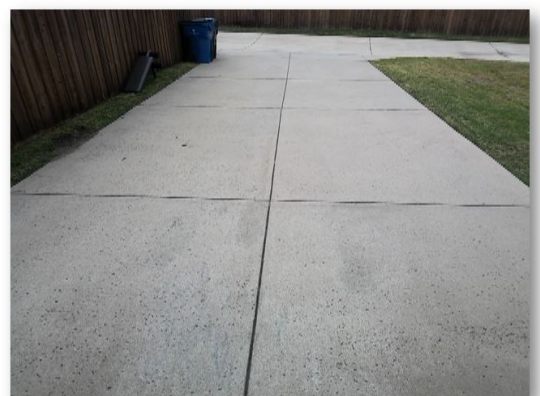
M-A small common hairline crack was observed at the corner of the walkway in front of the house. Monitoring is recommended to ensure it does not expand or worsen.

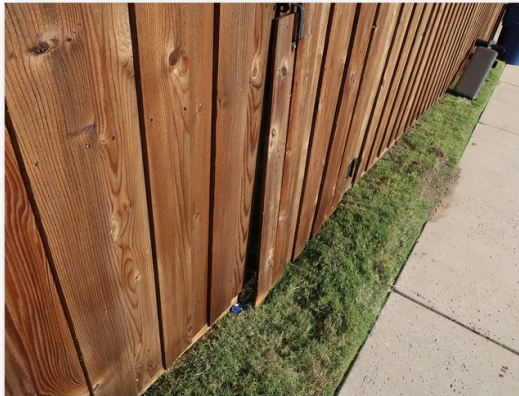
D-The gate on the fence by the garage does not close completely. Adjustment or repair is recommended to ensure proper functionality.

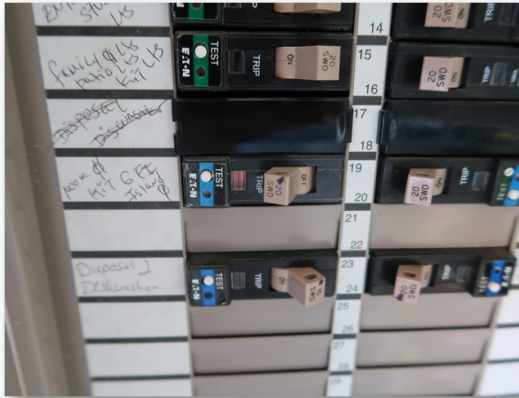
D-The GFCI outlet associated with the kitchen island sink receptacle is frequently tripping, which could indicate an issue with the outlet itself or a potential underlying electrical problem; it is recommended to have this outlet evaluate and, if necessary, replaced by a certified electrician to ensure safety and consistent functionality.

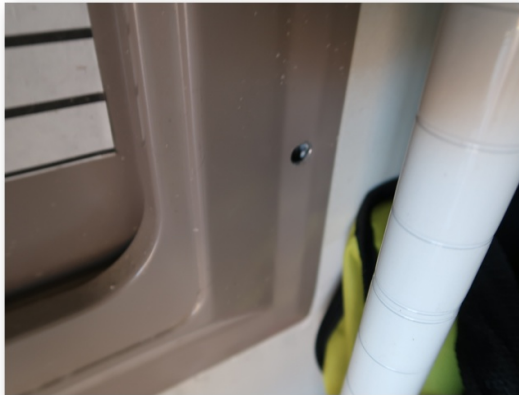
M-A bolt is missing from the electrical dead cover, which may compromise safety; it is recommended to replace the missing bolt to secure the cover properly.

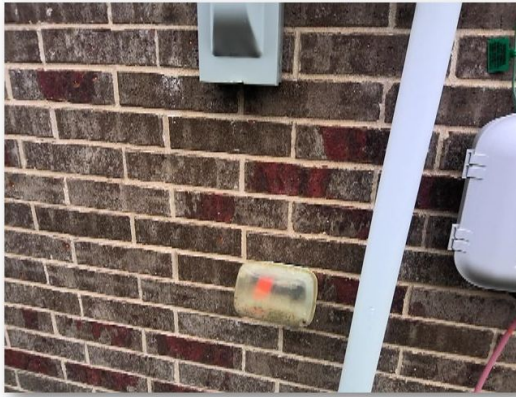
**S-**An open ground error was detected in the GFCI outlet near the electric meter, which can pose a safety risk. Evaluation and correction by a licensed electrician are recommended to ensure proper grounding and electrical safety.

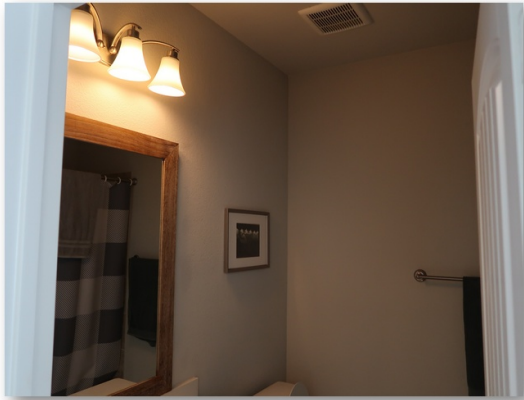
M-The lighting in the second-floor bathroom is noticeably dim, which may affect visibility and usability; it is recommended to assess the lighting fixtures and consider upgrading or replacing them to improve illumination in the space.

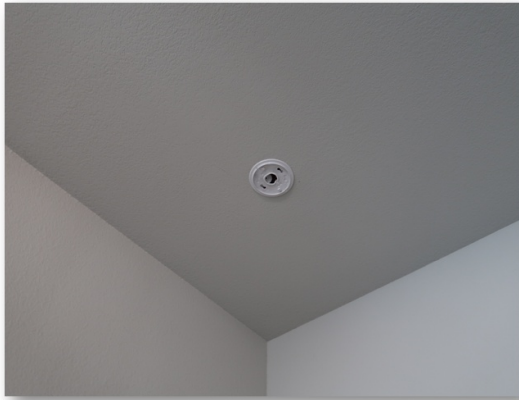
S-The smoke detector is missing in the master bedroom, which is a safety concern; installing a smoke detector is recommended to ensure proper fire safety measures are in place.

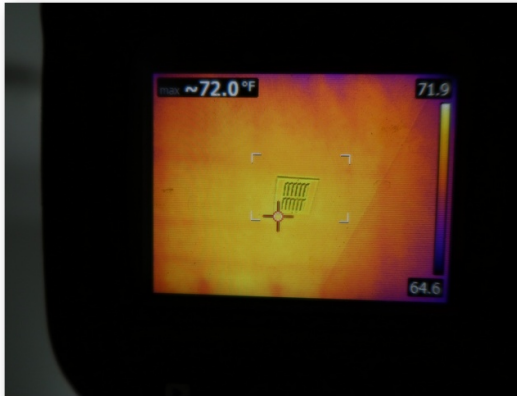
D-The HVAC supply in the second-floor guest room is not delivering air from the air handler, potentially due to a blockage or system malfunction; observation and evaluation by a certified HVAC technician are recommended to diagnose and restore proper airflow and functionality.

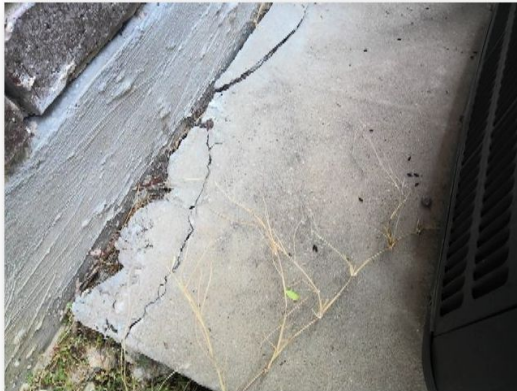
M-A crack was observed at the junction where the concrete pad of the outdoor air conditioning unit meets the wall; this crack does not indicate a foundation issue.

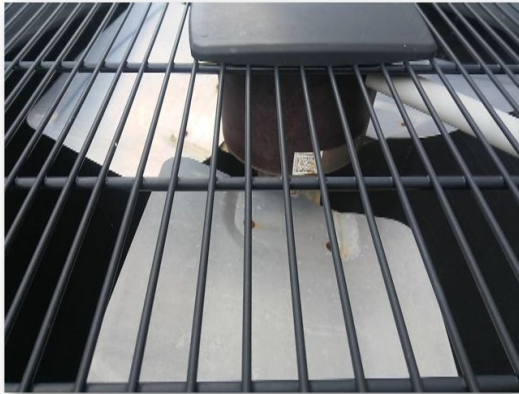
M-Rust was observed on the exterior of the fan motor casing for the A/C outdoor unit, which may lead to further deterioration; monitoring and potential maintenance are recommended to prevent rust-related damage.

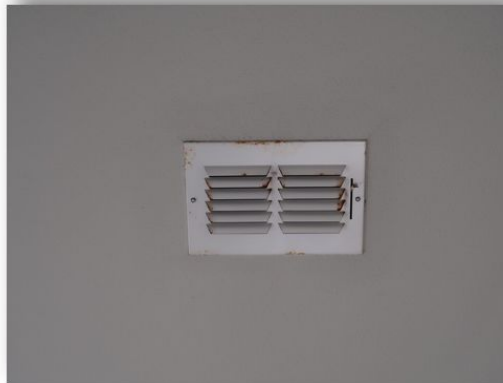
M-Rust was found on the mesh cover of the supply vent in the master bathroom, which may affect air quality and appearance; cleaning or replacing or paint the cover is recommended to maintain functionality and aesthetics.

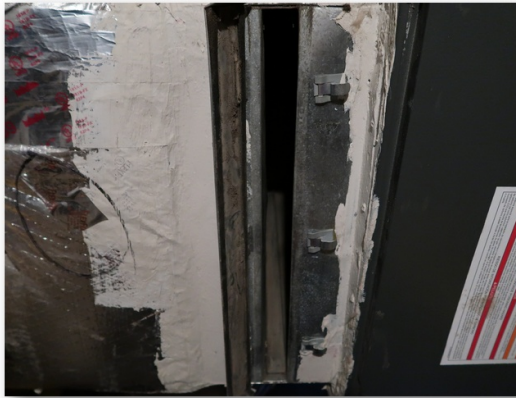
D-The furnace is currently missing an air filter, which can lead to decreased efficiency and potential buildup of dust and debris within the system; installing the appropriate filter is recommended to ensure optimal performance, protect internal components, and maintain air quality.

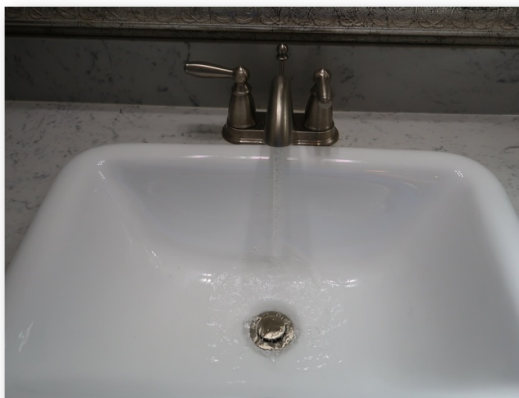
M-One of the bathroom drain stoppers was not functioning properly, preventing effective operation; adjustment or replacement is recommended to restore full functionality.

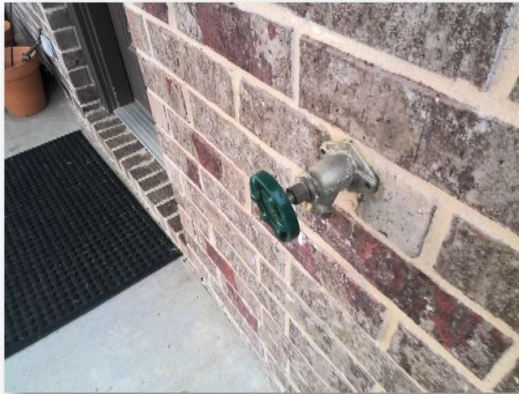
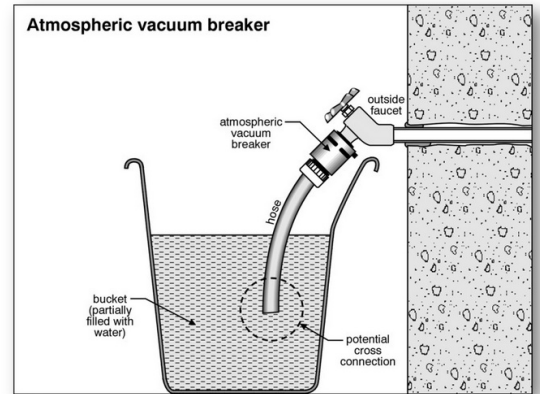
M-The outdoor faucet is missing a vacuum breaker, which is essential for preventing backflow and protecting the water supply from contamination. It is recommended to install a vacuum breaker to ensure safe.

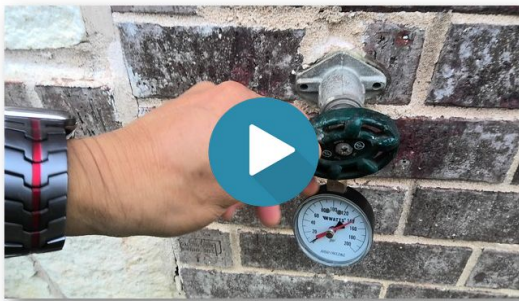
M-The handle on the exterior faucet on the right side of the house is loose, which may affect its operation; securing or repairing the handle is recommended to ensure proper functionality and prevent potential leaks.

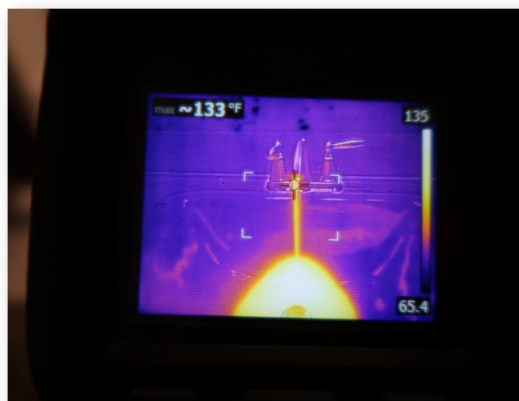
*Water Temp: 133 °F Recommended Hot Water setting should between 115°F – 120°F*

Water heater tanks (if applicable) should be flushed annually to prevent sediment built-up inside tanks and maintain energy efficiency. Recommend a plumbing contractor to service and flush the tank when the opportunity is right. Typical life expectancy for conventional water heaters is 16-18 years (hard water and poor maintenance of the unit may diminish its service life).

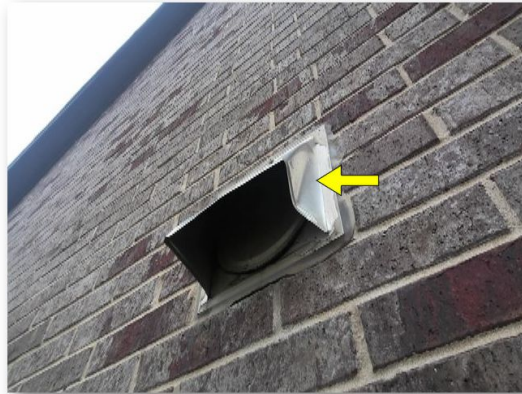
D-The exterior hood fan cover is dented, which may affect its appearance and functionality; repair or replacement is recommended to maintain proper ventilation and aesthetics.

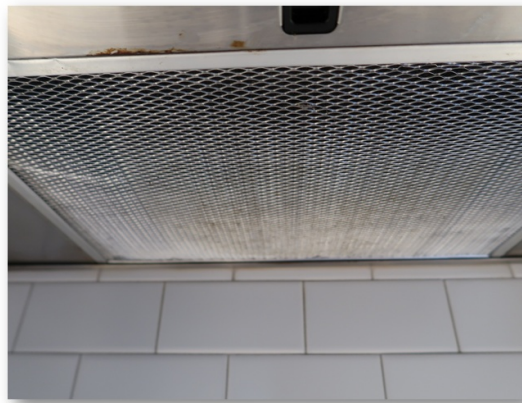
M-The hood filter is dirty, which may reduce its efficiency and airflow; cleaning or replacing the filter is recommended to maintain optimal performance and air quality.

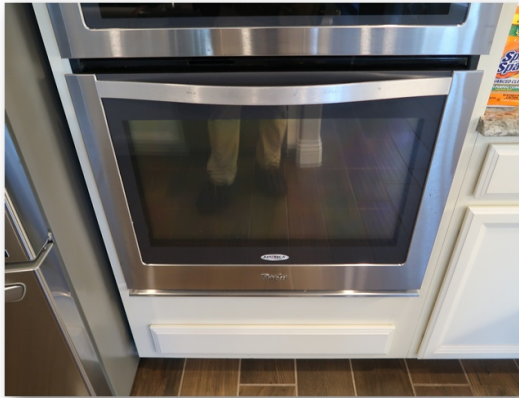
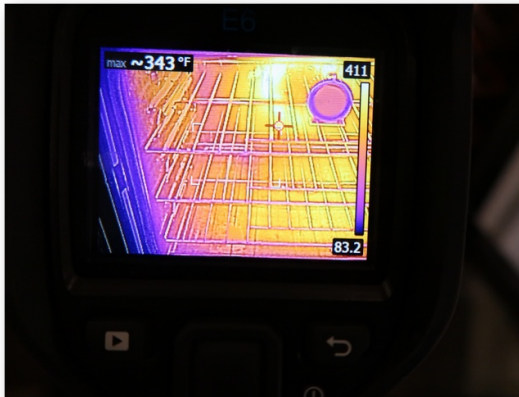
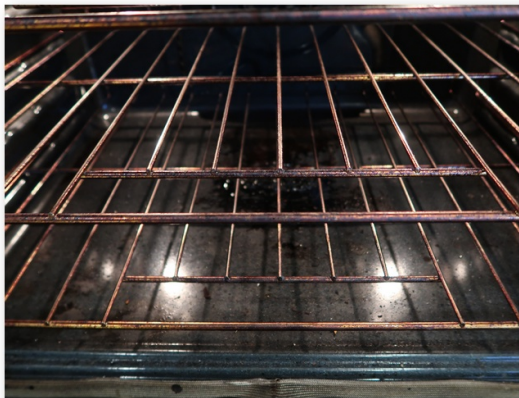
M-The interior of the oven is dirty, which may impact its performance and efficiency; a thorough cleaning is recommended to maintain functionality and hygiene.

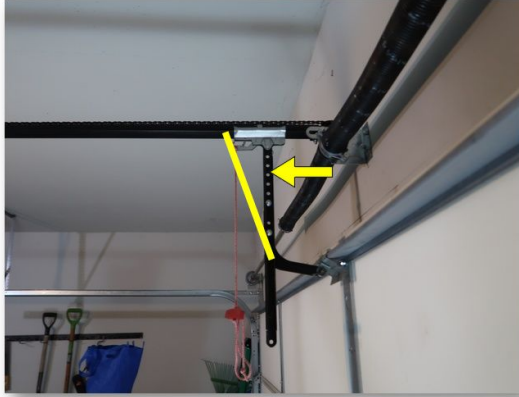
M-To ensure smooth operation of the garage door, it is recommended that the hockey stick part be adjusted to the 1 o'clock position.

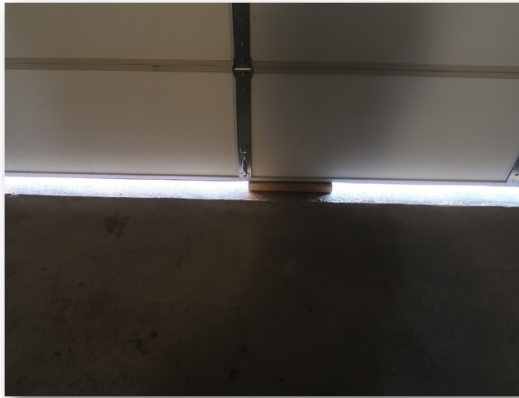
The pressure-activated automatic reverse feature was tested and appeared **not to be operating** in a satisfactory manner at the time of the inspection. Garage doors are not tested by the Inspector using specialized equipment and this inspection will not confirm adherence to manufacturer's specifications. This inspection is performed according to the Inspector's judgment from past experience.

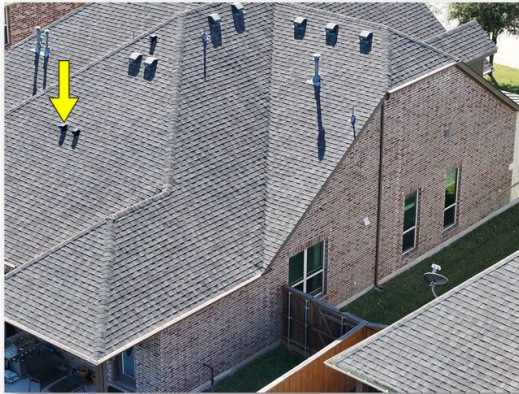
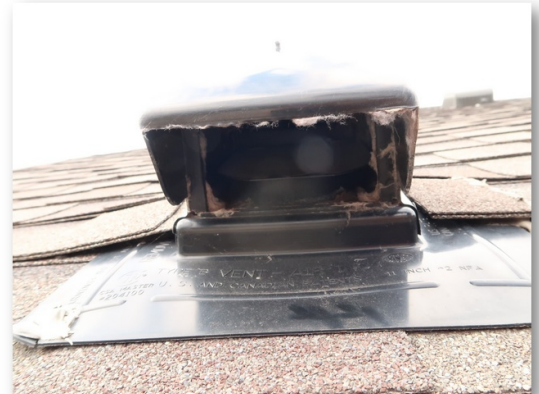
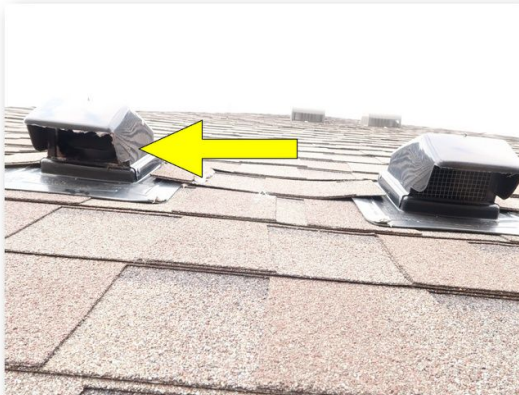
The dryer vent should be cleaned at least annually if not more frequently. Cleaning your dryer vent piping will allow the dryer to vent properly and work more efficiently. Dryer vents that are not cleaned regularly can be a fire hazard.

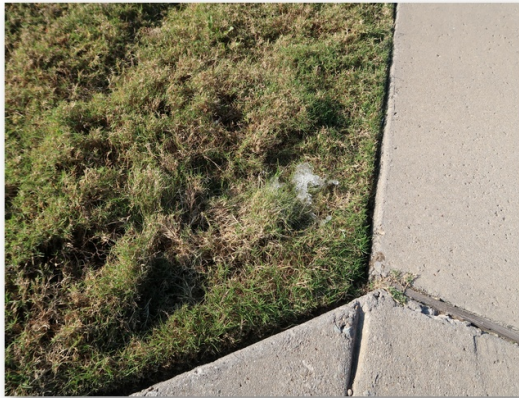
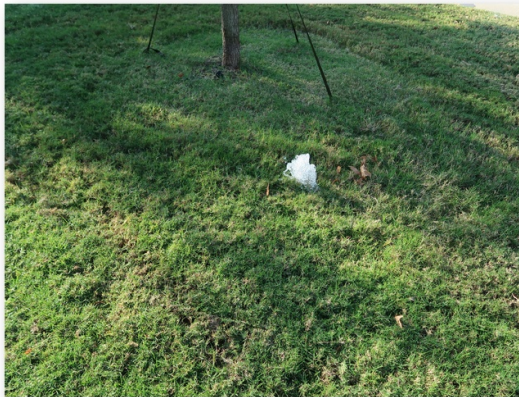
D-In sprinkler zones 2, 4, and 7, one of the heads is damaged, causing water to spray around the lawn area; repair or replacement of the affected sprinkler heads is recommended to ensure efficient water distribution.

Deficiencies in ZONE: 2,4,7

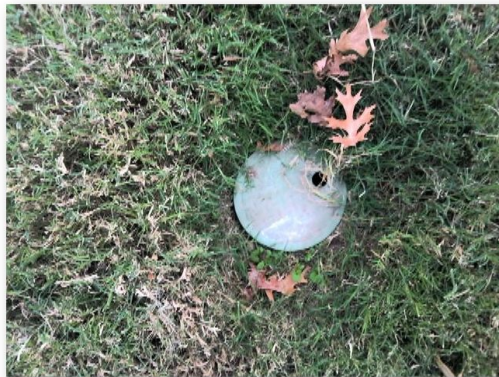
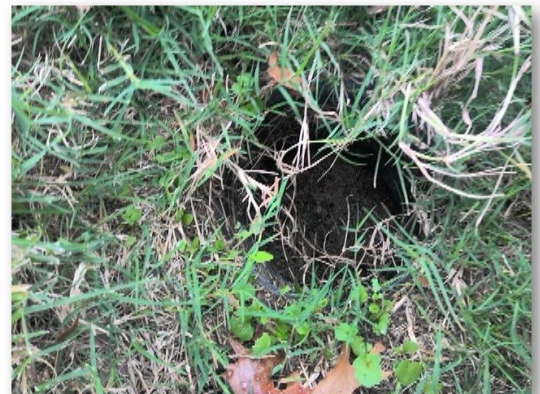
D-The main valve next to the irrigation backflow prevention box is buried in the ground, making it difficult to access in case of emergency; it is recommended to keep the valve visible at all times for easy access and quick shutoff if needed.
